2015 T.E.N.T.A.C.L.E. Incorporated Rehabilitation Report

Metromix Pty Ltd.
Teralba

Bush Regeneration

End of Year Report
2015

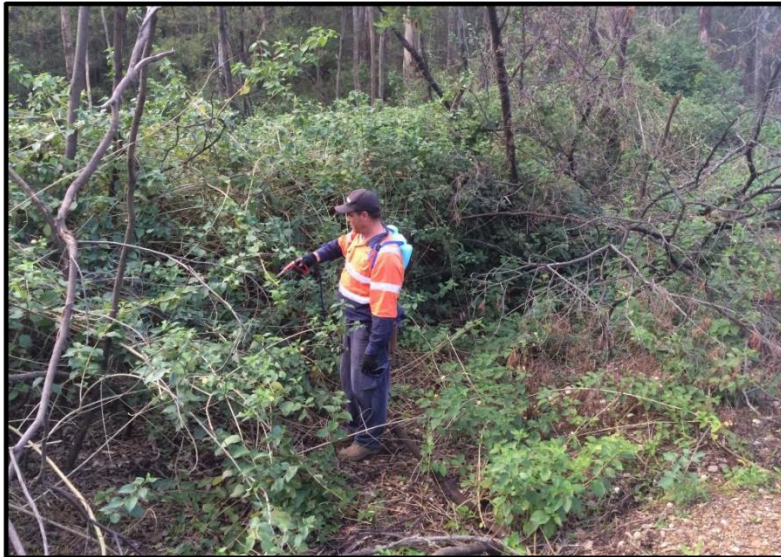
Several large, dense stands of weeds (primarily lantana) have been treated using chemical control methods (splatter gun) with great success. This method has left the vegetation in those areas quite lifeless, but due to the abundance of surrounding habitat, the method was deemed harmless.

**Figure 1: Splatter Gun control method used on dense lantana located to the north of the main pit.
(BEFORE)**
Date Taken: 9/6/15

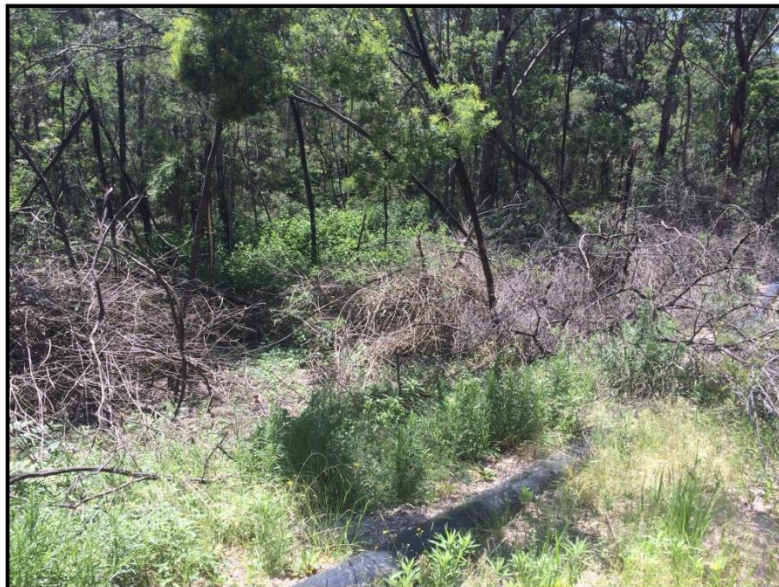
Figure 2: AFTER effects of Splatter Gun treatment.
Date Taken: 23/11/15

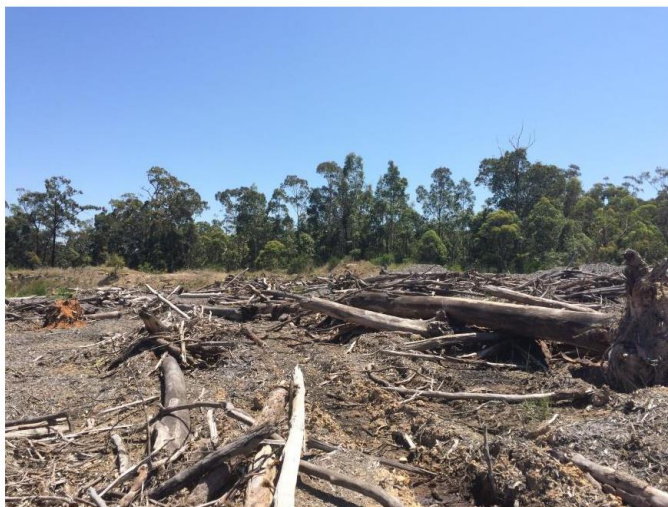
A mixture of 190 tree saplings were planted on the north-west section of the quarry as a part of Metromix's rehabilitation program. These species included:

Figure 3: Vegetation rehabilitation area in the north west part of the main pit. Date Taken: 23/11/2015

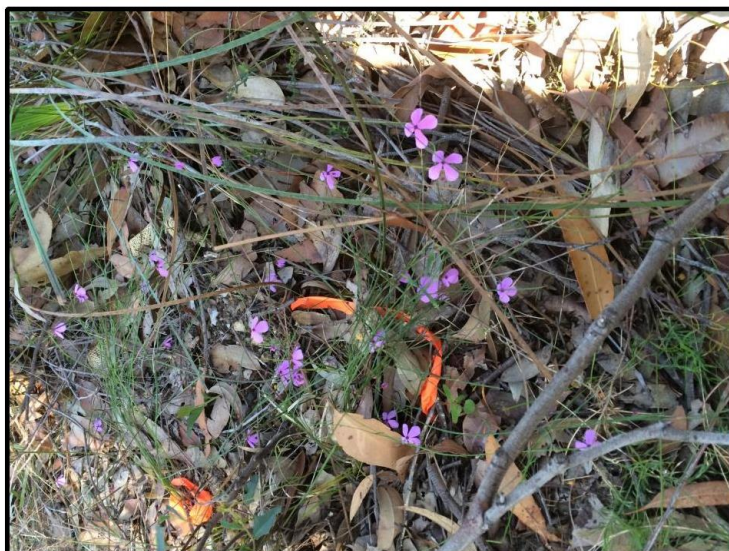
A total of 40 endangered *Tetratheca juncea* were identified and tagged, potted, translocated and planted to a section of the quarry that is not to be disturbed in the future. These plants are endemic to this region and have a notoriously poor survival rate after translocation. However, due to researched methods, careful implementation continual monitoring and reporting a large 80% of plants have survived after 4 months since translocation.

Figure 4: Translocated *T. juncea* displaying its upside down lilac coloured flowers.
Date Taken: 1/9/15

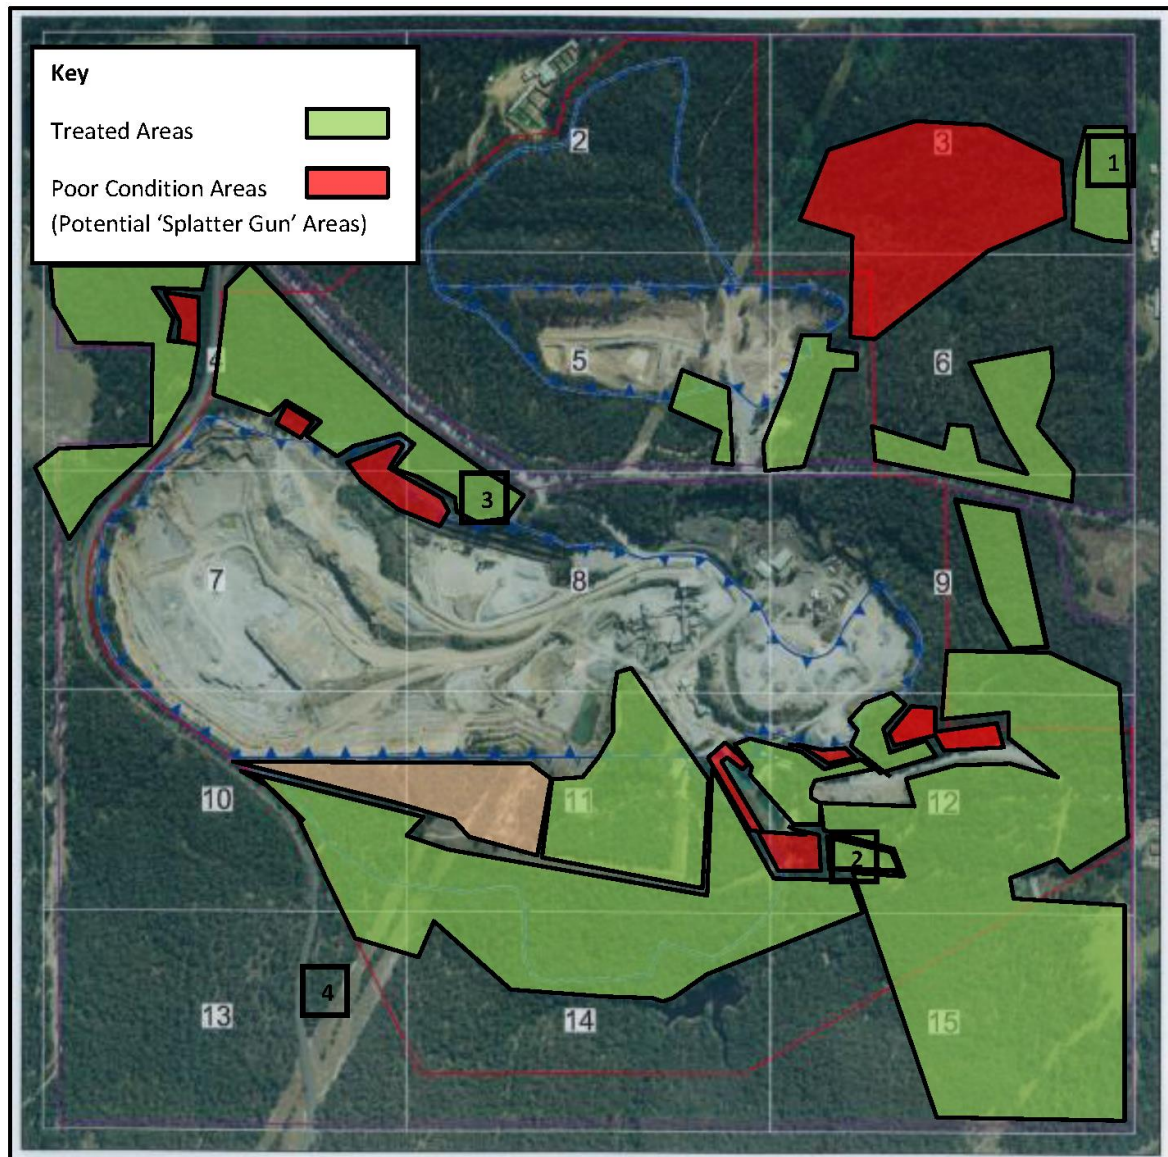
In summary, along with Figure 5, the vast majority of the site has now been treated and in moderate – good condition. Large stands of bushland void of weeds are present, particularly south of the pit. Along with these healthy environments, are areas that have been moderately – extensively treated this year, and cover a large portion of the site. There are several areas still present with dense stands of *L.camara*, but the main area of concern is located to the north east area of the site.

As the map displays (Figure 5), much of the site has been cleared during this year. Therefore all that will be required for these areas in the future will be secondary or maintenance weeding, which involves minimal labour. This is the type of control we are striving to achieve.

Much of the map remains without categorisations. This is due to the fact Tentacle has not ground proofed the area in recent times as it is not deemed likely to be drastically impacted by exotic species. These areas have been highlighted in 'red'.

Figure 5: Map of site showing areas that have been treated and areas of interest.
Source: Google Maps

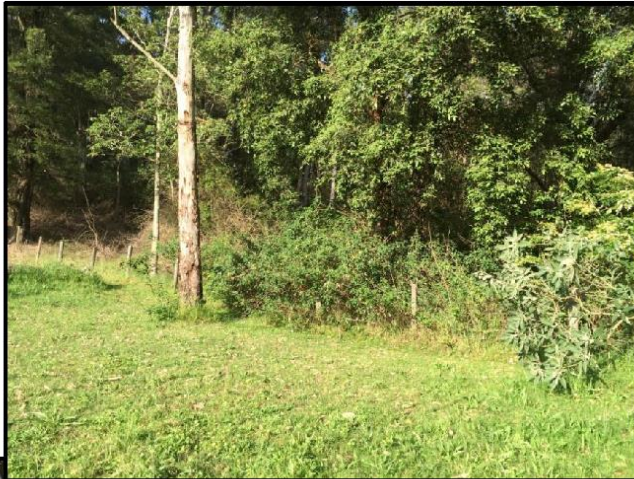
Location: North eastern corner of site.

BEFORE-

Dense coverage of *L.camara* and other exotic species along western border of site and residential property.

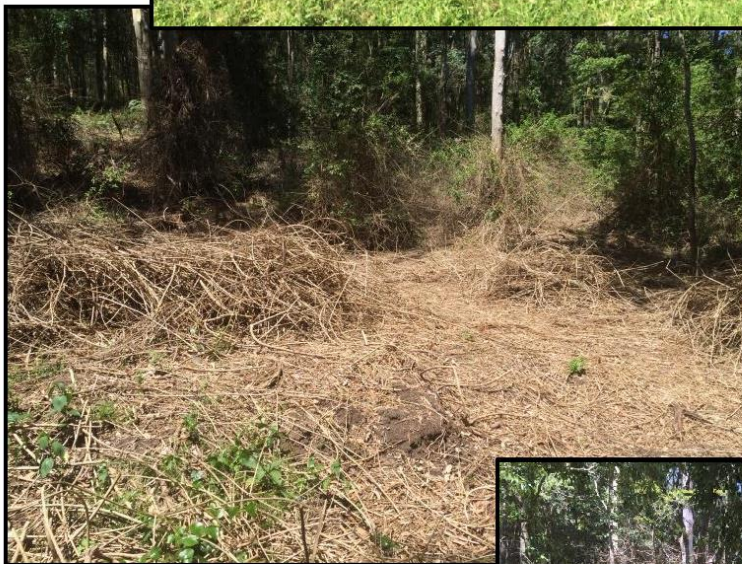
AFTER-

Hand removal method on mainly *L.camara*.

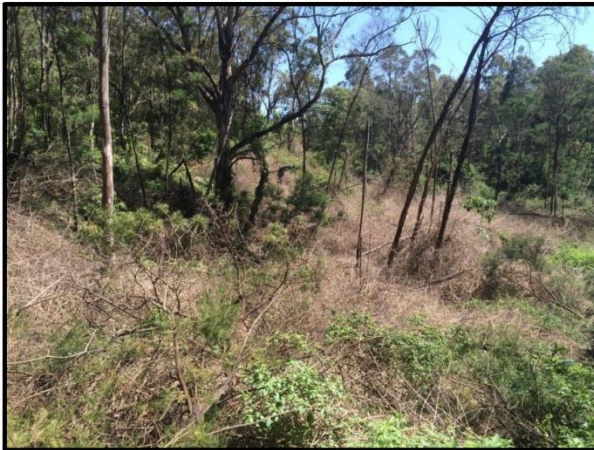
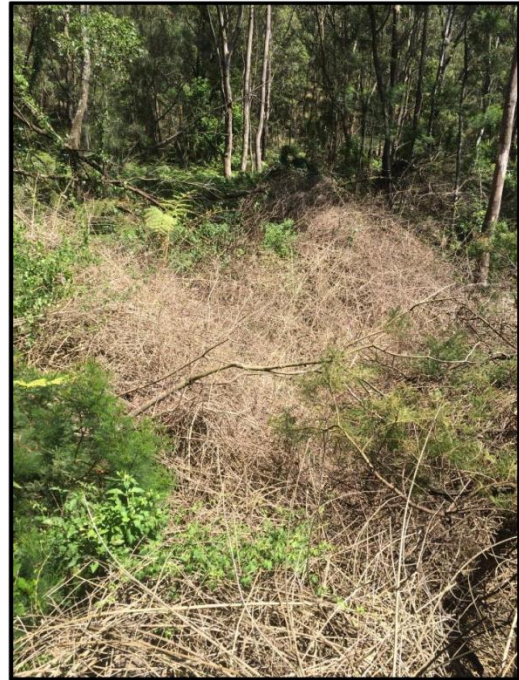
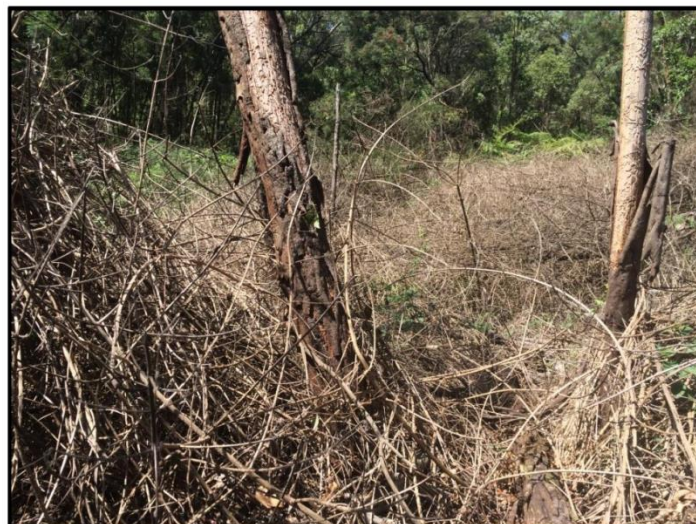
Location: 2- South of the entry road from the east.

After effects of splatter gun herbicide treatment of dense stands of *L.camara*.

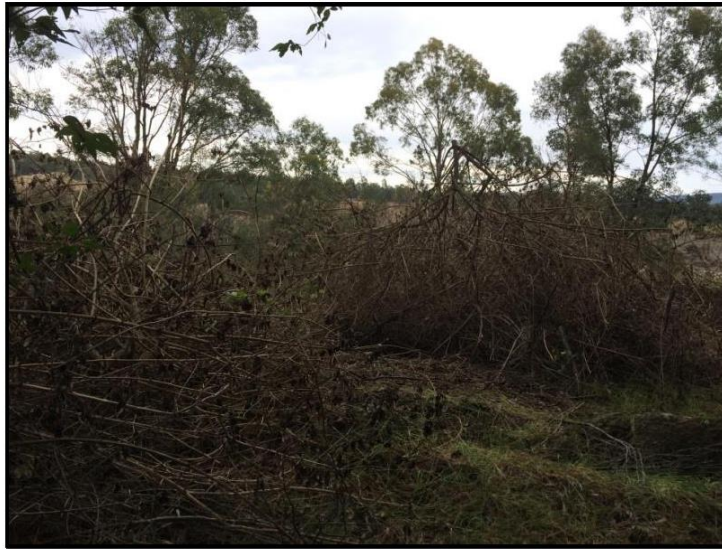
Location: 3 – Centre of the site between Rhonda rd and main pit.

Hand removal method used on dense *L.camara*.

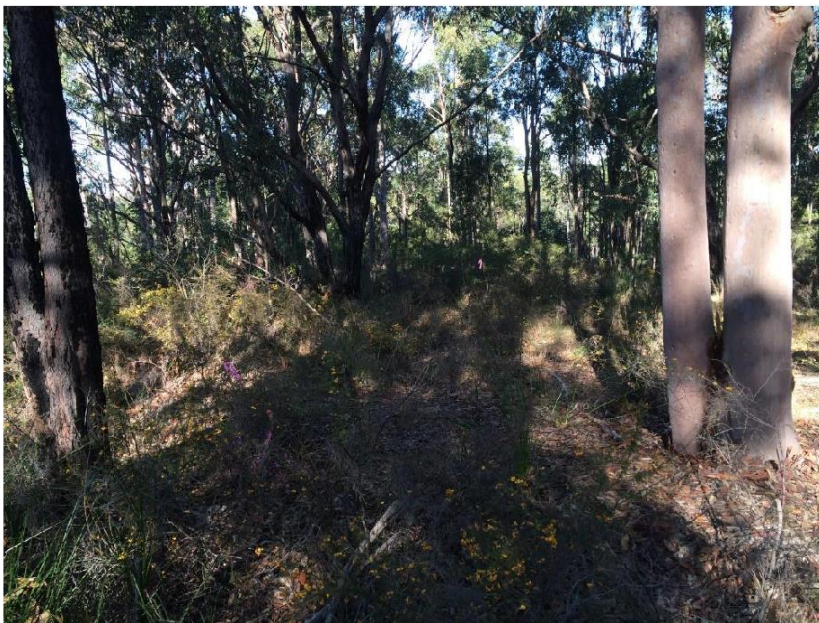
Location 4 – Between eastern haul road and southern power lines.

Site of translocated *T.junceae*.
