2021 Nest Box Monitoring Report

**2021 NEST BOX MONITORING
REPORT**

Teralba Quarry, Teralba, NSW

Job Reference 074 - November 2021

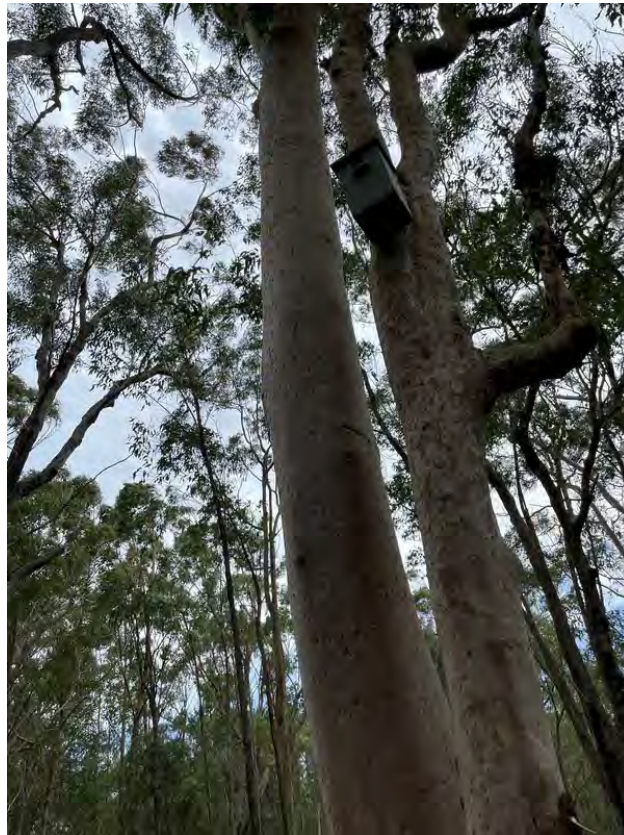
no, 2, Stringybark/Mahogany

Check Method	Nestbox camera
Pests?	Yes
Pest Species	Mud Wasps
Repairs required?	No
Occupation Evidence?	Yes
OccupationEvidenceType	Leaf nest
Fauna Species Observed	None
Number of fauna Species	0
Count Accuracy	Estimate
OccupationComments	Looks like Antechinus or feather tail glider style nest

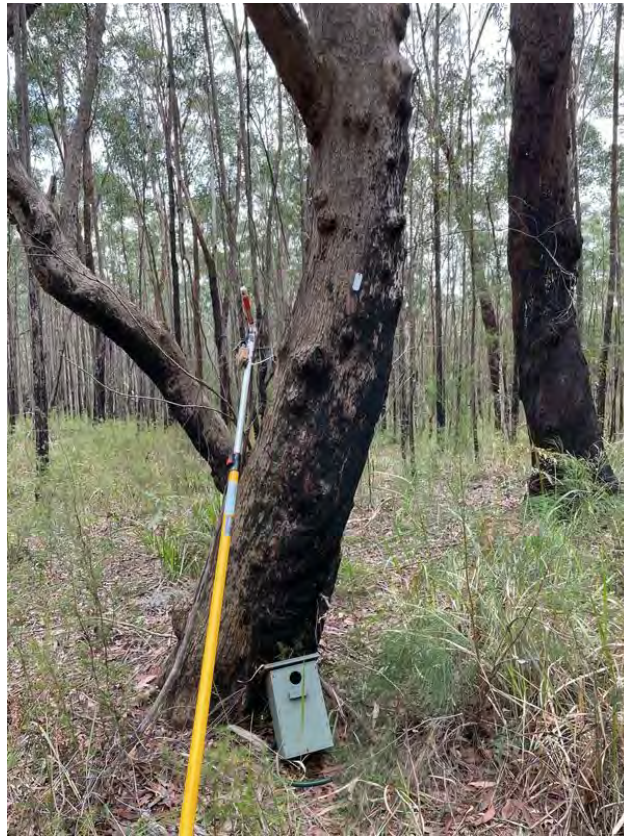
no, 3, Smooth-barked Apple

Check Method	Nestbox camera
Pests?	Yes
Pest Species	Mud Wasps
Repairs required?	Yes
What sort of repairs?	Box on ground, need new wire
Repairs complete?	No
Occupation Evidence?	Yes
OccupationEvidenceType	Leaves (loose)
Fauna Species Observed	None
Number of fauna Species	0
Count Accuracy	Accurate

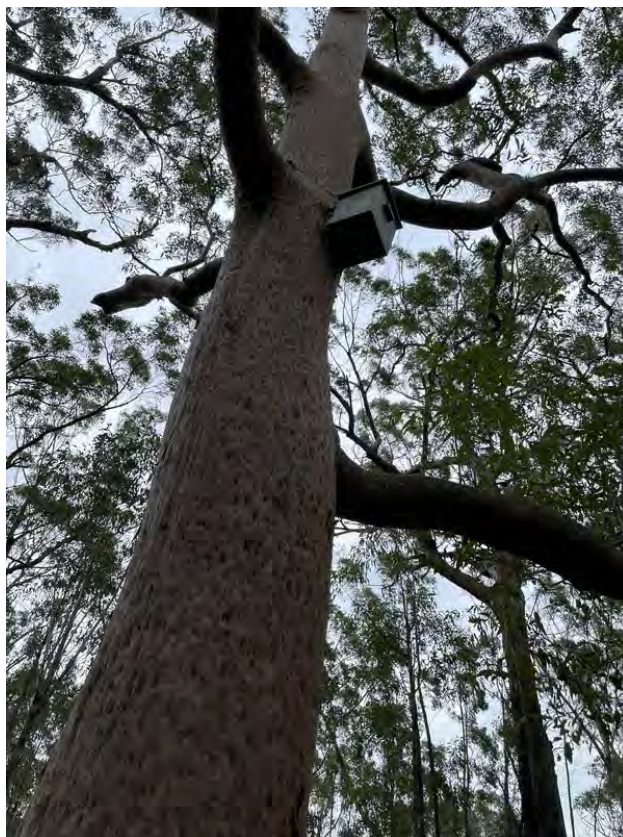
4, Smooth-barked Apple

Check Method	Nestbox camera
Pests?	No
Repairs required?	Yes
What sort of repairs?	Tree tag has fallen off
Repairs complete?	No
Occupation Evidence?	Yes
OccupationEvidenceType	Leaf nest
Fauna Species Observed	None
Number of fauna Species	0
Count Accuracy	Accurate

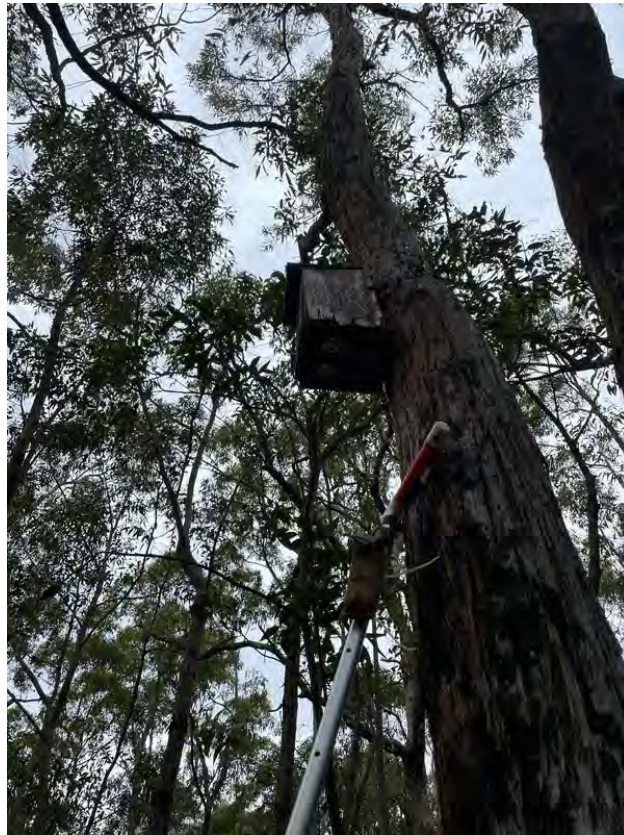
11, Stringybark/Mahogany

Check Method	Nestbox camera
Pests?	Yes
Pest Species	Termites
Repairs required?	No
Occupation Evidence?	Yes
OccupationEvidenceType	Leaf nest
Fauna Species Observed	None
Number of fauna Species	0
Count Accuracy	Accurate
OccupationComments	Termites just started don't need to replace yet

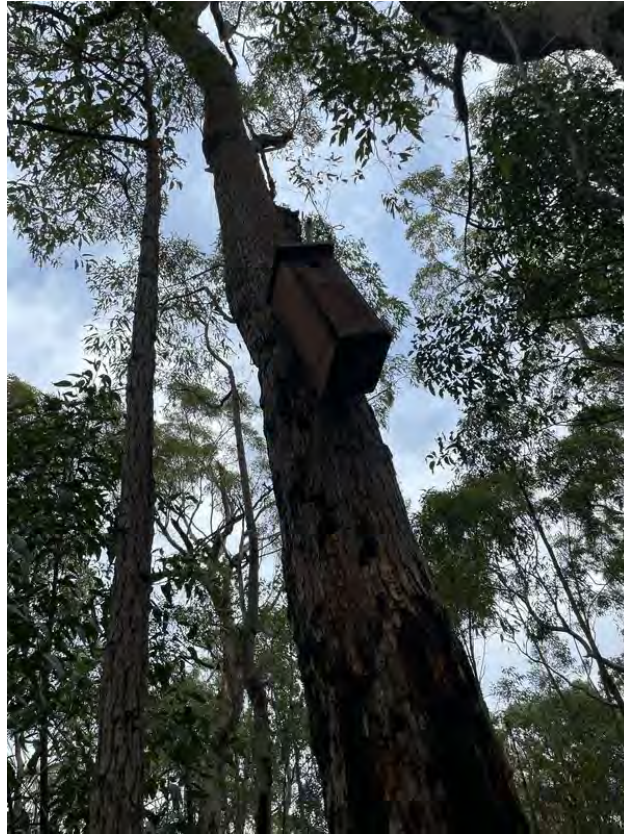
13, Stringybark/Mahogany

Check Method	Nestbox camera
Pests?	Yes
Pest Species	Termites
Repairs required?	No
Occupation Evidence?	No
OccupationComments	Termites just started

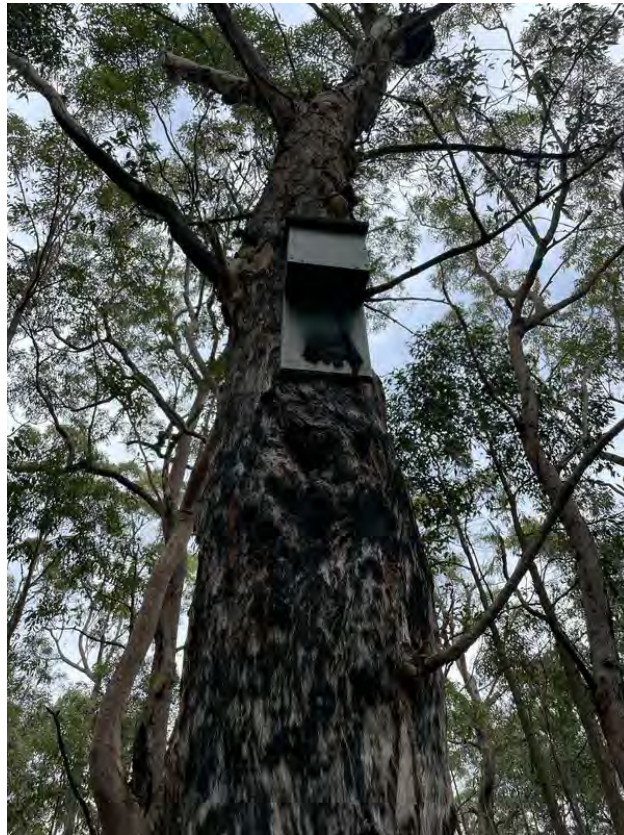
14, Stringybark/Mahogany

Check Method	Nestbox camera
Pests?	Yes
Pest Species	Termites
Repairs required?	No
Occupation Evidence?	No
OccupationComments	Termites probably 1/5 of box. Still lots of room for fauna to cohabit
