# Appendix 7

## Bush Regeneration Annual Report 2021

# METROMIX TERALBA BUSH REGENERATION

*Annual Report*  
*2021*

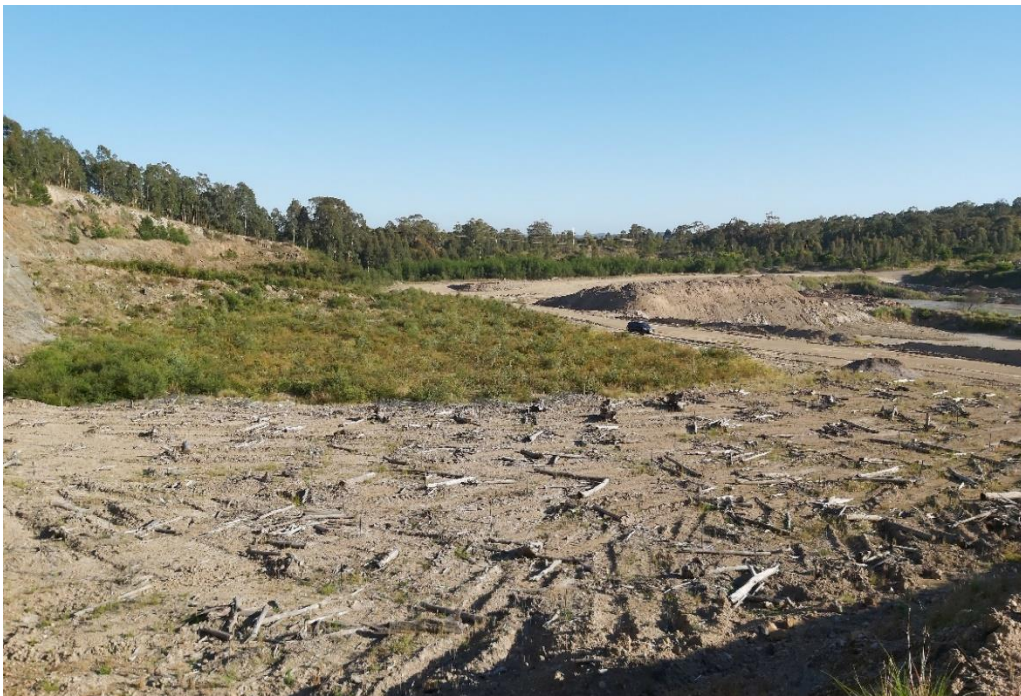
The previously planted revegetation areas are doing exceptionally well, the natives planted have grown significantly in size, and have started to produce seed further increasing the density of natives in those areas. Natural regeneration has occurred with various native species emerging that weren't planted, increasing the biodiversity in the revegetation areas. The previously planted areas have minimal weed species and only require small amounts of maintenance weeding.

**Figure 1:** Photo showing the contrast of the revegetation areas planted in 2020 and 2021.

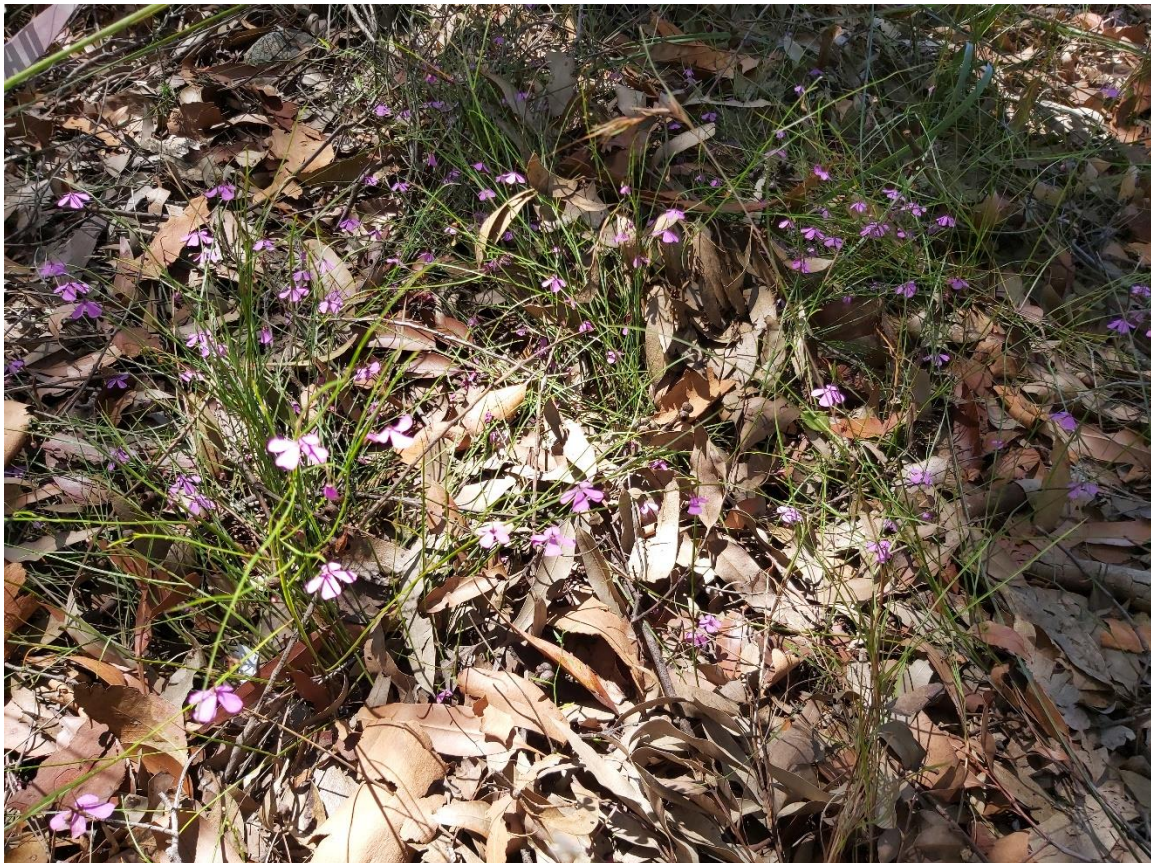
Four new *Tetratheca juncea* plants have been found in proximity of the translocation area. A sweep of weeds was done throughout the translocation area, no weeds were found. Continued monitoring of the *Tetratheca* areas will be carried out in the following year to ensure no weeds emerged and to monitor the health and population of the *Tetratheca*.

Mountain bike riders continue to use a track that goes straight through the middle of the translocation area despite the area being repeatedly tapped off. The track is right next to several *Tetratheca* plants. This can potentially damage or kill plants that are in the area and stop new plants from growing, in addition to introducing weed species to the site. It is recommended that wire fence be installed around the area and that signage put in place to deter the riders from entering the area.

**Figure 2:** A cluster of flowering *Tetratheca juncea* in the translocation area.

The natives planted this year are in good health, continued maintenance weeding of all the revegetation areas will continue next year to allow the natives to have the best chance of survival, stopping competition from weeds. It is recommended that wire fence be installed around the *Tetradlea* translocation area, and that signage be put in place to deter the mountain bike riders from entering the area.

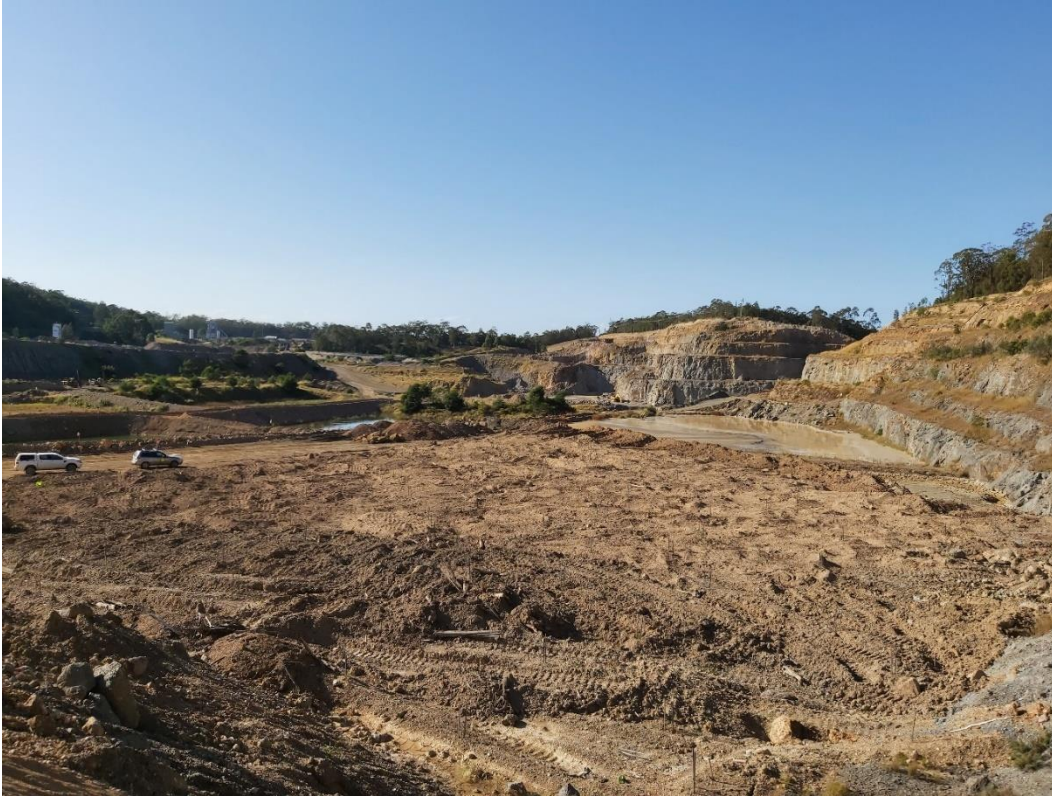
**Figure 4:** Photo Point 1 – A before photo of the revegetation area that was planted out in 2020.  
(Looking Southeast) - Date Taken: 5/05/2020

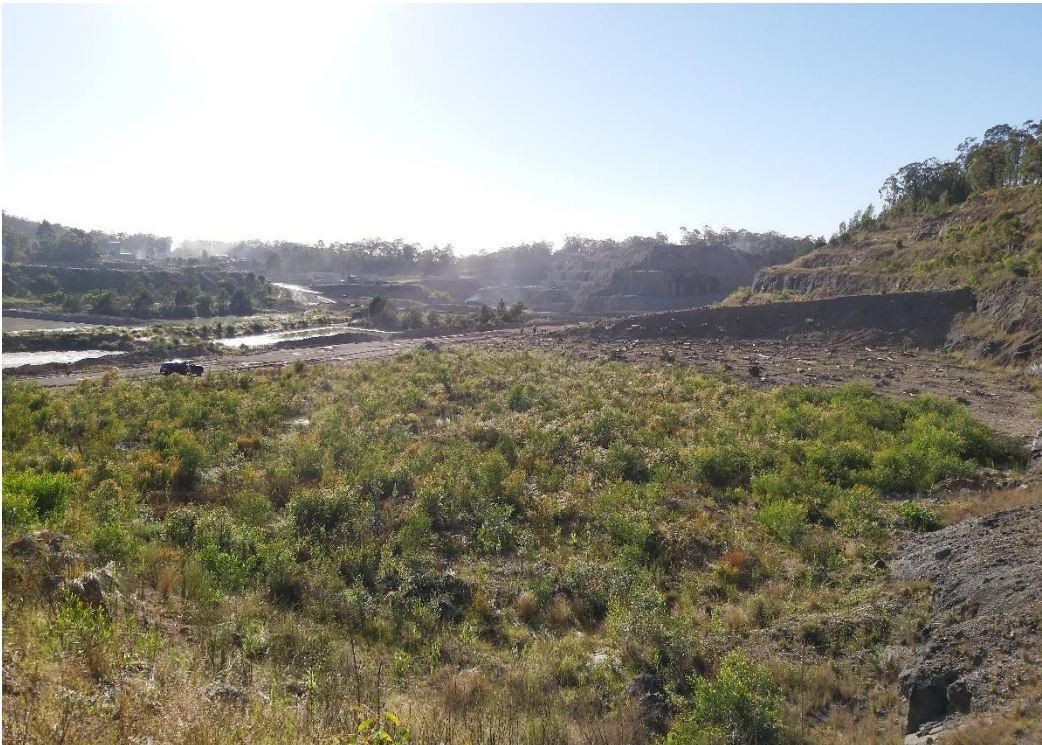
**Figure 5:** Photo Point 1 – An updated photo of the revegetation area that was planted out in 2020.  
(Looking Southeast) - Date Taken: 15/12/2021

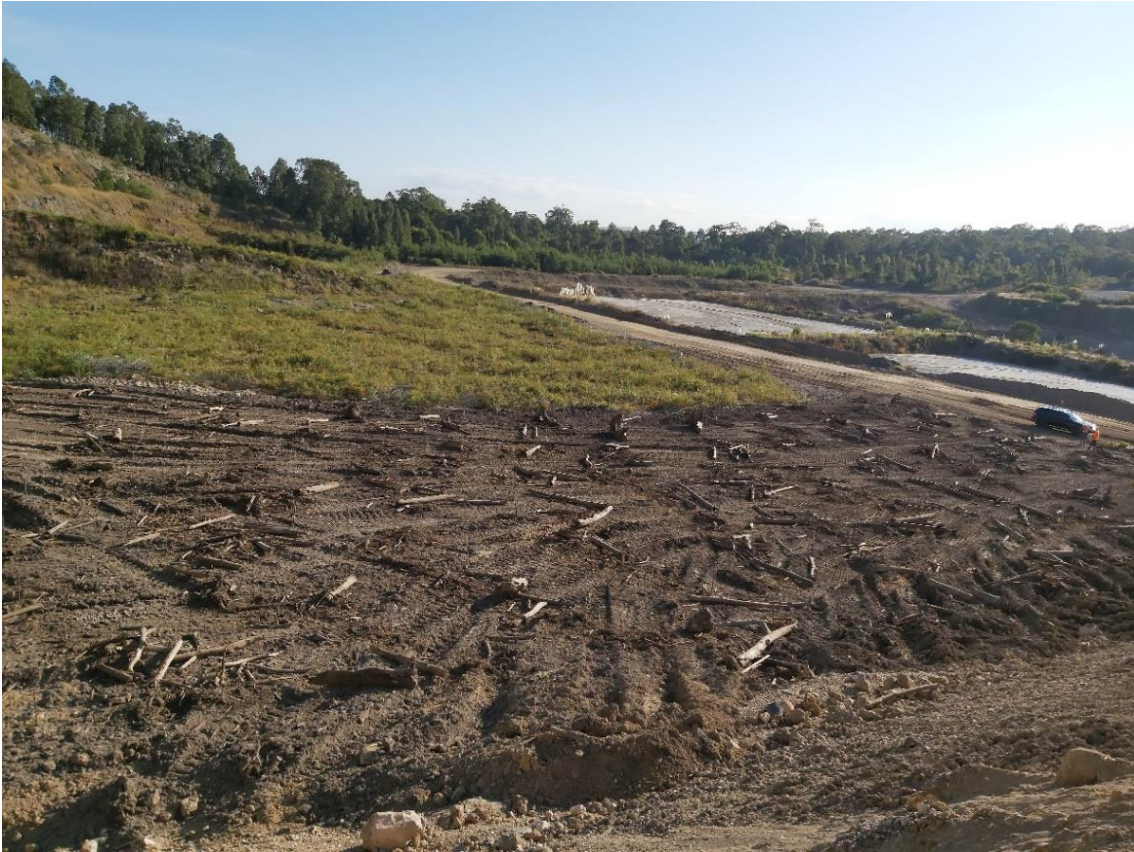
**Figure 6:** Photo Point 2 – Photo of the revegetation area while planting was in progress.  
(Looking North) - Date Taken: 28/04/2021

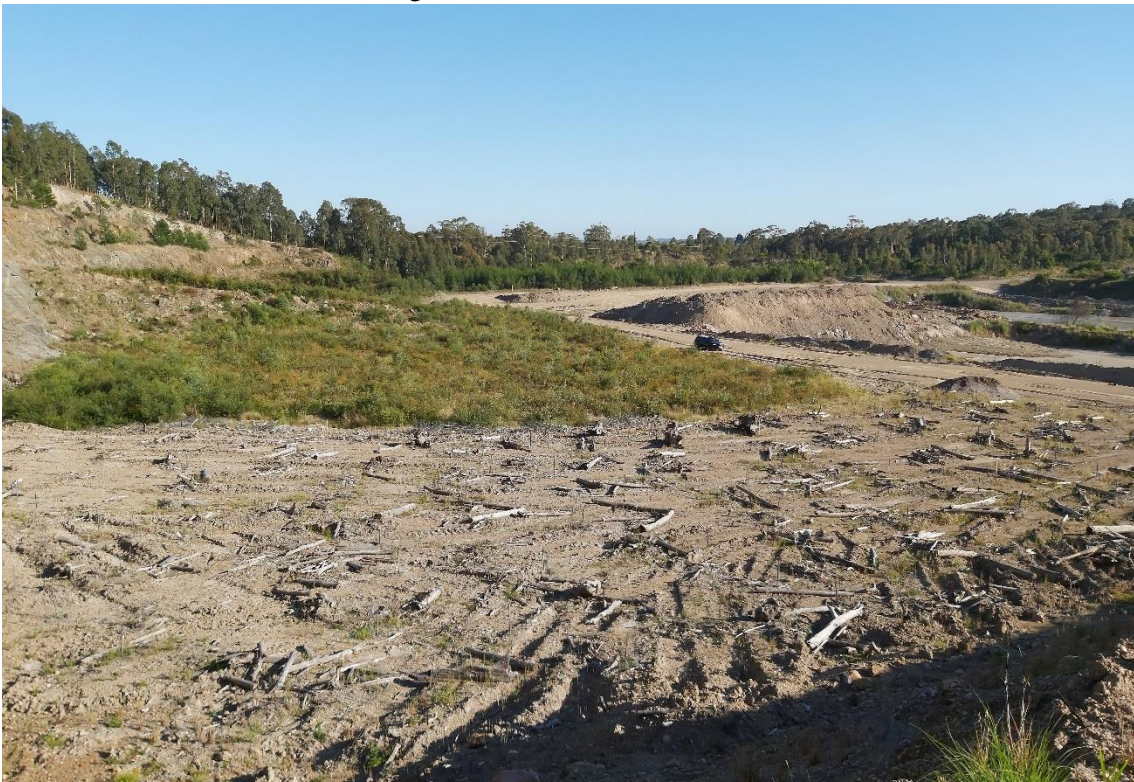
**Figure 7:** Photo Point 2 – Updated photo of the revegetation area.  
(Looking North) - Date Taken: 15/12/2021

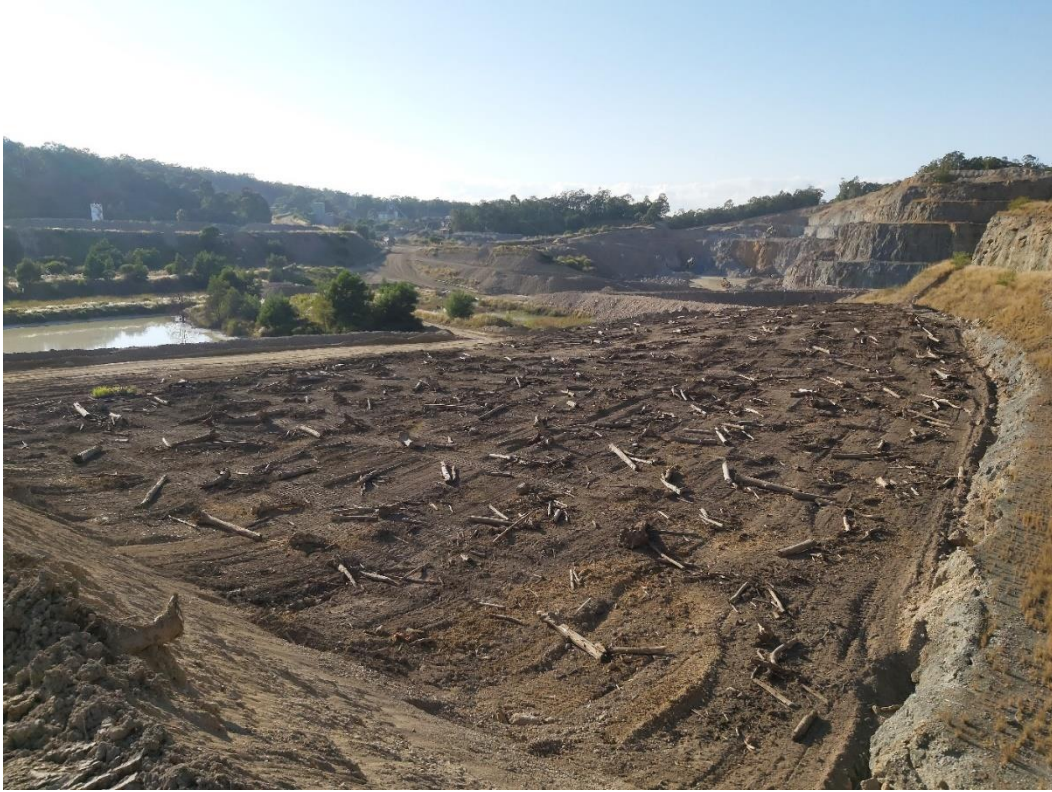
**Figure 8:** Photo Point 2 – Photo of the revegetation area while planting was in progress.  
(Looking East) - Date Taken: 28/04/2021

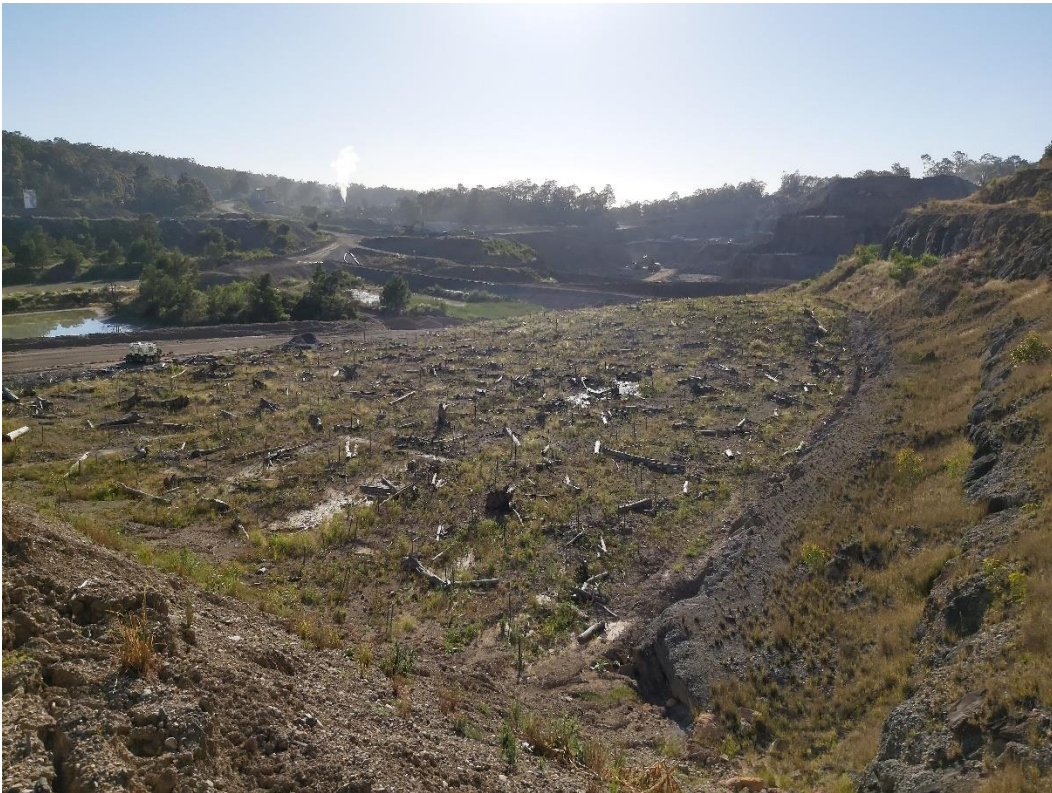
**Figure 9:** Photo Point 2 – Updated photo of the revegetation area.  
(Looking East) - Date Taken: 15/12/2021

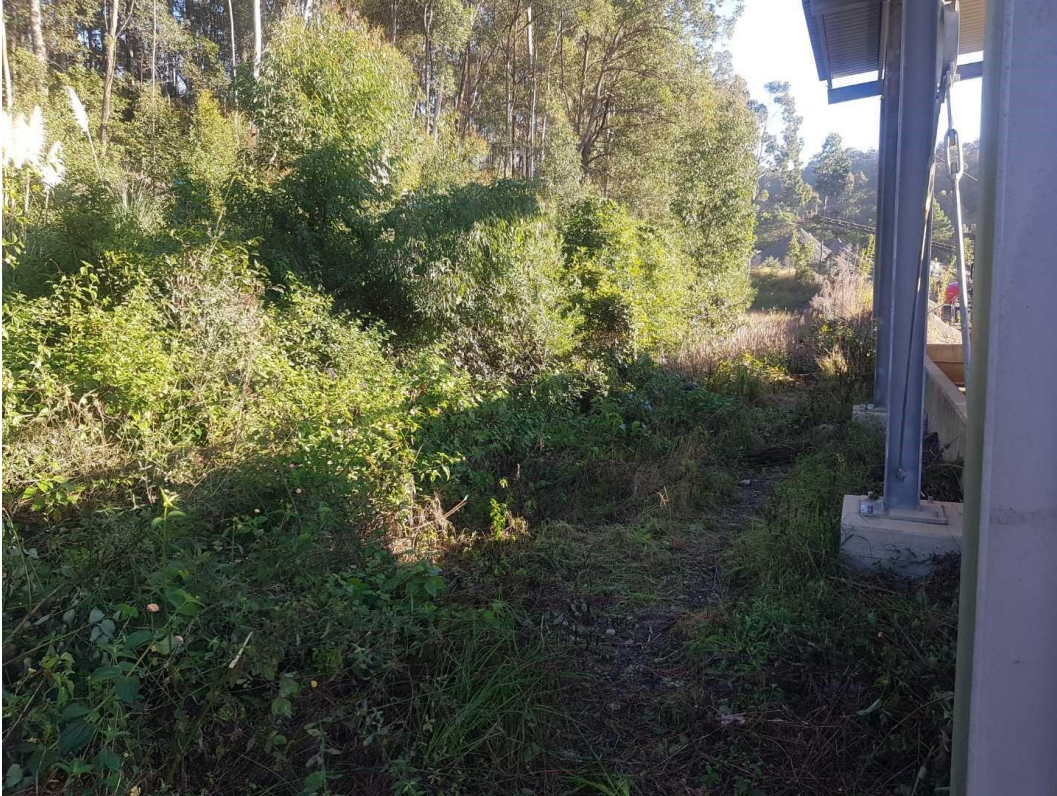
**Figure 10:** Photo Point 3 – Photo of vegetation behind the fuel pump before being removed.  
(Looking Northwest) - Date Taken: 1/06/2021

A 20-meter perimeter was cleared of all vegetation around the fuel pump station to reduce the risk of fire, all plants with the exception to grasses were cut and treated with glyphosate. Once the larger plants were removed, the area was brush cut to remove grasses that were growing throughout the perimeter. The area was sprayed on two occasions to remove any seedlings and grasses that had emerged after the initial removal of vegetation was completed. Multiple areas around the main office and surrounding buildings were sprayed that were becoming overgrown during the first quarter of the year. An area was sprayed around the septic hole to allow easier access.

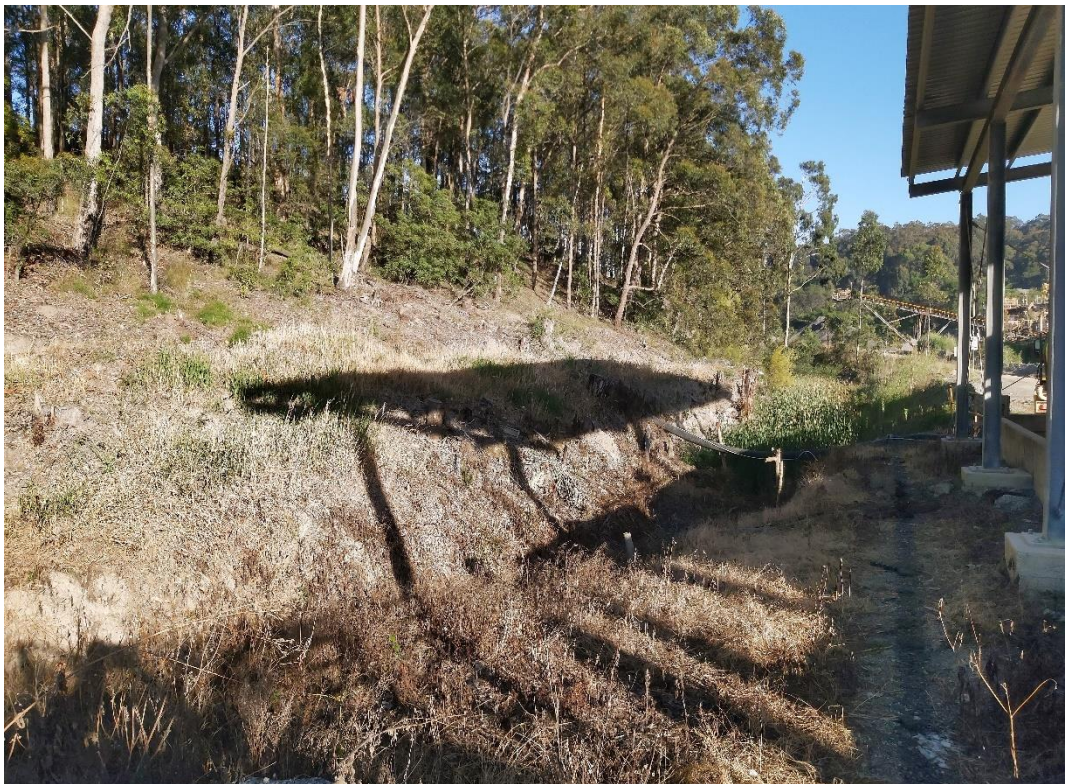
**Figure 11:** Photo Point 3 – Updated photo after vegetation behind the fuel pump was sprayed.  
(Looking Northwest) - Date Taken: 15/12/2021

The 20-meter perimeter that was cleared behind the fuel pump station will greatly reduce the risk of fire coming into contact of the fuel station and reduce the risk of fire spreading in the event of fire at the fuel station. The area was sprayed on two occasions killing seedling that had started to grow. This area will be continually monitored in the future for any plants that grow within the 20-meter perimeter around the fuel station, these plants will be removed to keep a reduced risk of fires.

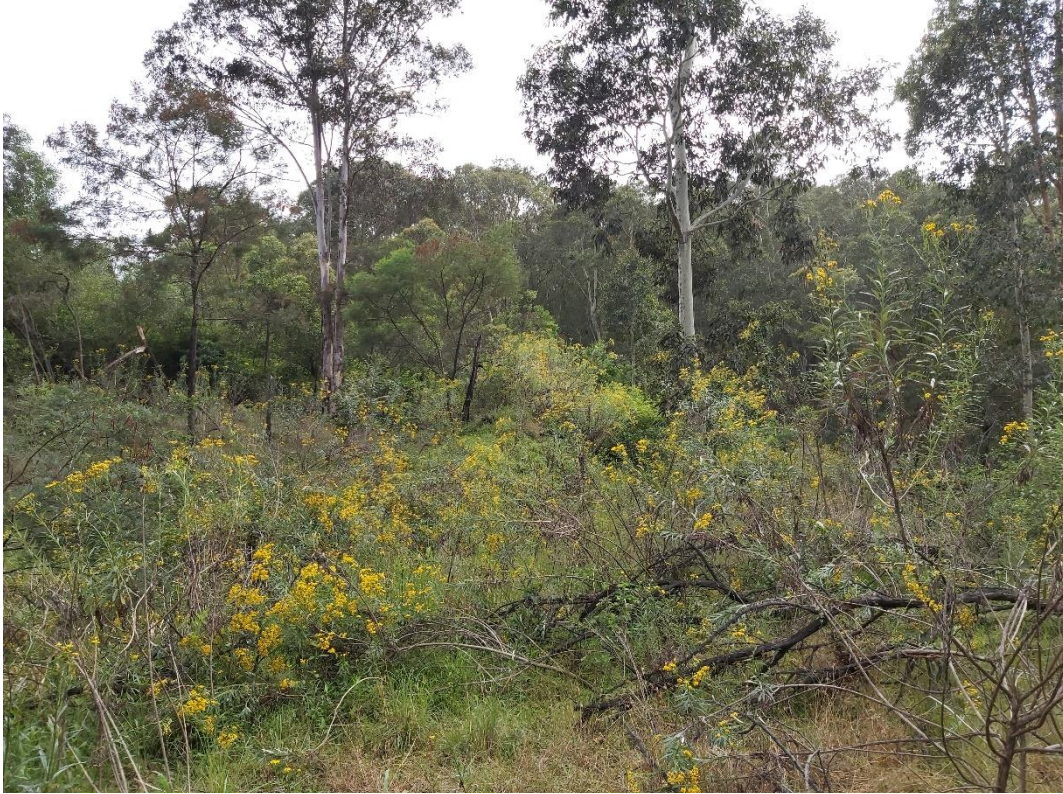
**Figure 12:** Photo Point 4 – Photo of a large amount of African daisy north of the boom gate.  
(Looking North) - Date Taken: 29/11/2021

Large amounts of African daisy, cassia and lantana were cut and painted north of the boom gate, sections of crofton were sprayed in this area. Maintenance weeding was done through the large are of bushland south Dam-A and Dam-D targeting lantana and crofton. An area of crofton, morning glory, arum lilies, lantana and morning glory were removed from the outlet of Dam-A, these weeds were hand removed to eliminate any risk of herbicide runoff into the water. Large amounts of the native *Typha orientalis* have started to grow in the area where the weeds were removed.

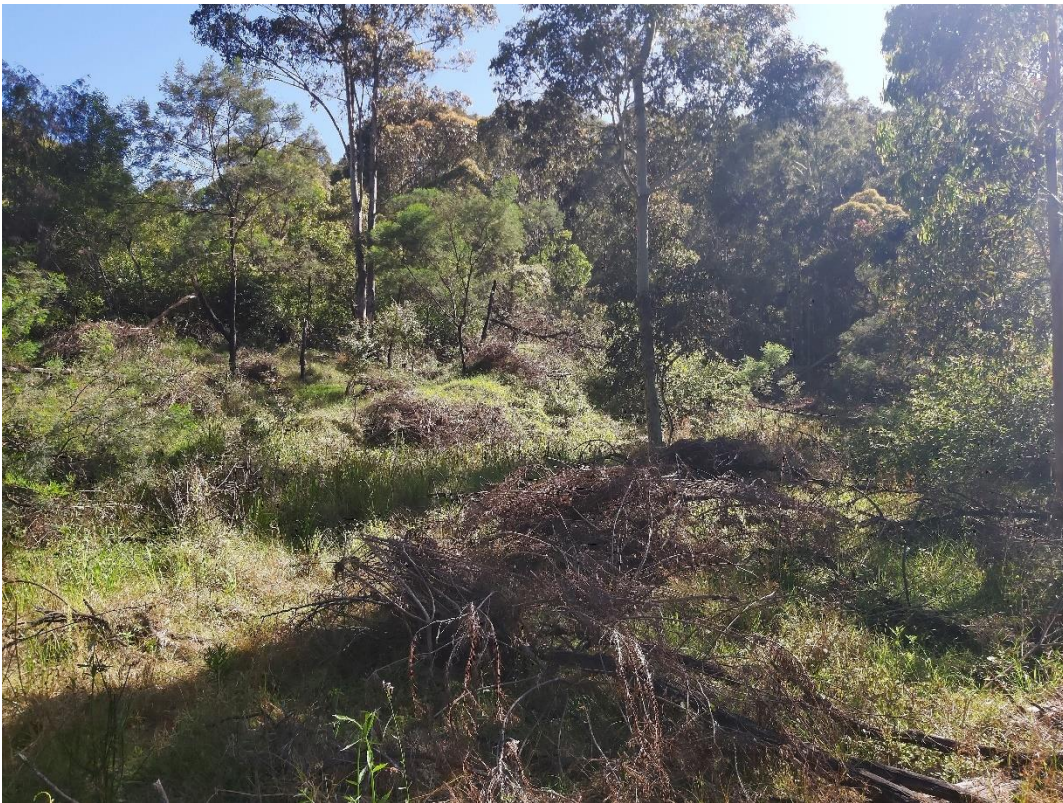
**Figure 13:** Photo Point 4 – Photo after the African daisy was removed and rafted.  
(Looking North) - Date Taken: 15/12/2021

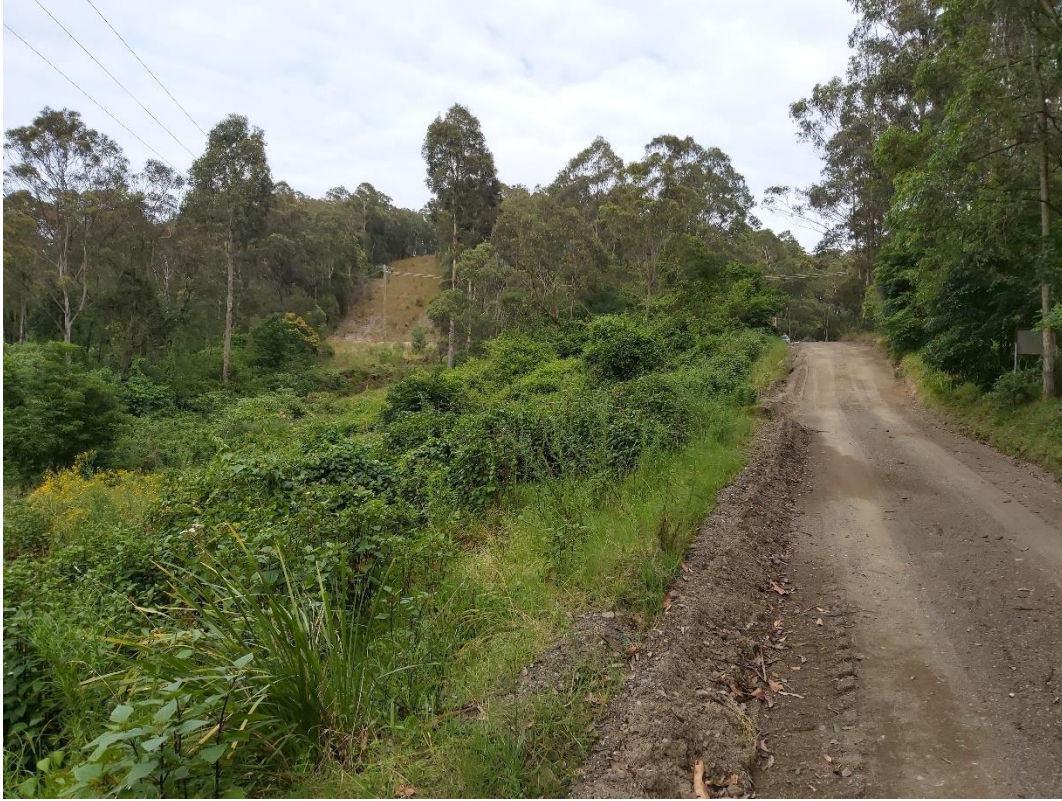
**Figure 14:** Photo Point 5 – Photo of an area of Crofton adjacent to Dam-D.  
(Looking West) - Date Taken: 6/12/2021

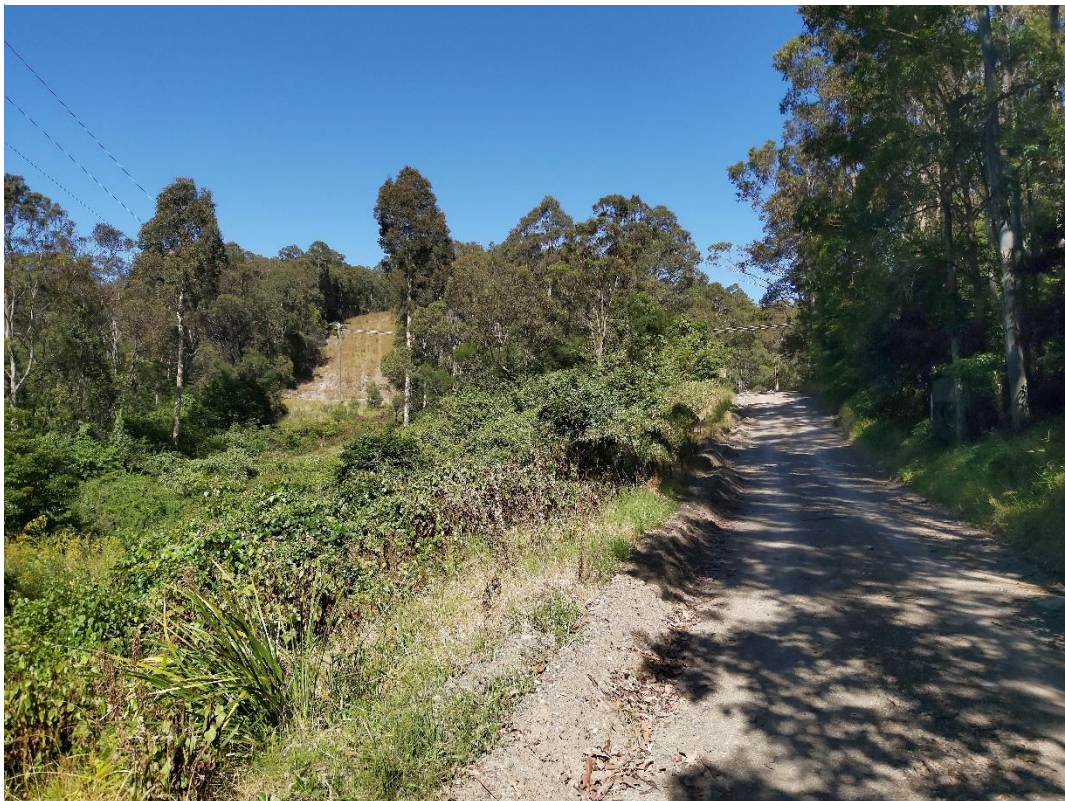
**Figure 15:** Photo Point 5 – Photo after the Crofton was sprayed, starting to show signs of dying.  
(Looking West) - Date Taken: 15/12/2021

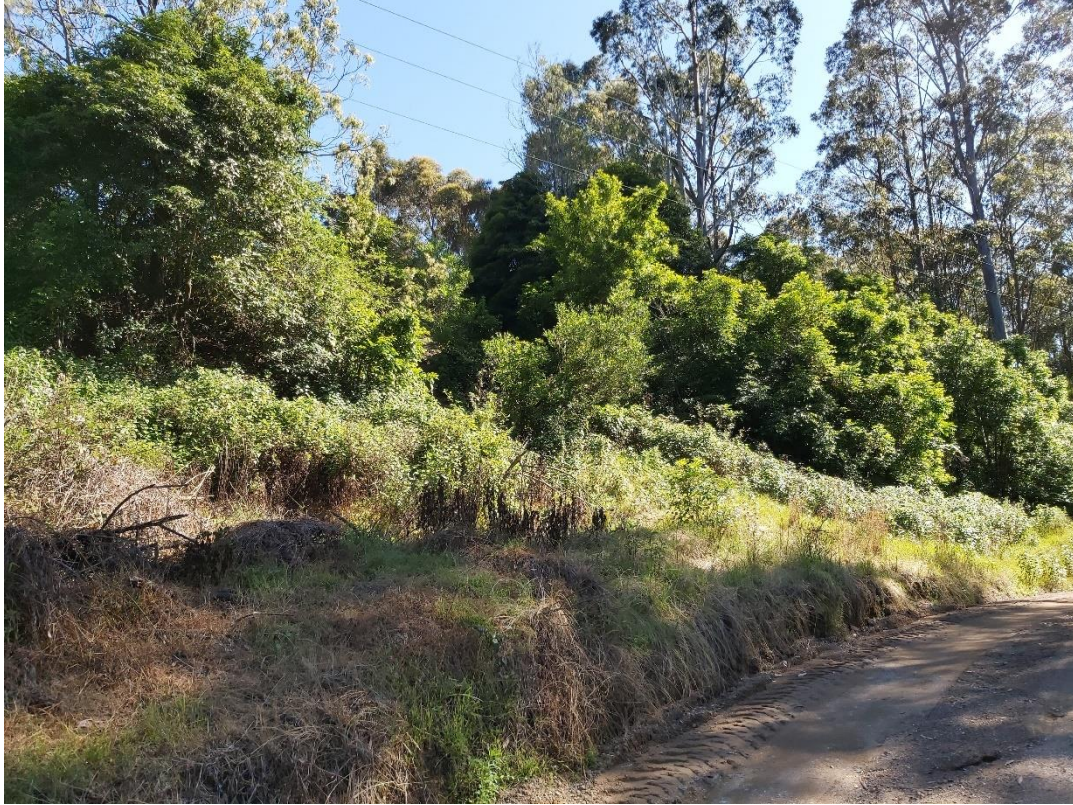
**Figure 16:** Photo Point 6 – Photo of an area of Crofton and turkey rhubarb along the road adjacent to Dam-D.  
(Looking Northeast) - Date Taken: 3/12/2021

Maintenance weeding was completed between Dam-A and Dam-D, as well as the northeastern area adjacent to Dam-A. The weeds were removed either by hand and rafted or cut and painted and applied with glyphosate, the species removed through these areas were crofton, lantana, green cestrum, madeira vine, wild tobacco, scotch thistle, and African daisy. Multiple areas of crofton and turkey rhubarb were sprayed along the roads edge adjacent to Dam-D. Multiple areas of crofton and turkey rhubarb were sprayed along the roads edge between Dam-A and Dam-D.

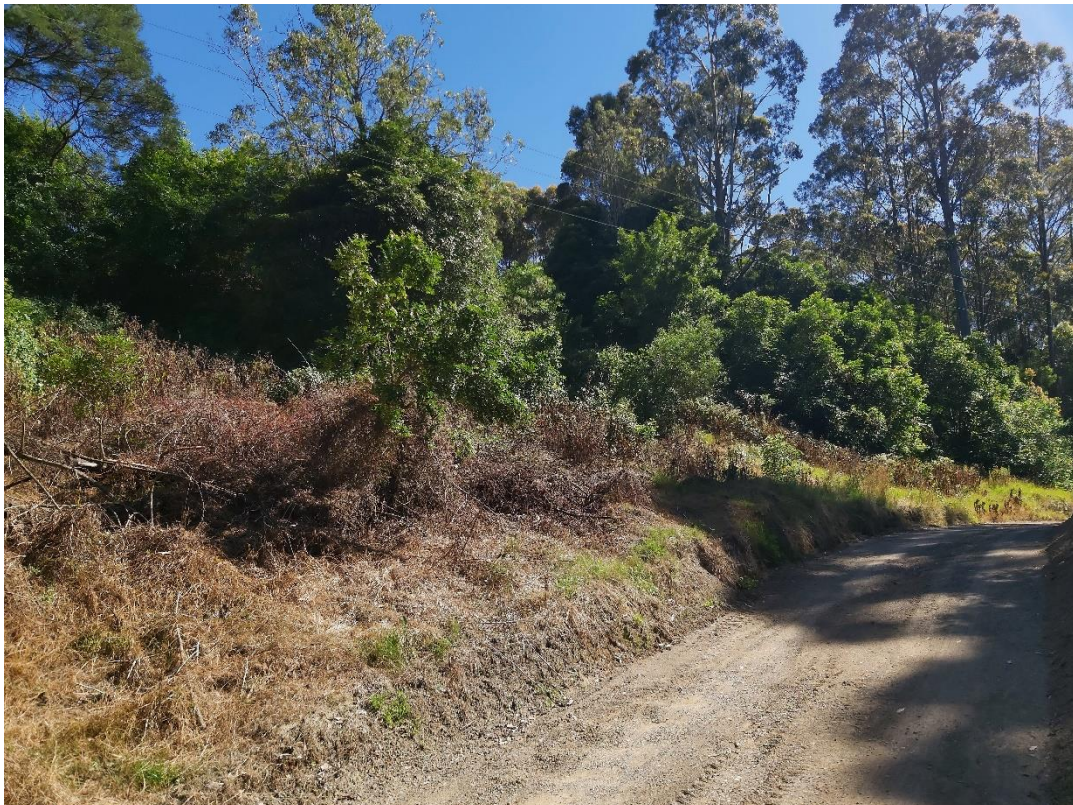
**Figure 17:** Photo Point 6 – Photo after Crofton and turkey rhubarb was sprayed.  
(Looking Northeast) - Date Taken: 15/12/2021

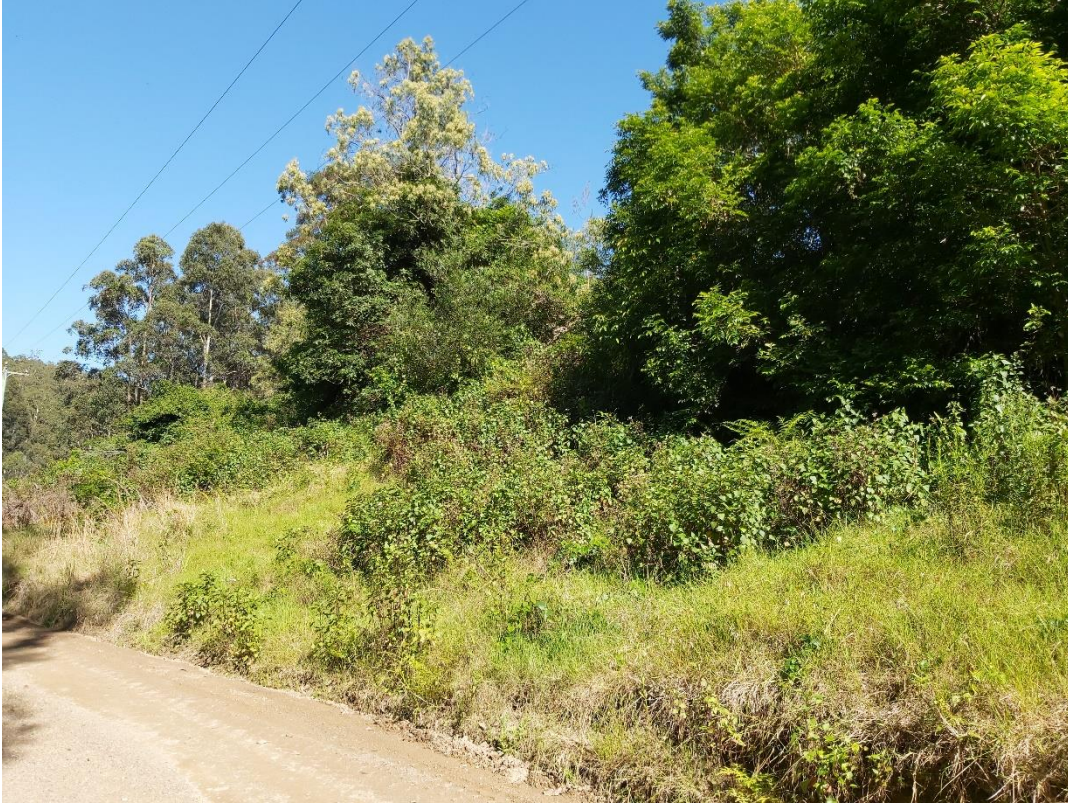
**Figure 18:** Photo Point 7 – Photo of an area of Crofton and turkey rhubarb along the road between Dam-A and Dam-D. (Looking Northeast) - Date Taken: 3/12/2021

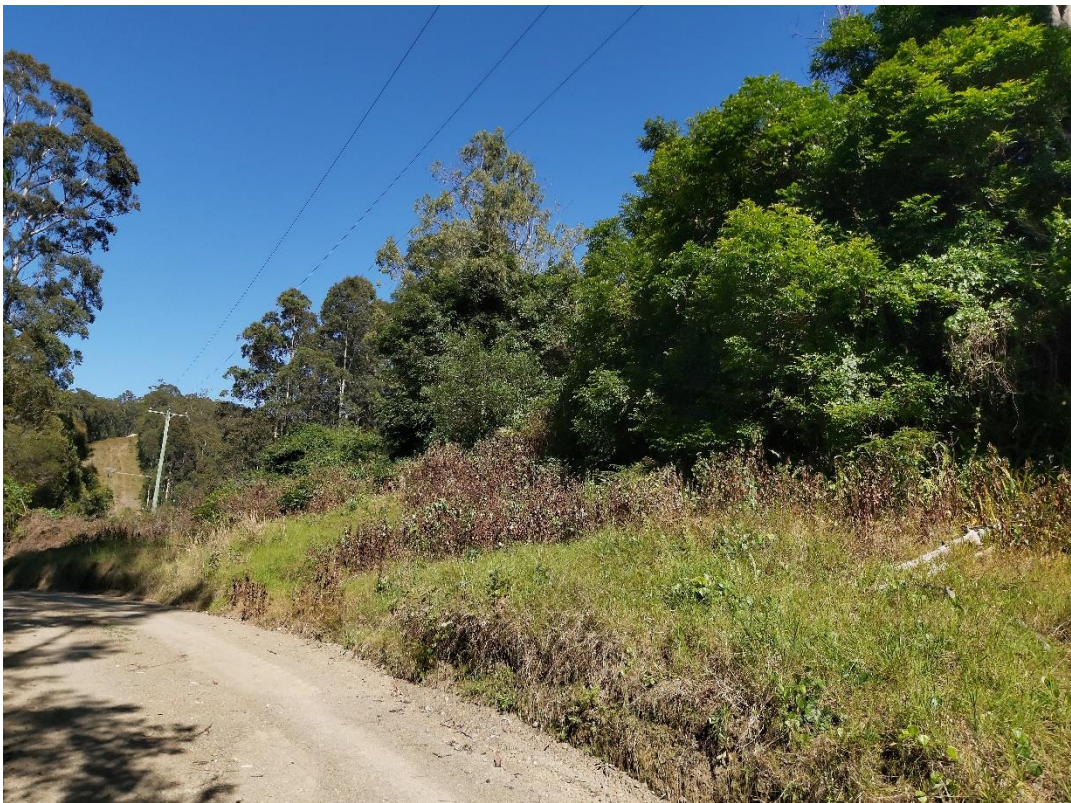
**Figure 19:** Photo Point 7 – Photo after Crofton and turkey rhubarb was sprayed. (Looking Northeast) - Date Taken: 15/12/2021

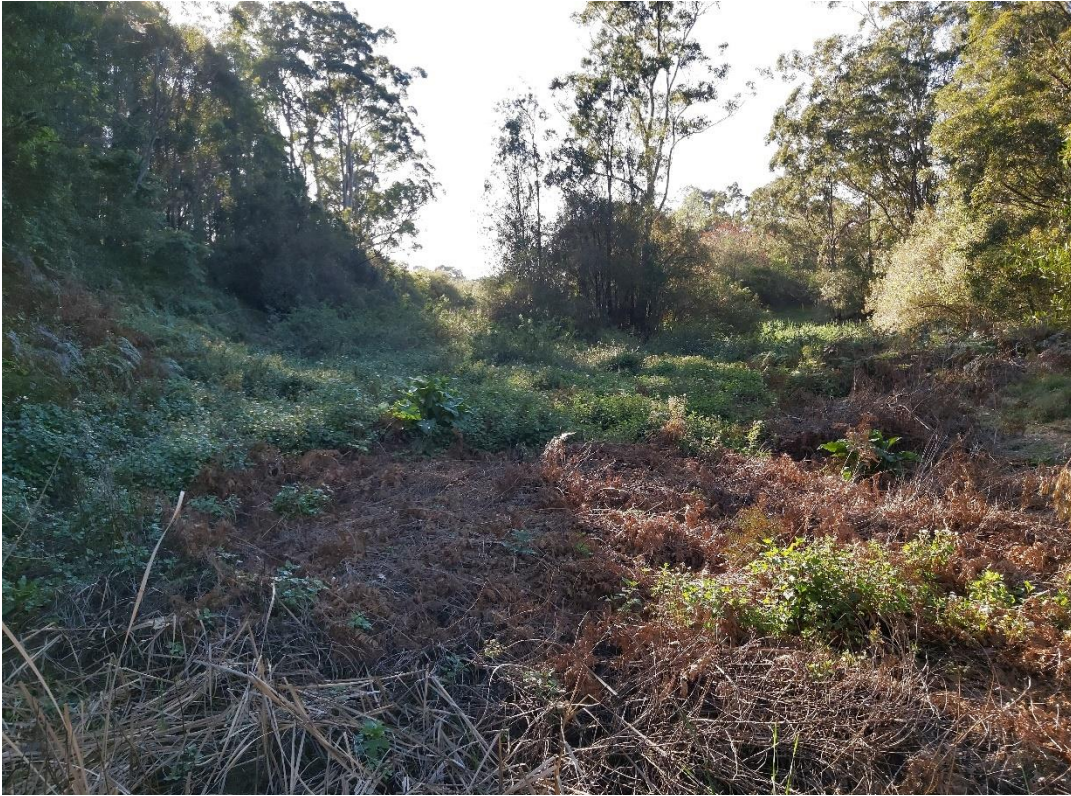
**Figure 20:** Photo Point 8 – Photo of an area of Crofton, morning glory, arum lilies and lantana at the outlet of Dam-A.  
(Looking East) - Date Taken: 24/09/2021

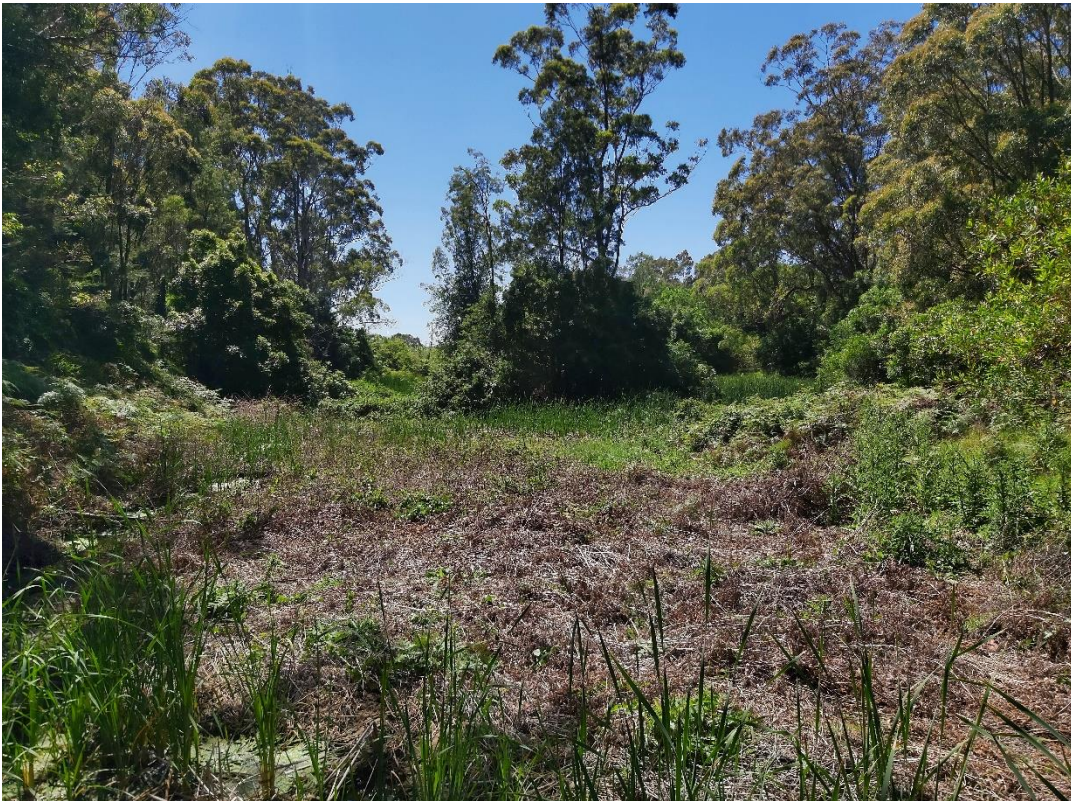
**Figure 21:** Photo Point 8 – Photo after weeds were hand removed and rafted, showing natural regeneration of *Typha orientalis*.  
(Looking East) - Date Taken: 15/12/2021
