# Teralba Quarry

## 2013 Annual Review

### Project Approval: PA10\_0183

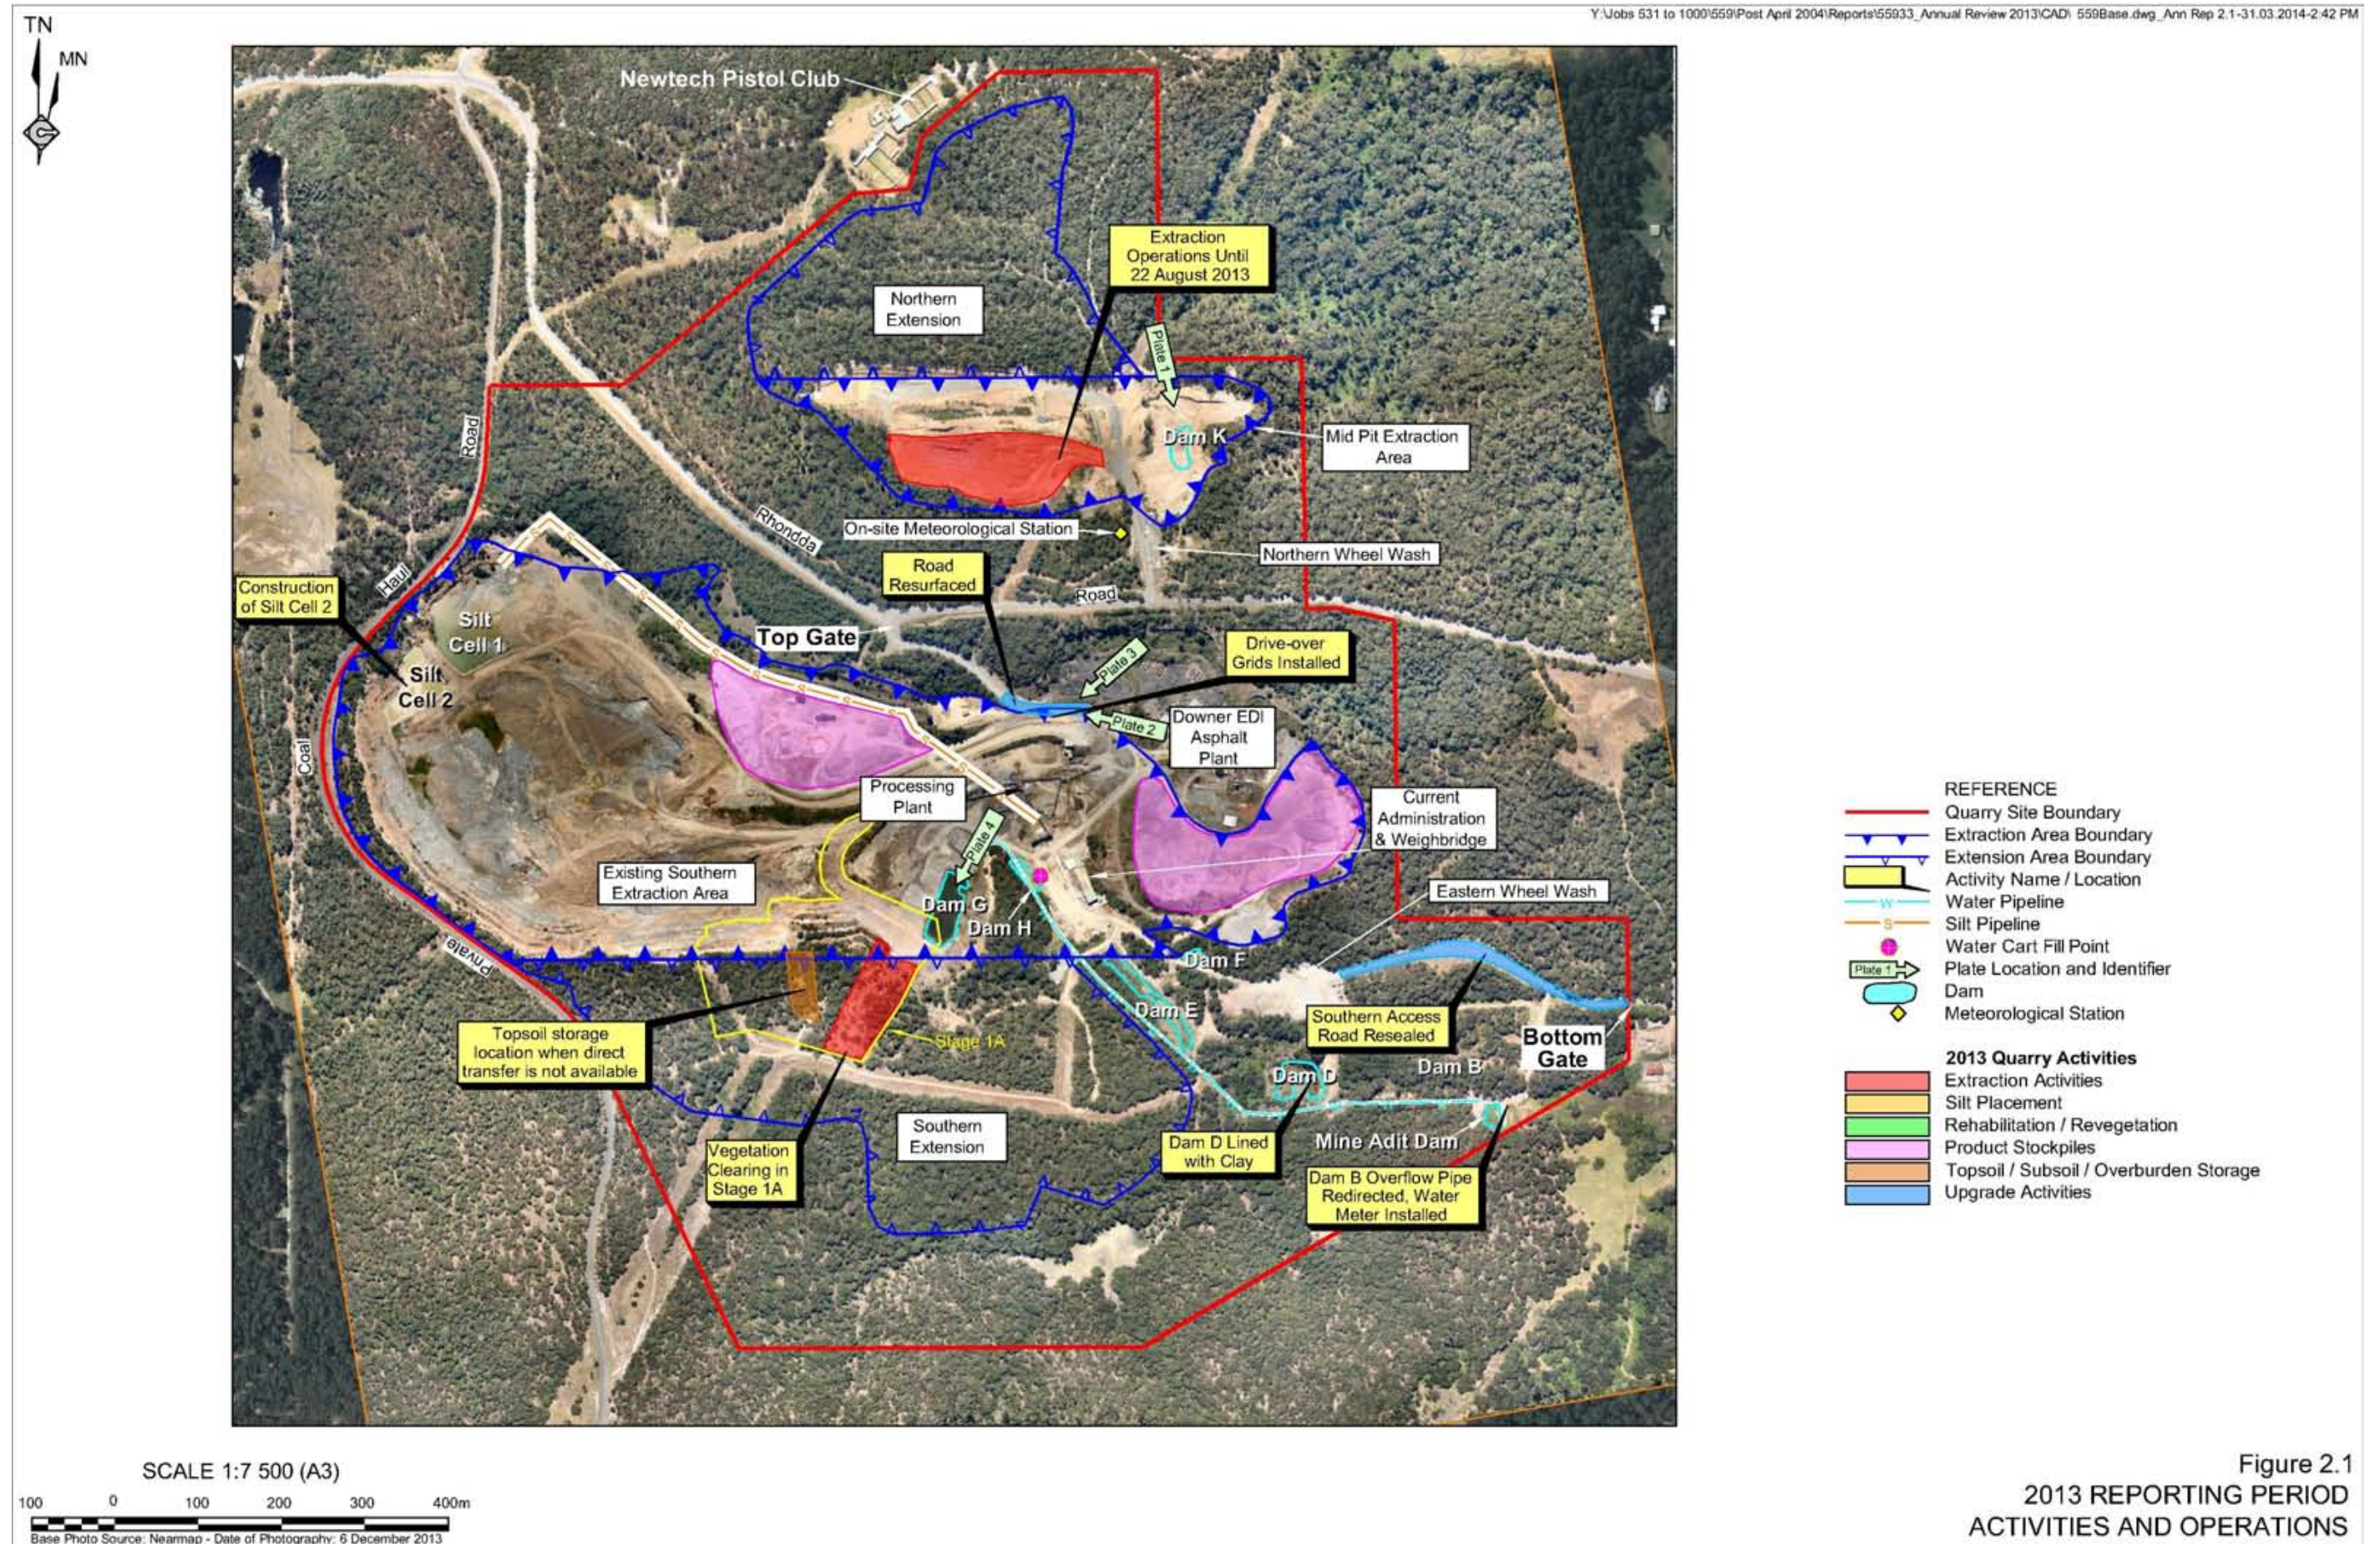
Figure 2.1  
2013 REPORTING PERIOD  
ACTIVITIES AND OPERATIONS

**Table 2.1** lists the principal activities / milestones that occurred at the Teralba Quarry throughout 2013 with activities undertaken as part of those approved under PA10\_0183 identified in **bold**. **Figure 2.1** presents the location(s) of the activities described, including activities shown within **Plates 1 to 4**.

In addition, *Condition 3(21)* requires Metromix to ensure a suitable meteorological station in operational in the vicinity of the Quarry, complying with the requirements outlined in *Approved Methods for the Sampling and Analysis of Air Pollutants in NSW* (DECCW, 2007) and is capable of continuous real-time measurement of temperature lapse rate, in accordance with the *NSW Industrial Noise Policy* (EPA, 2000), or as otherwise approved by EPA. Metromix operates a comprehensive meteorological station in an elevated area adjacent to the Mid Pit Extraction Area (see **Figure 2.1**).

*Condition 3(21)* requires that a meteorological station operate in the vicinity of the Project Site for the life of the Project. Metromix has installed a meteorological station (location shown on **Figure 2.1**), ensuring that the meteorological station complies with the requirements in the *Approved Methods for Sampling of Air Pollutants in New South Wales* guideline.

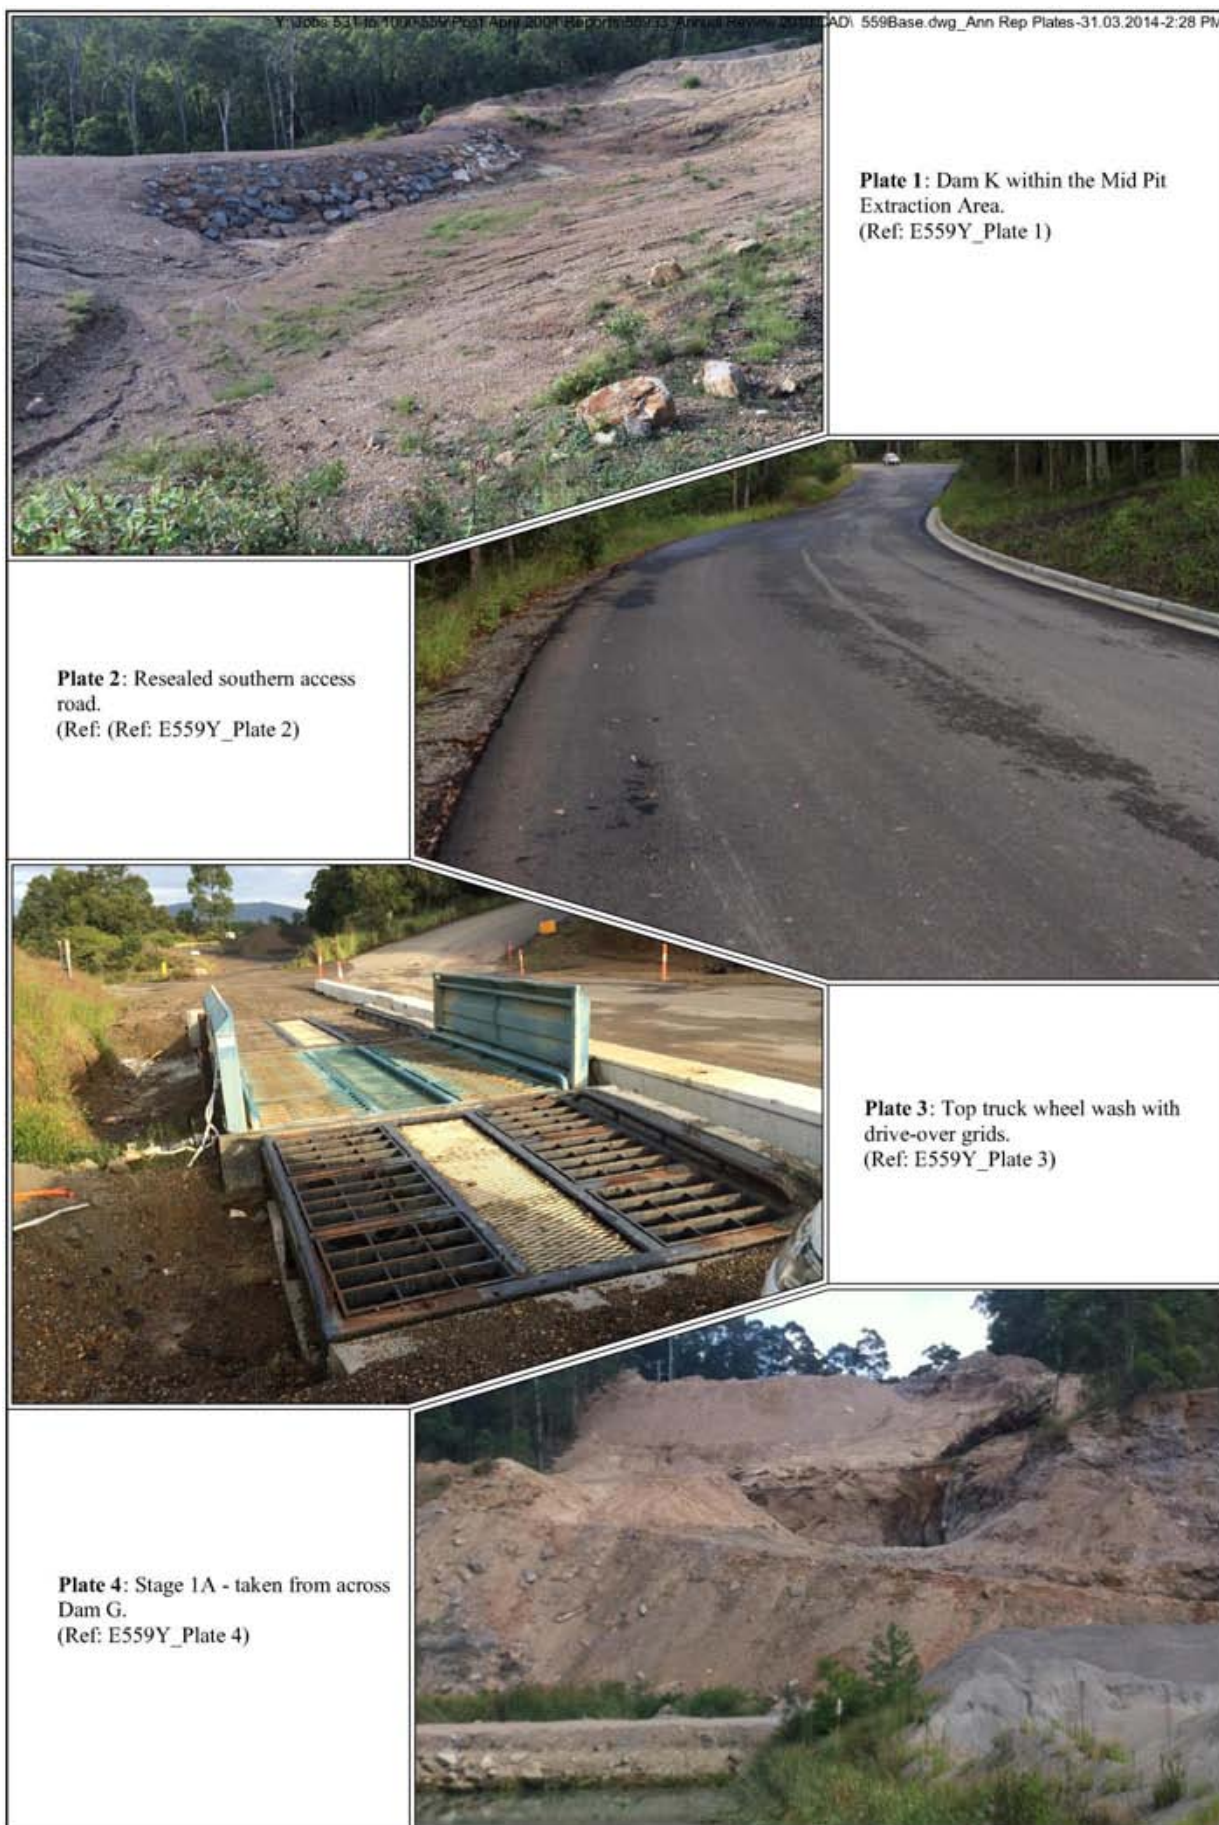
Operational areas within the Teralba Quarry are referred to in the same manner as described in the 2011 *Environmental Assessment* (RWC, 2011) i.e. Northern Extension, Mid Pit Extraction Area, Southern Extraction Area and Southern Extension.

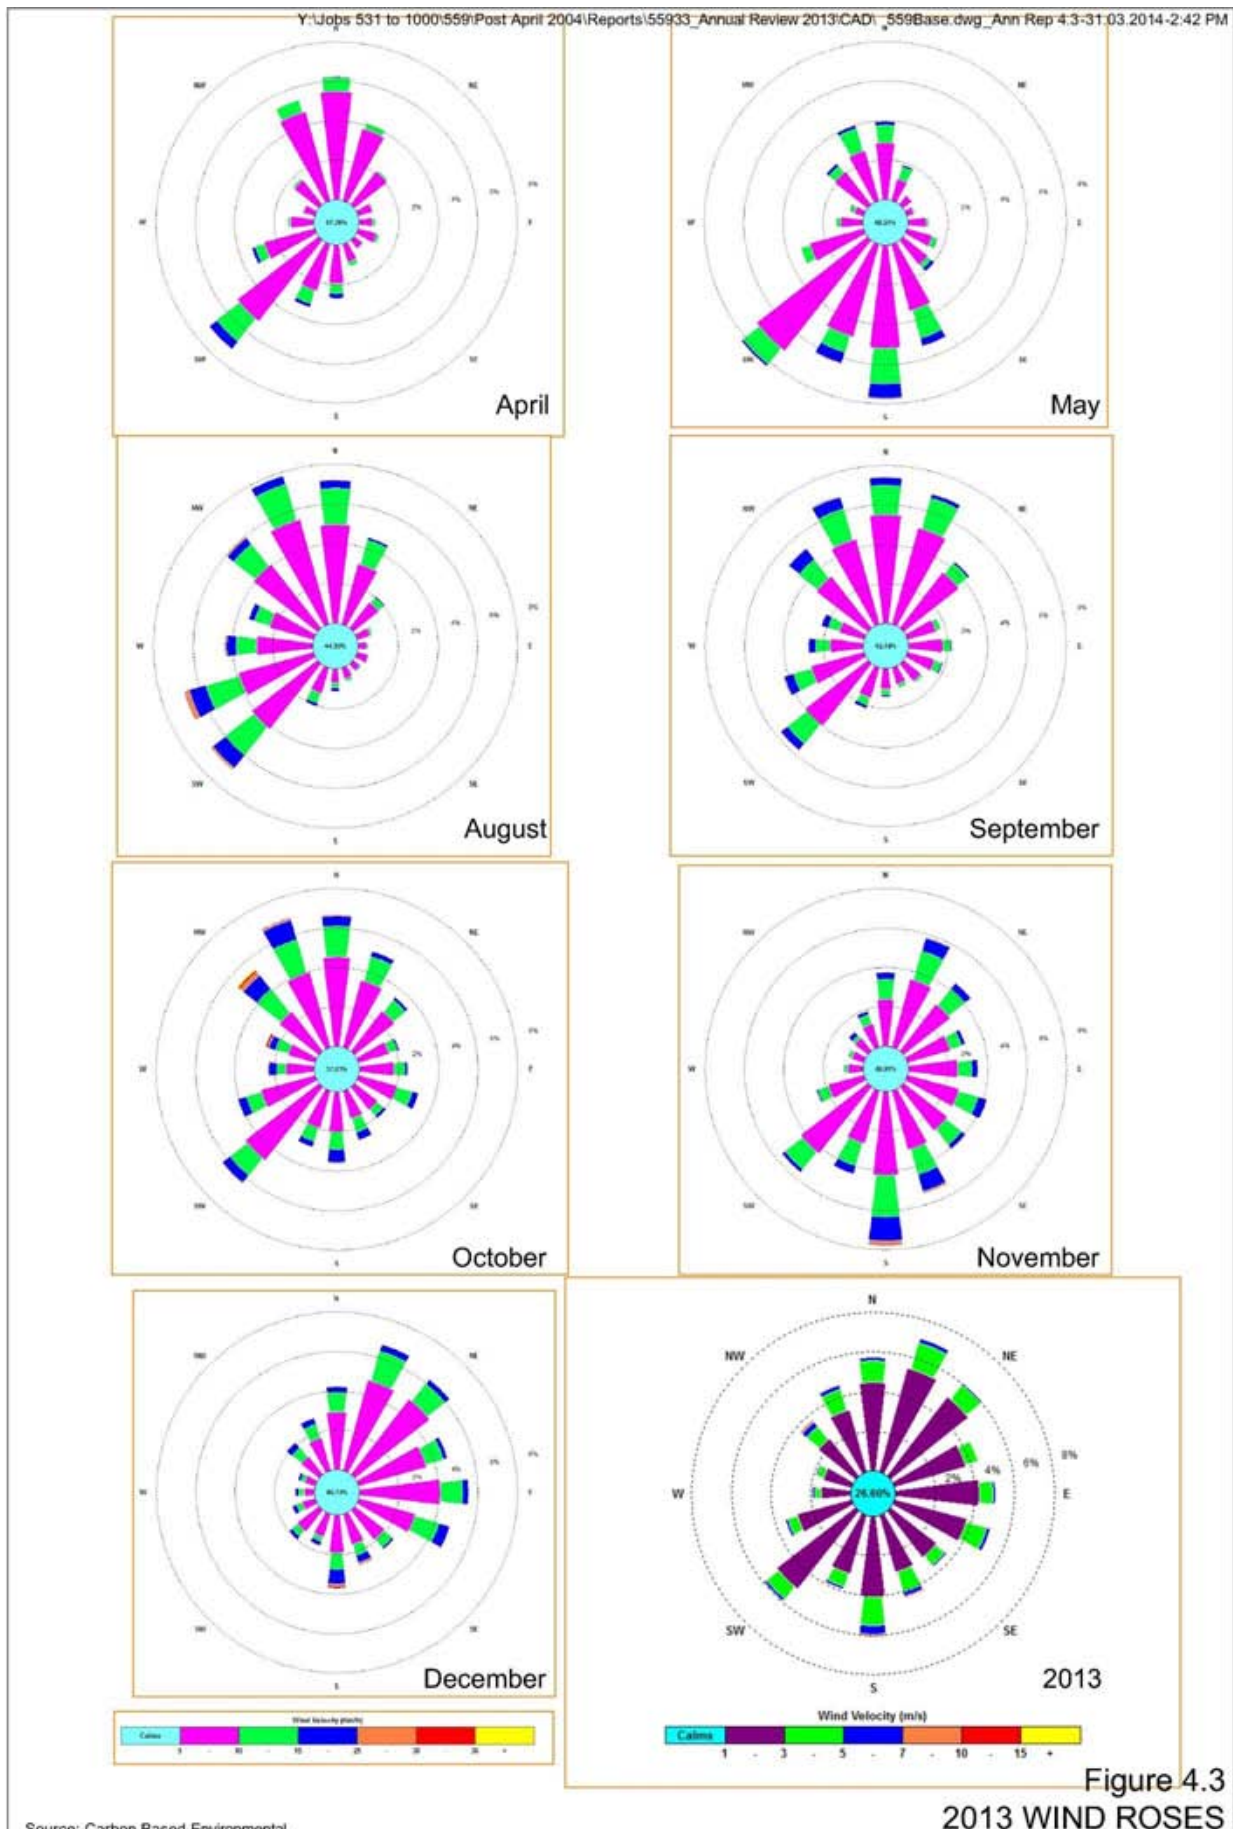
Figure 4.3  
2013 WIND ROSES

**Figure 4.3** provides the monthly and annual wind roses for the Quarry. It should be noted that due to a cancellation of the meteorological station's SIM card by the SIM card operator, weather data was not available for the months of June and July 2013, hence the omission of wind roses in **Figure 4.3** for those months.

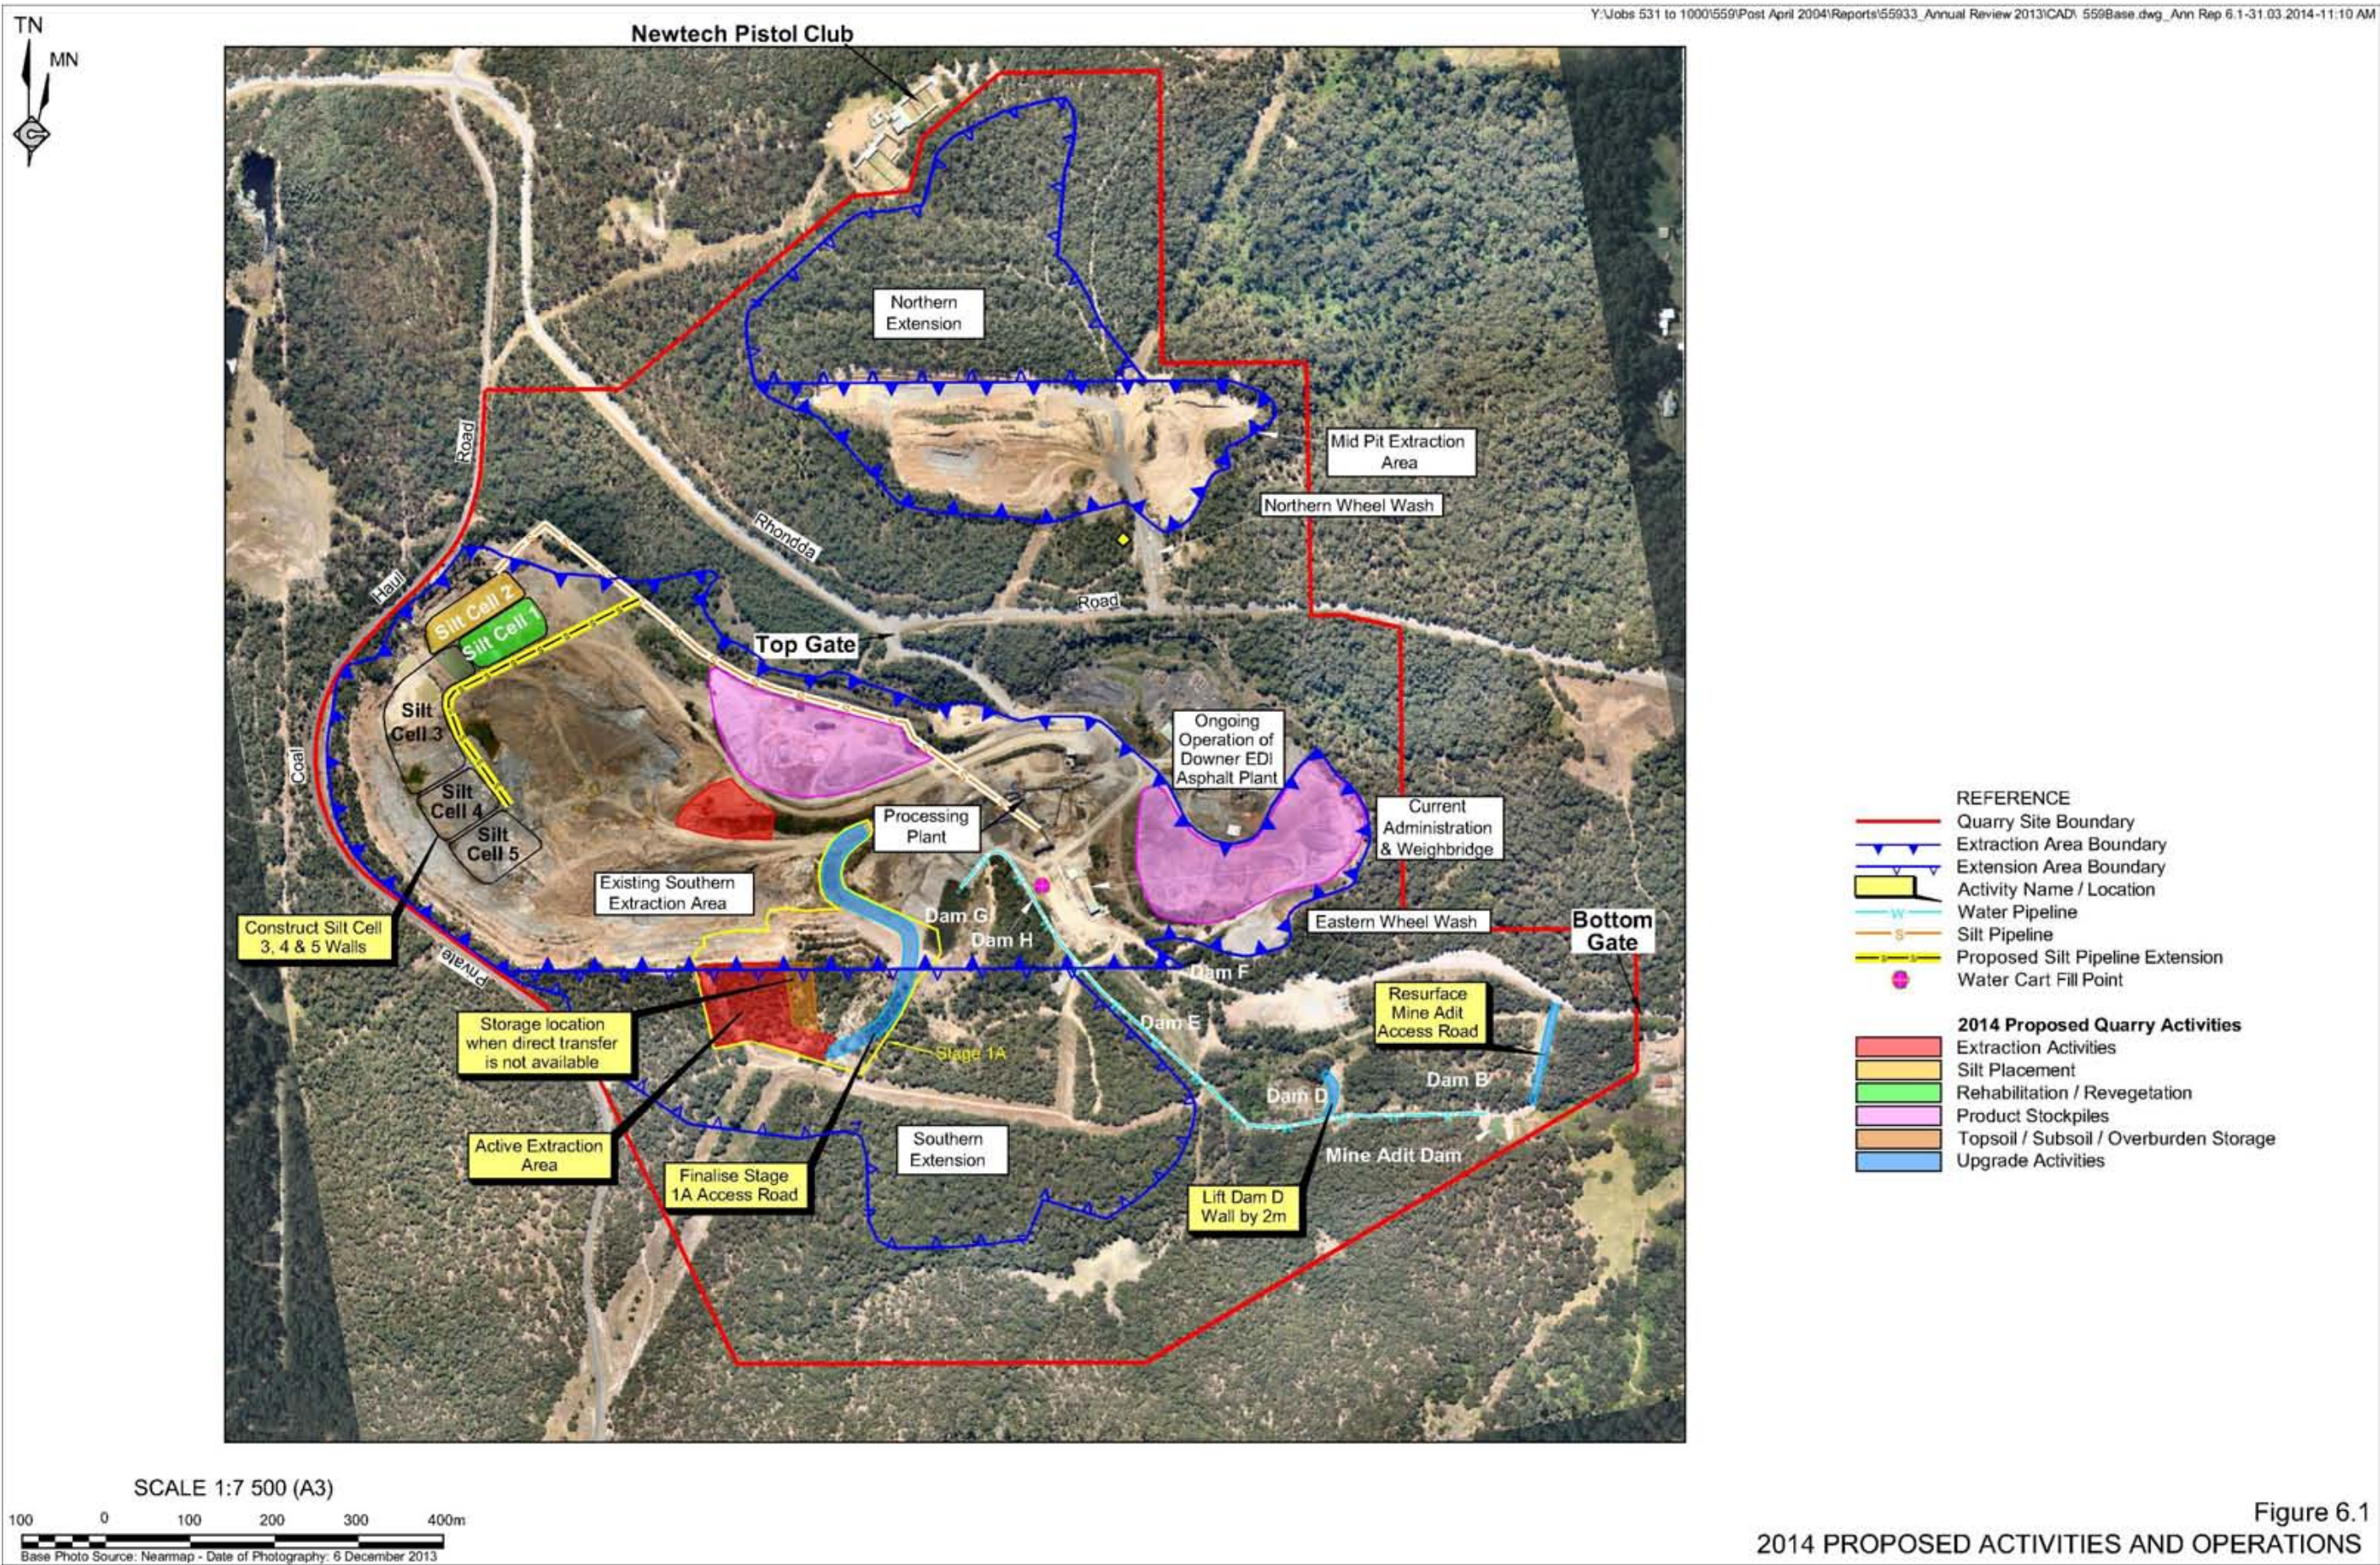
Overburden will be moved in stages during the year as the Stage 1A pit develops. The first stage will be completed during the period February to April and the second stage during the period October to November. Silt Cells 3 and 4 will be completed during 2014 through the placement of overburden within the areas displayed on **Figure 6.1**. Waste water with a 6% silt content will be continued to be pumped from the processing plant to Silt Cells 1 to 4 in 2014.
