Teralba Quarry

2017 Annual Review

Project Approval PA10_0183

Period: 1 January 2017 to 31 December 2017

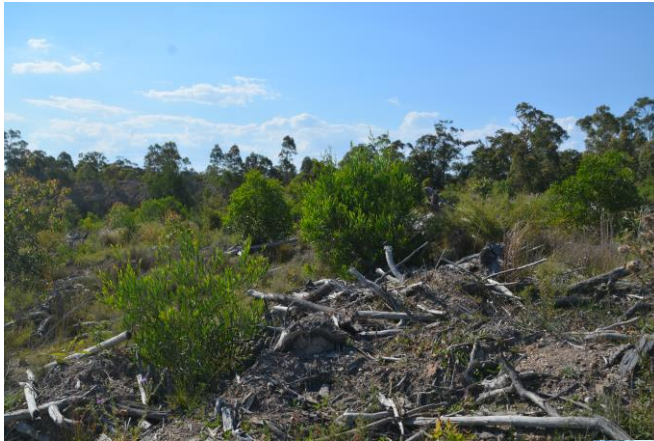
Plate 5 Excellent growth on placed overburden near Silt Cell 1
(E559AG_064)

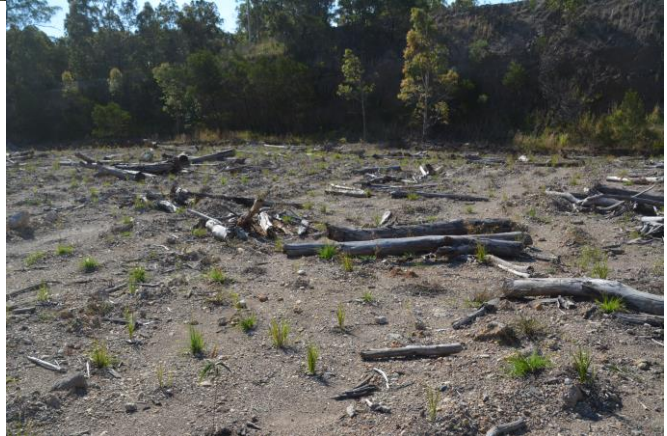
Plate 6 Initial growth of planted tube stock on Silt Cell 1
(E559AG_068)

A total of 600 tree saplings, 720 native shrubs and over 6 000 native grasses were planted in November 2017, the majority being in the rehabilitation area over Silt Cell 1 and the remaining plants at the upper two benches of Stage 1B that faces north. Due to the dry conditions experienced over December 2017, hand watering was undertaken, as needed. At the time this document was finalised, the survival rate with both the tree saplings and the native shrubs has been well above expectations and estimated to be at 80% or above.

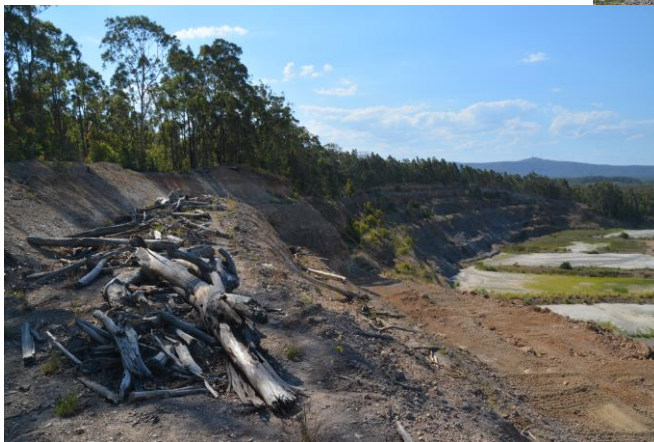
Plate 7 A view along the upper extraction bench in Stage 1B with placed timber and plants
(E559AG_045)

In order to mitigate visual impacts from these locations, Metromix prioritised revegetation activities on the two upper benches within Stage 1B with tubestock and placed logs, etc. (**Plate 7**) and trialled bitumen emulsion applications on the visible faces (**Plate 8**). While the bitumen emulsion trials were considered successful, it is recognised that tree screening will be important to provide a vegetated view consistent with the surrounding landscape.

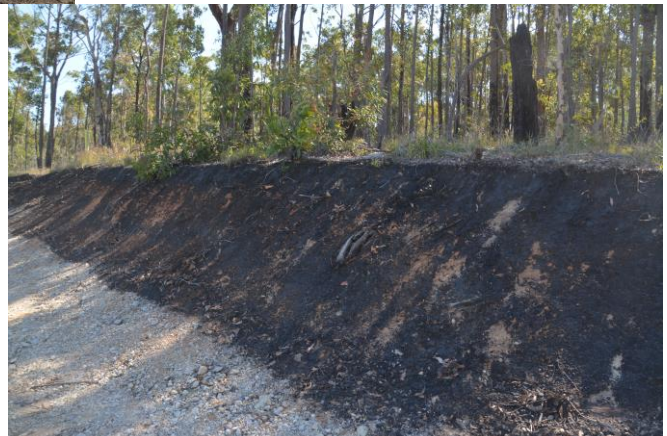
Plate 8 A view of the bitumen treatment of the upper extraction bench in Stage 1B
(E559AG_055)

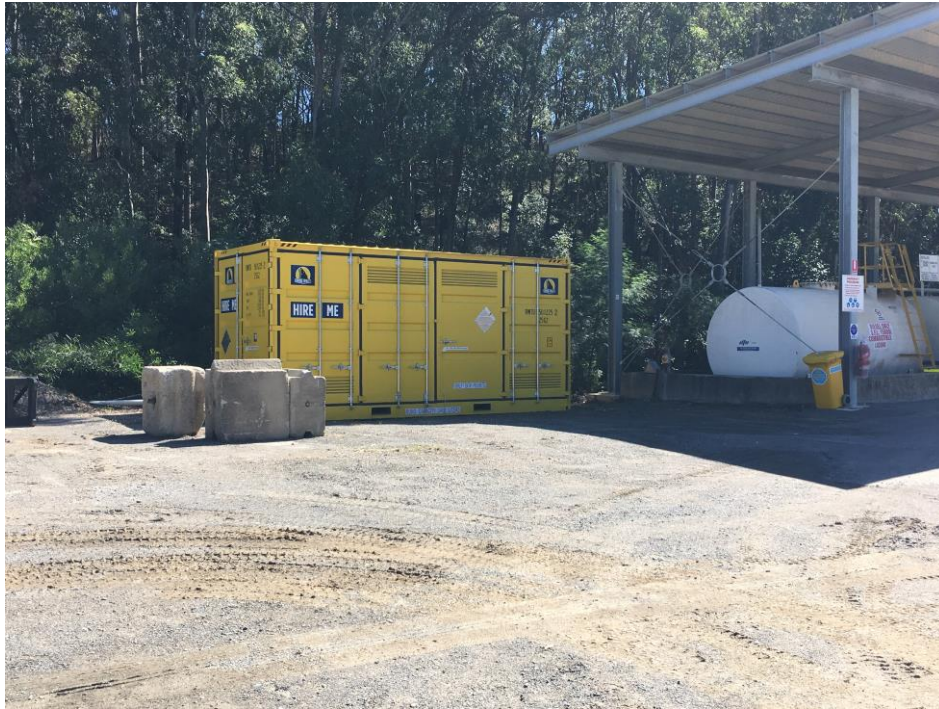
Plate 9 Portable Oil Storage Container (Ref: IMG_1308)

During the reporting period, a self-bunded portable oil storage container was installed on site to temporarily store oil that was delivered to the Quarry. Oil will be stored in this container until needed.

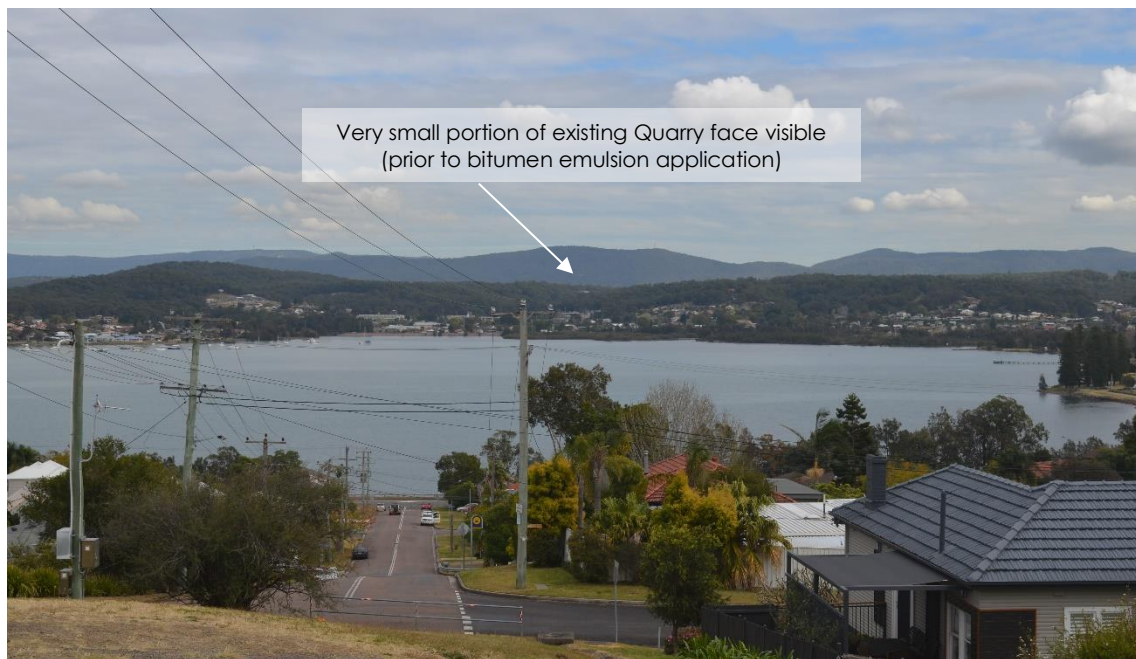
Plate 10 **View of the Quarry from Speers Point**

During the reporting period, it was identified that the upper benches of the Southern Extension Extraction Area (Stage 1B) were visible from some parts of the residential areas in the vicinity of Speers Point. The upper benches that are visible represent only minor impacts, as Speers Point is more than 4.3km from the Quarry.

Plate 10 displays the area visible from Speers Point.

Rehabilitation activities and progress are described in Section 8, however, the revegetation activities in Stage 1B had a 95% success rate during the reporting period and vegetation condition would continue to be monitored in this area.

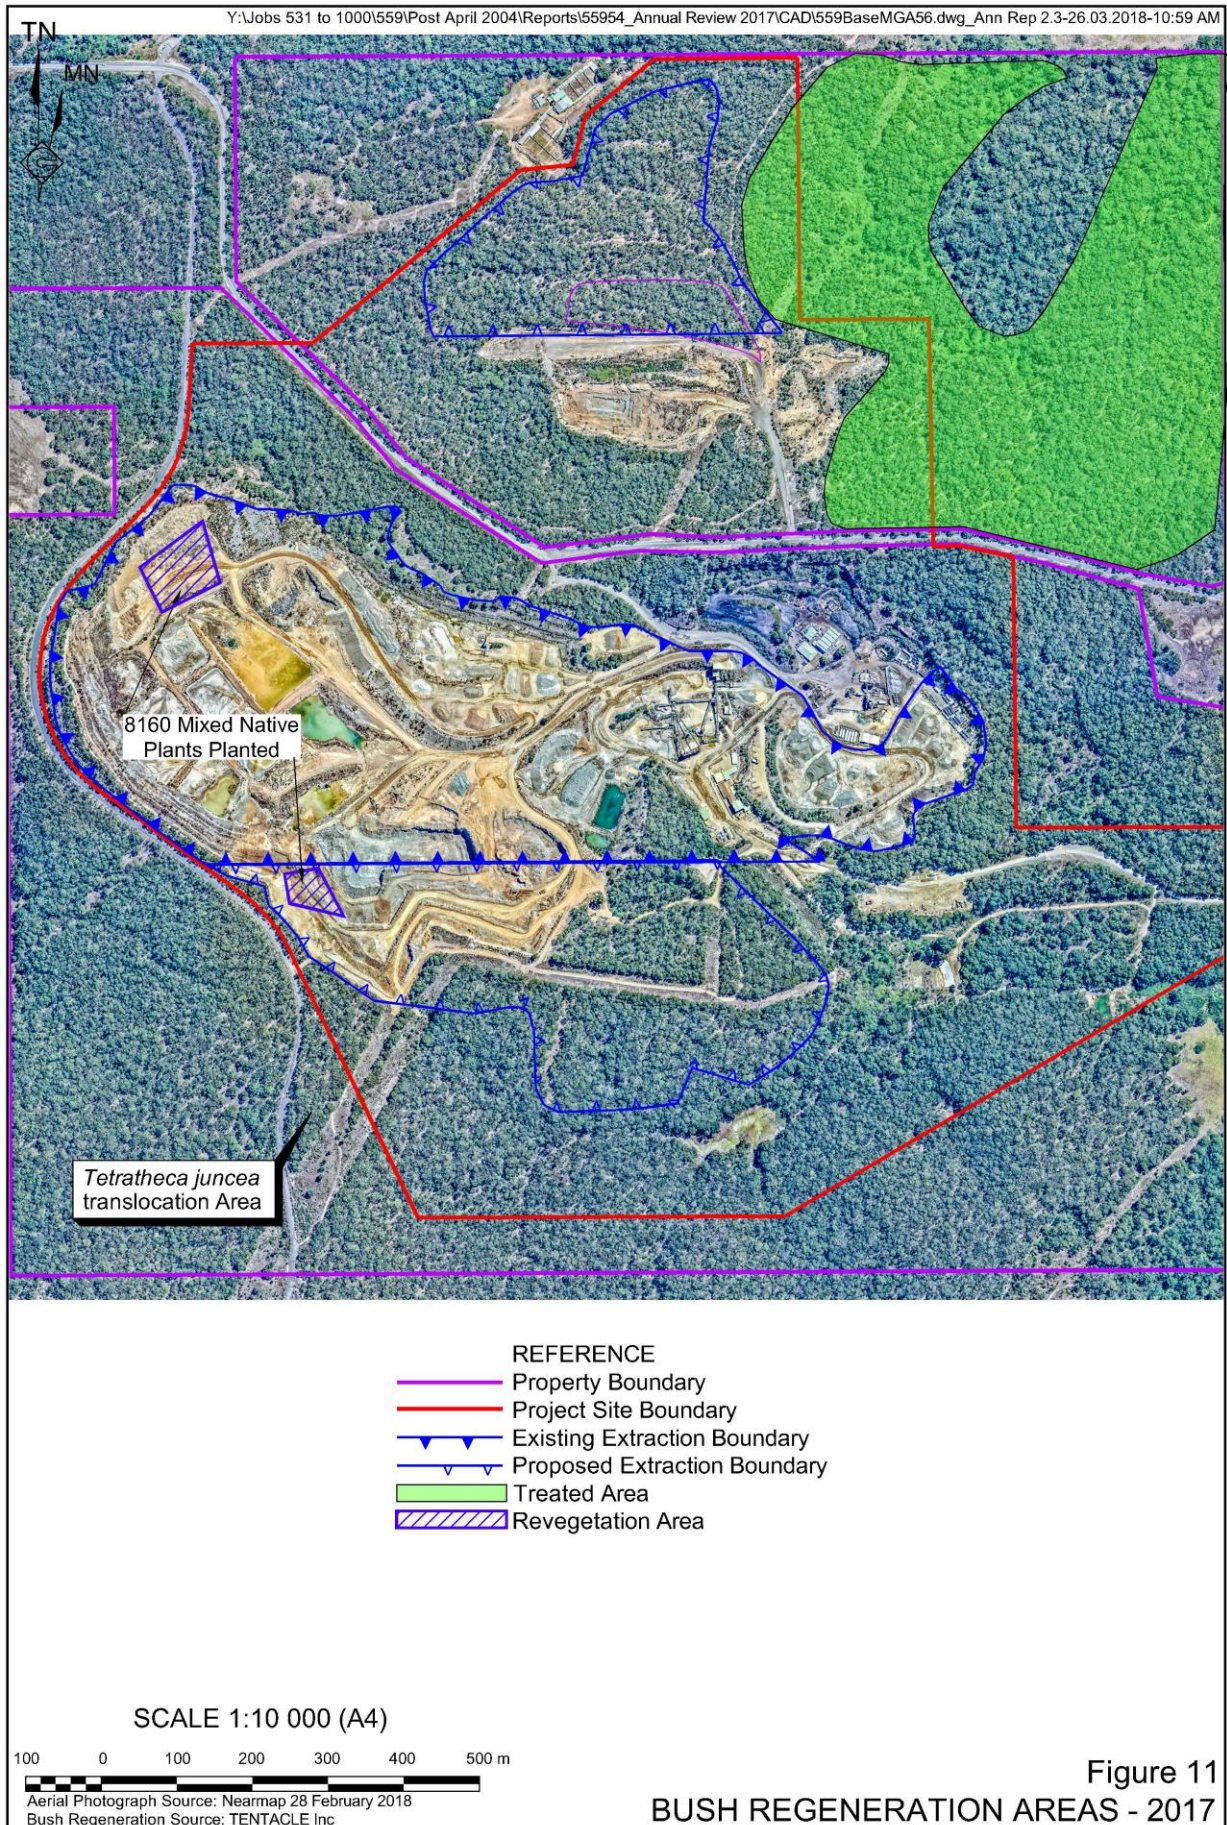
The status of land under rehabilitation adjacent to and above the former Silt Cell 1 is provided in **Plates 5** and **6**. The majority of rehabilitation works undertaken during the reporting period occurred within the Northern Area and non-operational areas in the form of weed reduction and eradication programs. **Figure 11** identifies the location of weeding activities undertaken throughout the reporting period.
