# Teralba Quarry

## 2018 Annual Review

Project Approval PA10\_0183

Period: 1 January 2018 to 31 December 2018

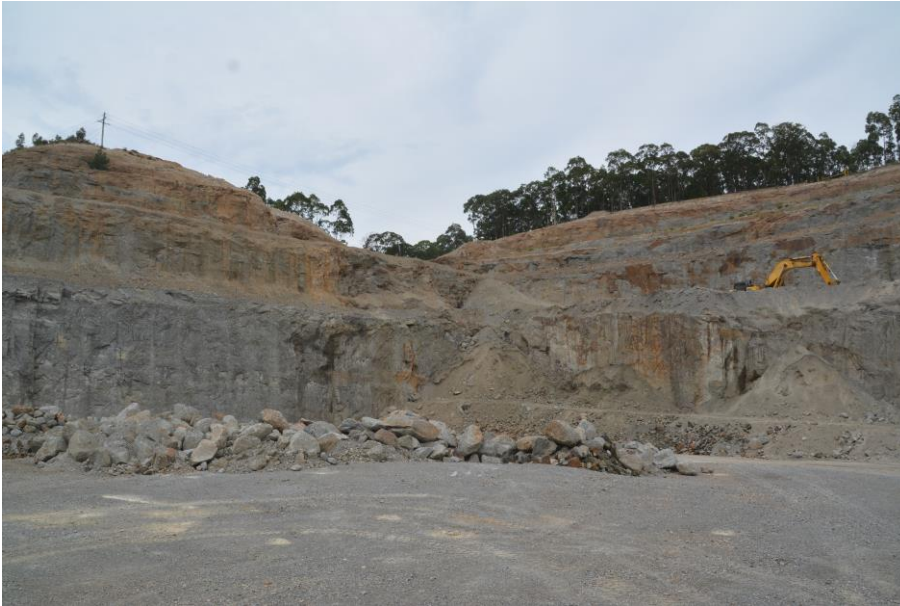
**Plate 1**  
A view to the south  
towards the active  
extraction faces in the  
Southern Extension  
(E559AH\_100)

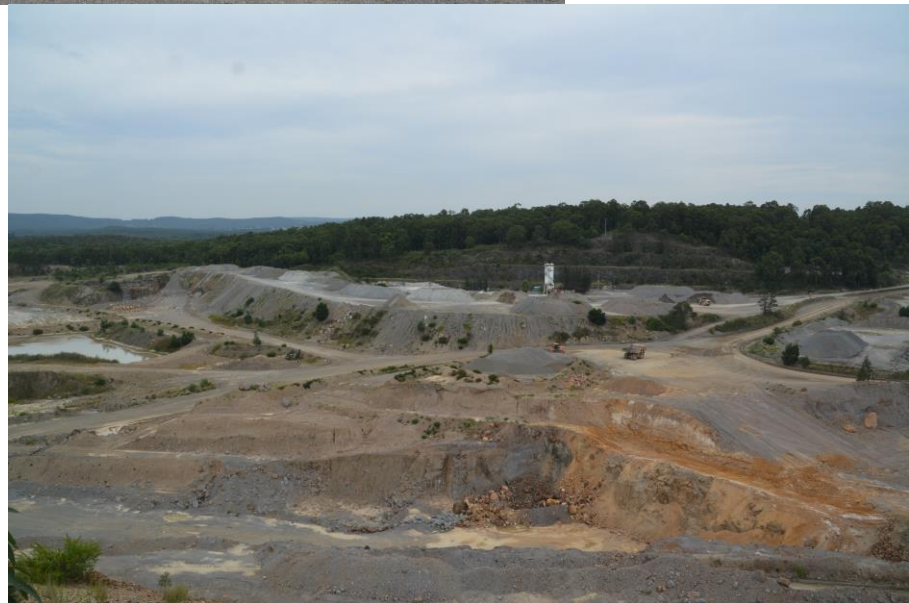
**Plate 2**  
A view to the northwest  
towards the Pugmill and  
pugmill stockpile area  
(E559AH\_061)

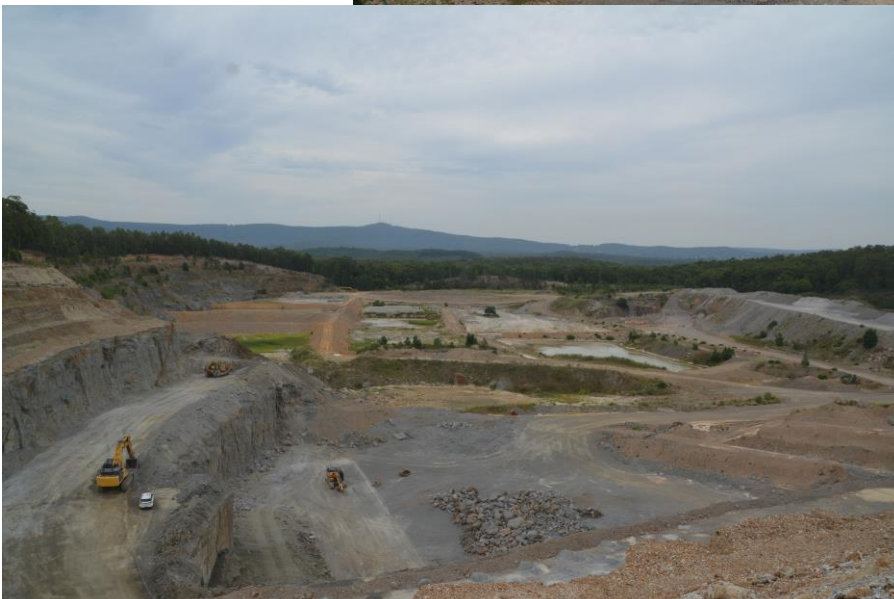
**Plate 3**  
A view to the northwest  
across all silt cells  
(E559AH\_045)

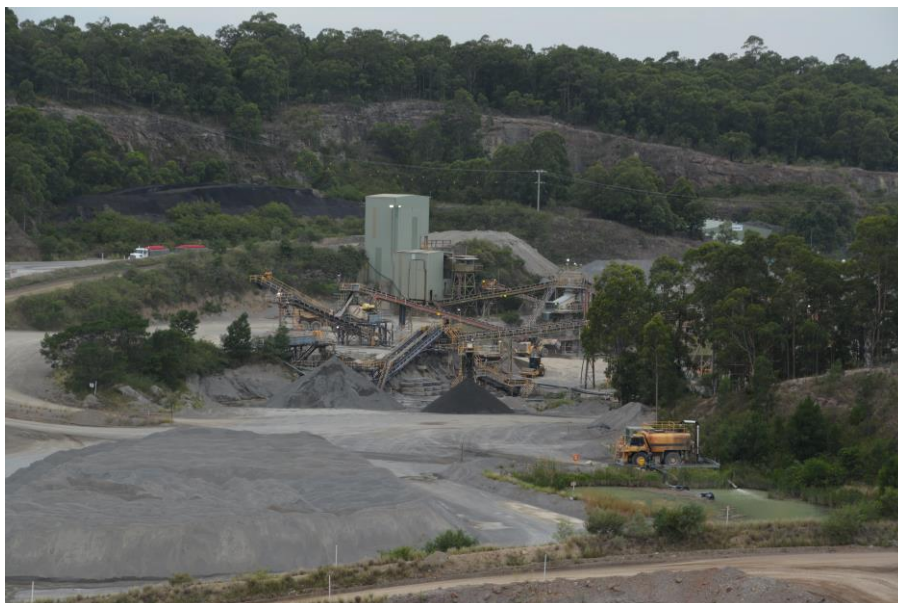
**Plate 4**  
A view to the northeast  
towards the Processing  
Plant  
(E559AH\_057)

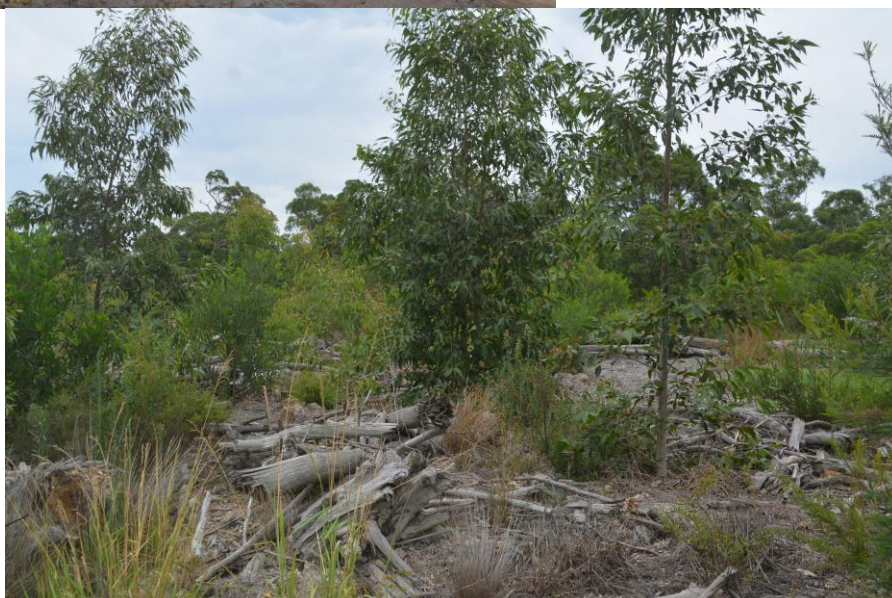
**Plate 5**  
Excellent growth on  
placed overburden near  
Silt Cell 1  
(E559AH\_075)

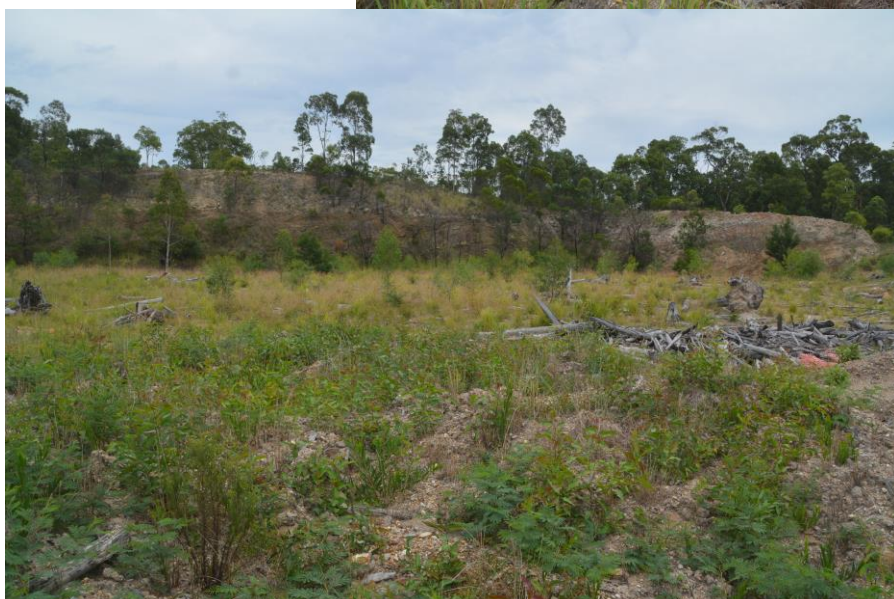
**Plate 6**  
Initial growth of planted  
tube stock on Silt Cell 2  
(E559AH\_078)

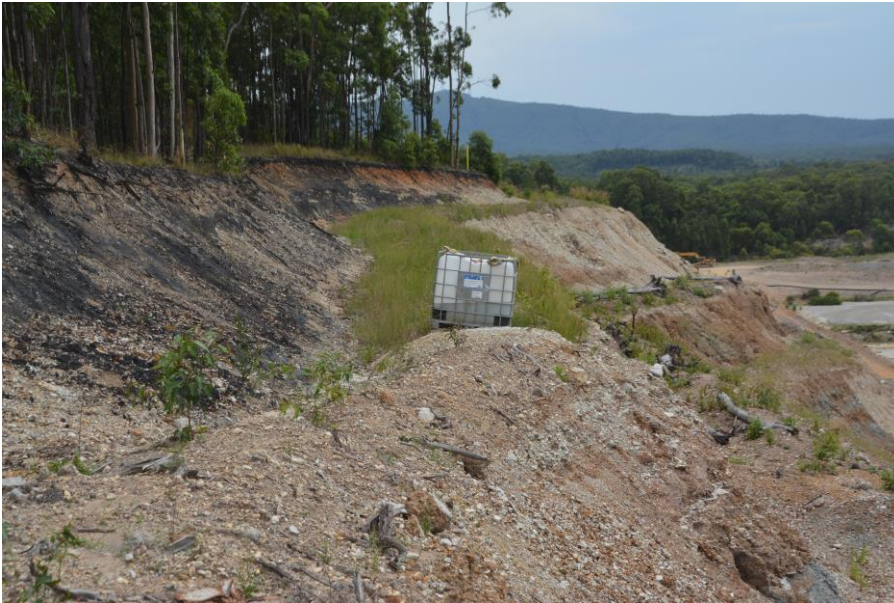
**Plate 7**  
A view along the upper extraction bench in Stage 1B. Intermediate bulk container used to store water for intermittent watering. (E559AH\_112)

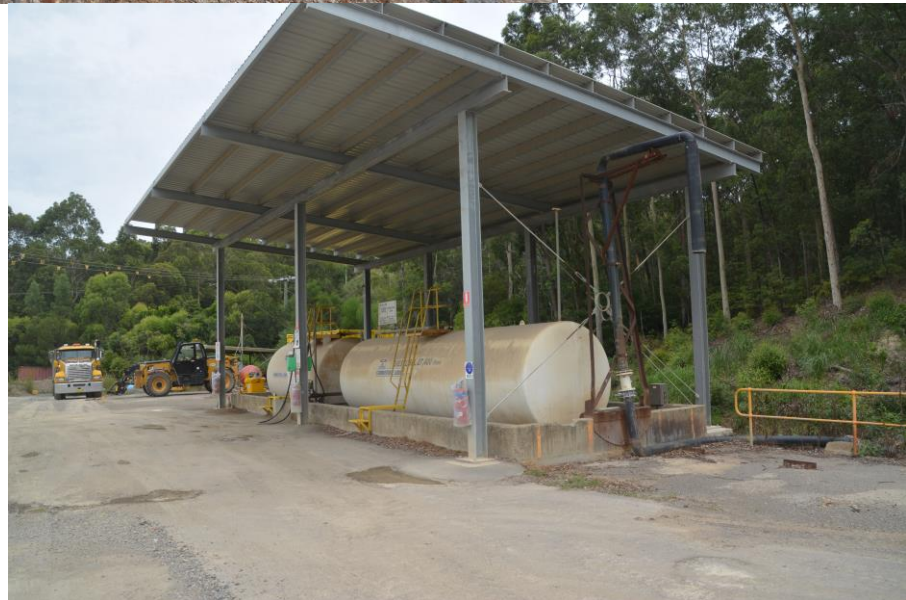
**Plate 8**  
A view of the vehicle refuelling area (E559AH\_139)

Hazardous materials within the Quarry Site are appropriately managed with diesel fuel stored in above ground tanks with roofing and appropriate bunding (110% of the total diesel tank capacity) (see **Plate 8** and **Plate 10**).

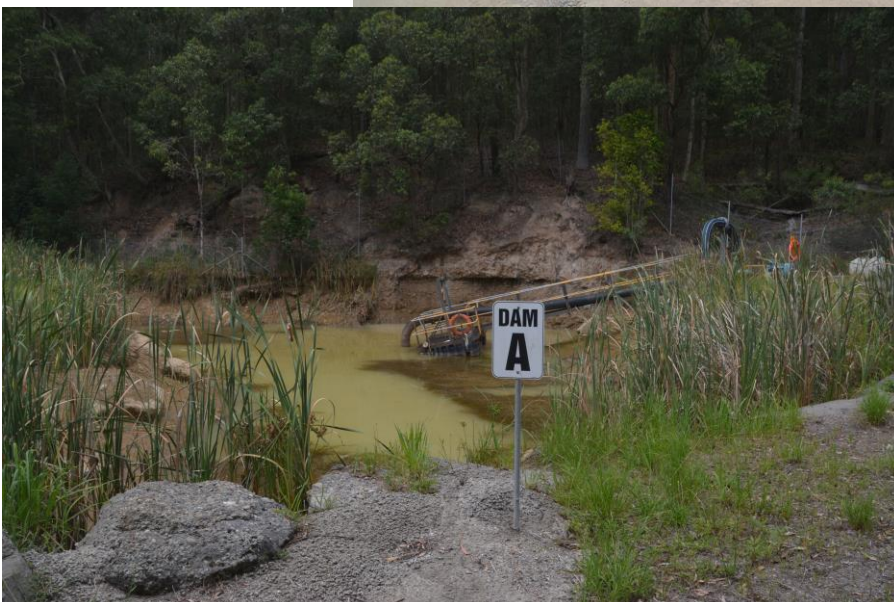
**Plate 9** View of the Mine Adit Dam and pump infrastructure (E559AH\_021)

Water quality monitoring is required to be undertaken at EPA Point 4 (Mine Adit Dam overflow – **Plate 9**), EPA Point 5 (Discharge off site from Dam B), EPA Point 6 (Northwestern boundary into unnamed creek) and EPA Point 7 (Northeastern boundary to unnamed creek) with these locations shown on **Figure 10**.

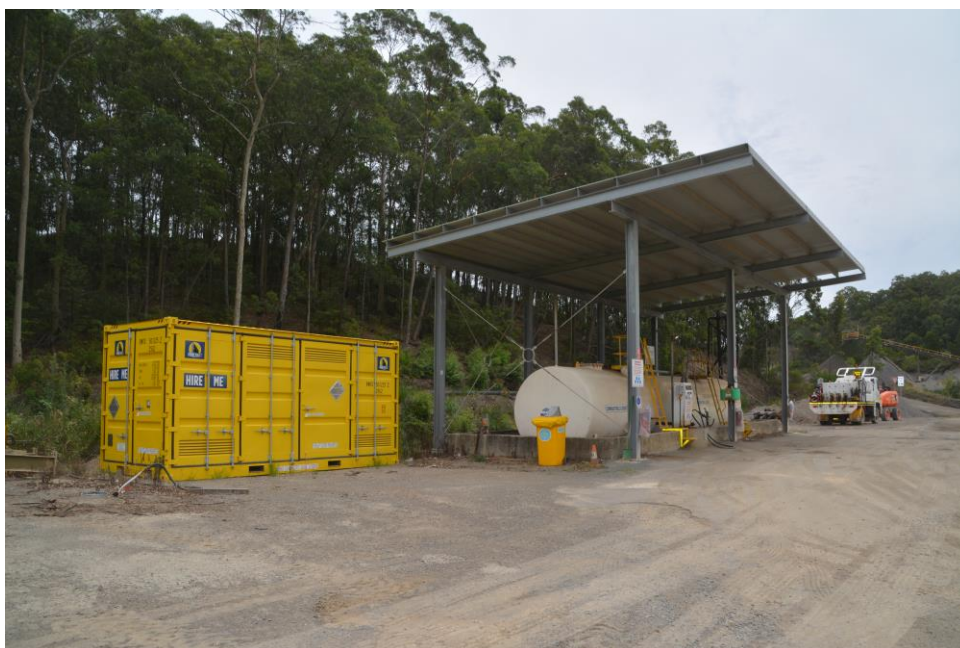
**Plate 10**      **Portable Oil Storage Container**  
(Ref: E559AH\_143)

During the reporting period, a self-bunded portable oil storage container was used on site to temporarily store oil that was delivered to the Quarry (see **Plate 10**). Oil is stored in this container until needed.

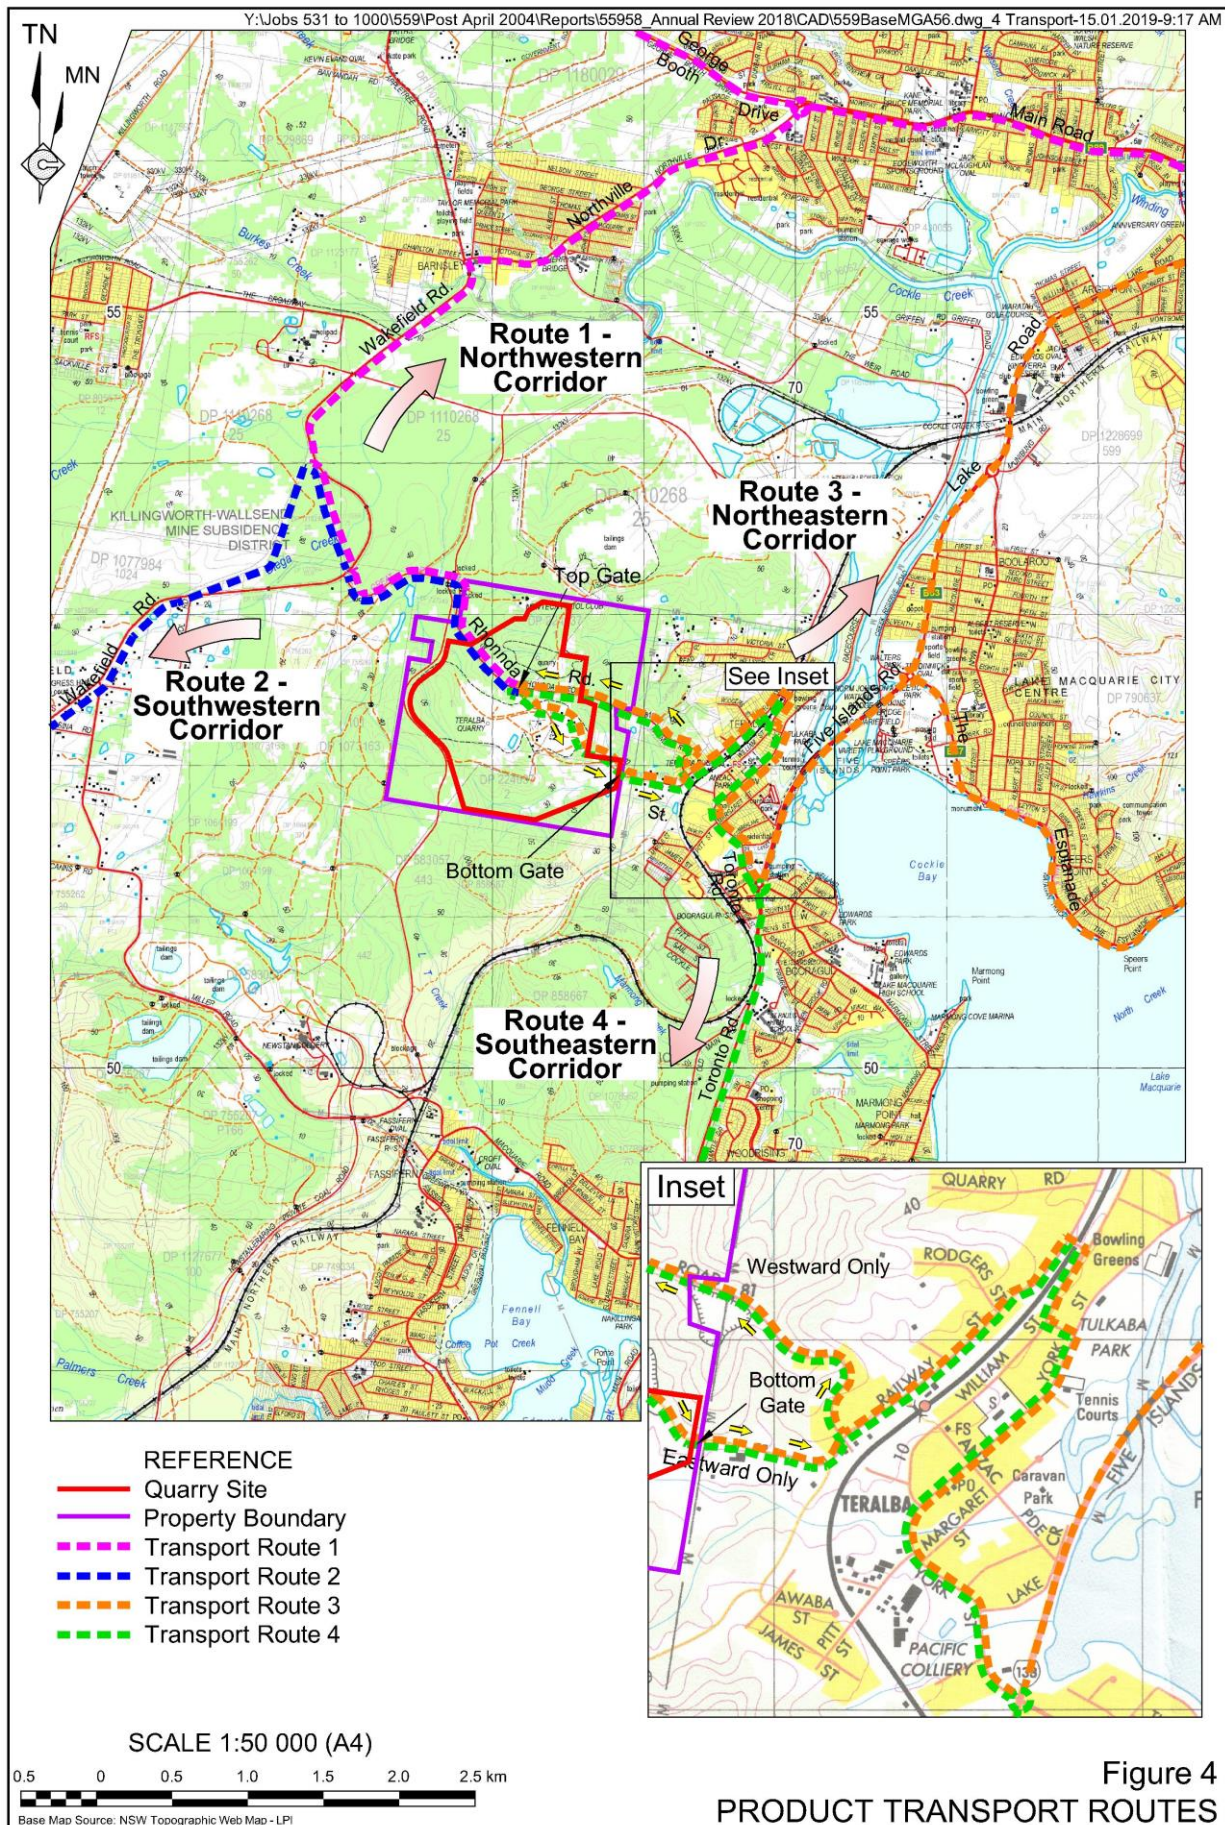
Figure 4  
PRODUCT TRANSPORT ROUTES

**Route 3 – Northeastern Corridor:**

Northeast along Railway St Teralba, crossing the railway line, then southwards along York St Teralba, then northeasterly along Five Islands Road to either The Esplanade (to the east) or Lake Road (to the north).

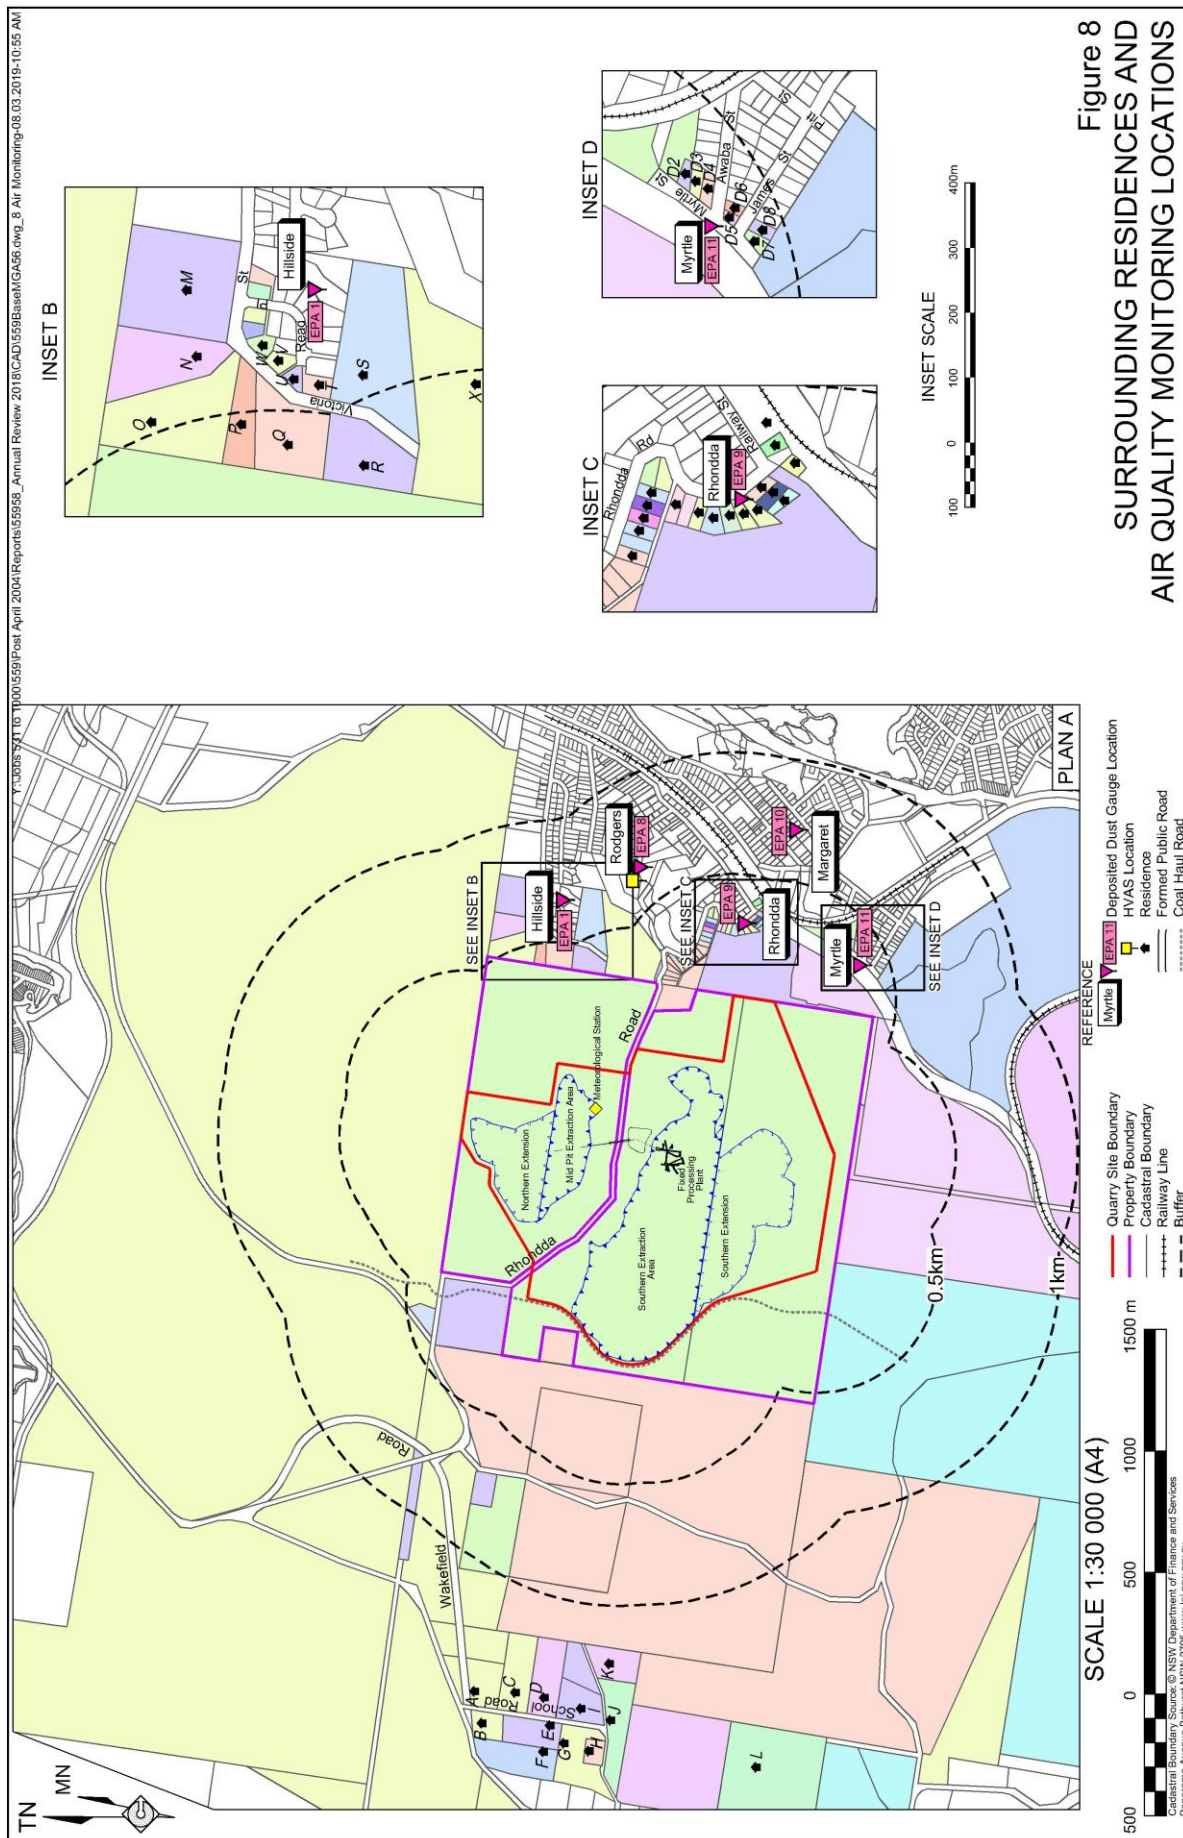
Figure 8  
SURROUNDING RESIDENCES AND  
AIR QUALITY MONITORING LOCATIONS

The HVAS required to monitor for PM<sub>10</sub> is located at EPA Point 3, at the same location as the Rodgers Street deposited dust gauge.

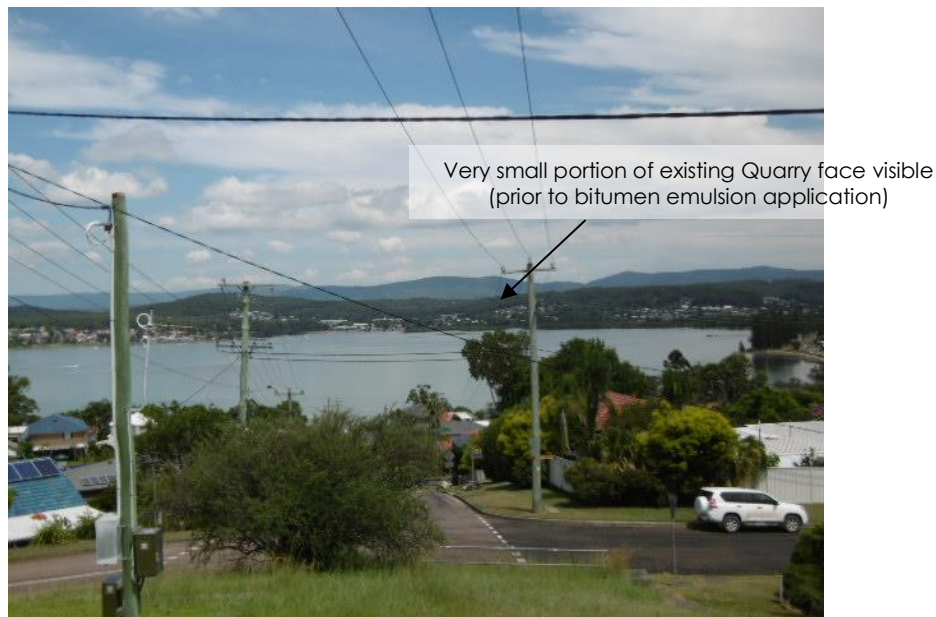
**Plate 11**      **View of the Quarry from Speers Point**

It has been acknowledged in previous reporting that the upper benches of the Southern Extension Extraction Area (Stage 1B) are visible from some parts of the residential areas in the vicinity of Speers Point. The upper benches that are visible represent only minor impacts, as Speers Point is more than 4.3km from the Quarry.

**Plate 11** displays the area visible from Speers Point.

In order to mitigate visual impacts from these locations, Metromix prioritised revegetation activities on the two upper benches within Stage 1B with tubestock and placed logs, etc. (**Plate 7**) and trialled bitumen emulsion applications on the visible faces. While the bitumen emulsion trials were considered successful, it is recognised that tree screening will be important to provide a vegetated view consistent with the surrounding landscape.

During the reporting period, rehabilitation activities on these benches was enhanced through watering and maintenance. Vegetation condition would continue to be monitored in this area.
