# **Teralba Quarry Community Consultative Committee**

**5<sup>th</sup> May 2021**

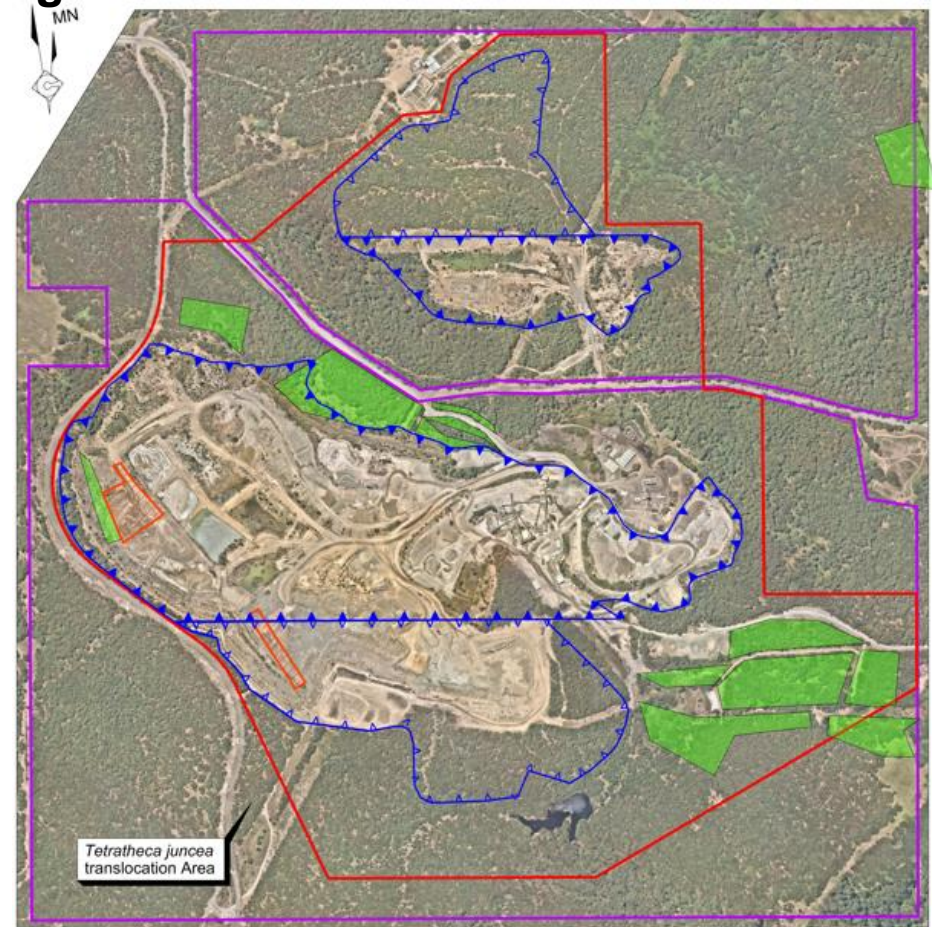
During 2020 a total of 1,634 native trees, shrubs and grasses were planted in the western portion of the Quarry along completed benches and completed silt cells.

- REFERENCE
- Property Boundary
  - Project Site Boundary
  - Extraction Area Boundary
  - Proposed Extraction Boundary
  - Treatment Area
  - 2020 Planting Area

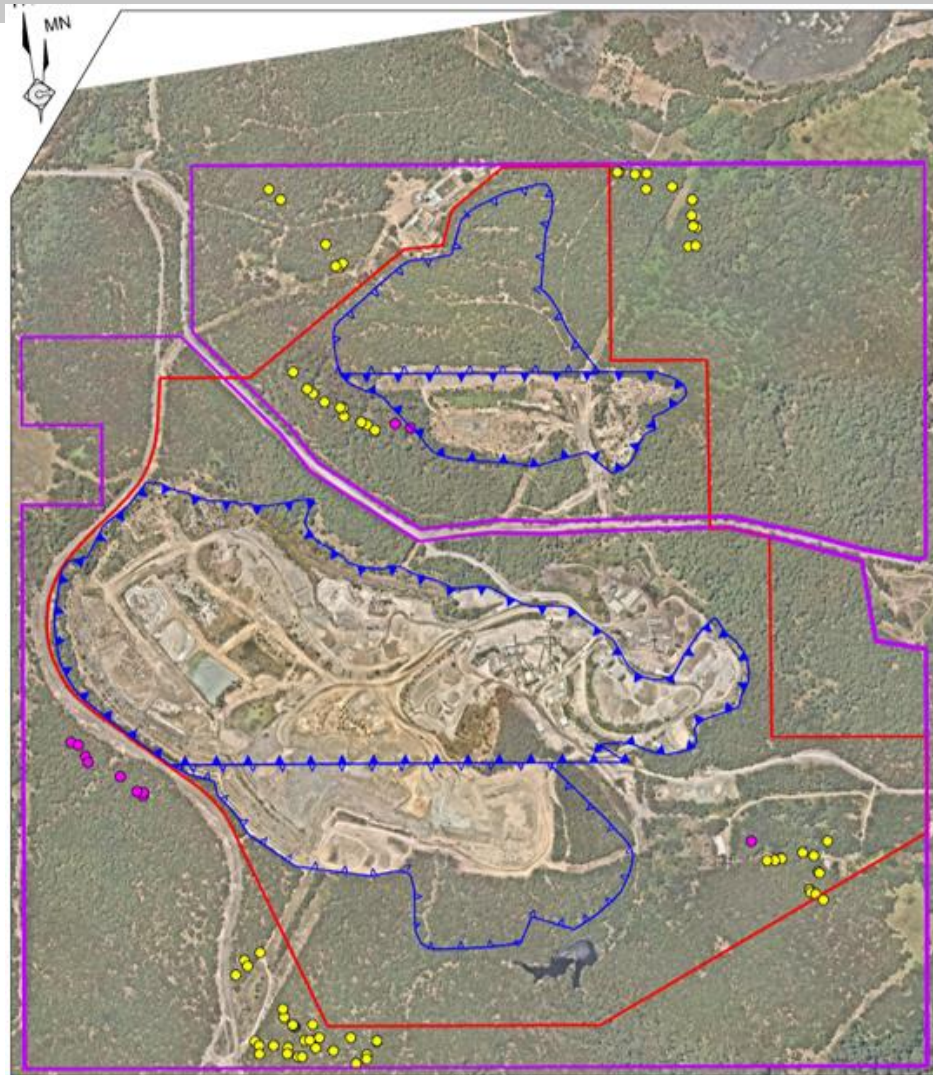
- REFERENCE
- Property Boundary
  - Quarry Site Boundary
  - Existing Extraction Area
  - - - Extension Area Boundary
  - Nesting Box Location
  - New Nesting Box Location

Note: Nesting box locations are often co-located and are superimposed in this figure.

Nesting boxes were inspected on 24th September 2020 by Echo Ecology and Surveying. An additional 11 nesting boxes were installed as required under a commitment relating to vegetation clearing for the approval for the powerline relocation. These boxes have now been included as part of the annual nesting box monitoring program.

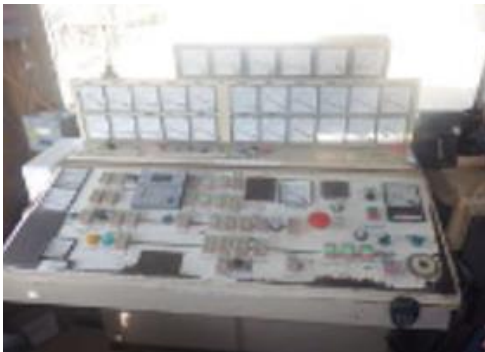
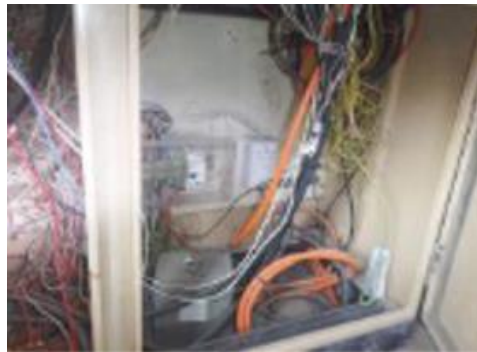
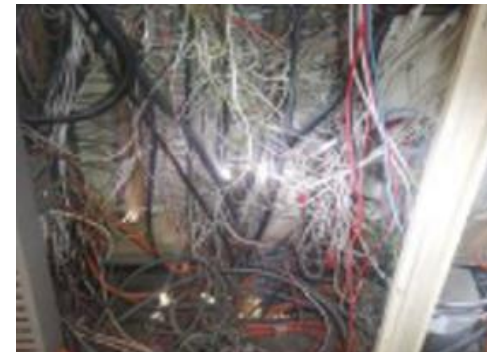
- \* Upgraded the existing Plant Motor Control Centre architecture and installed a new PLC system in the control tower. (Cost \$490k)

- \* Installed remote switching and field full current lockout devices. (Cost \$99k)
- \* Installed a second hydraulic pump and connections for the Pug Mill. (Cost \$15k)

- \* The existing Plant Motor Control Centre architecture was outdated. This upgrade achieved a level of functional safety by using extra low voltage field control circuits, prestart alarms and sequenced automatic starting/stopping.
- \* Installing remote switching and field full current lockout devices addressed existing arc flash issues and provided a more robust and safe method of isolation/lockout.
- \* Installing a second hydraulic pump and connections for the Pug Mill was part of the PLC and SCADA system that was installed in 2019.

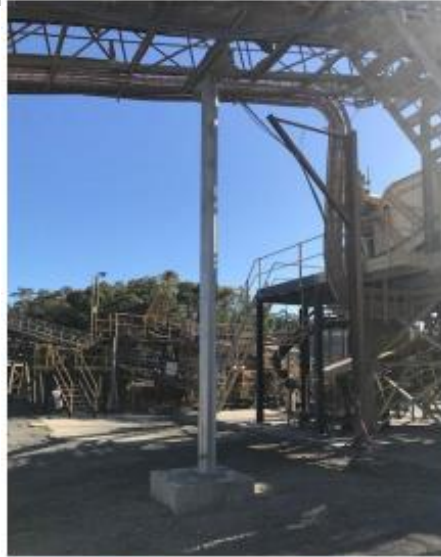
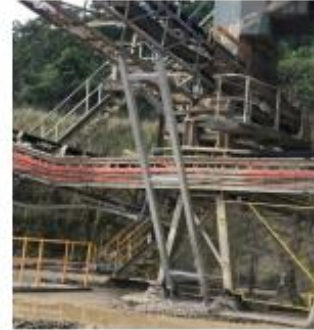
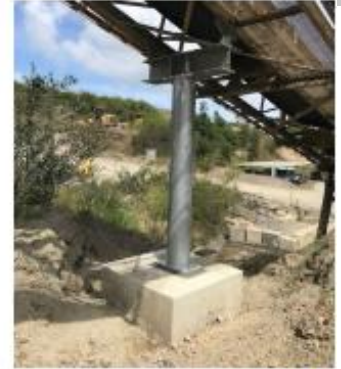
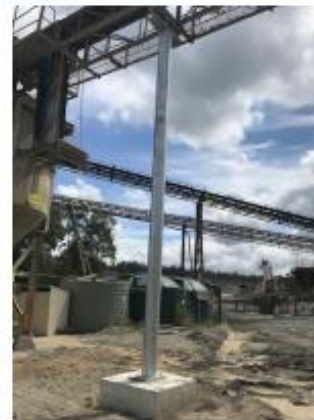
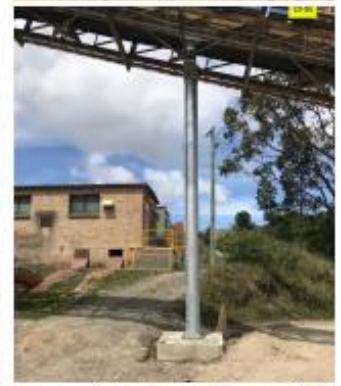
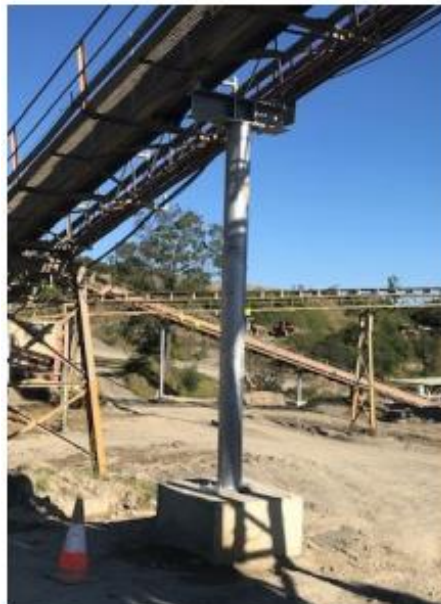
\* Structural Engineer deemed the span lengths of some conveyors were to long and did not meet Australian Standards.

\* Installed additional trestles to conveyors 1, 2, 3, 5, 7, 10 and 11.

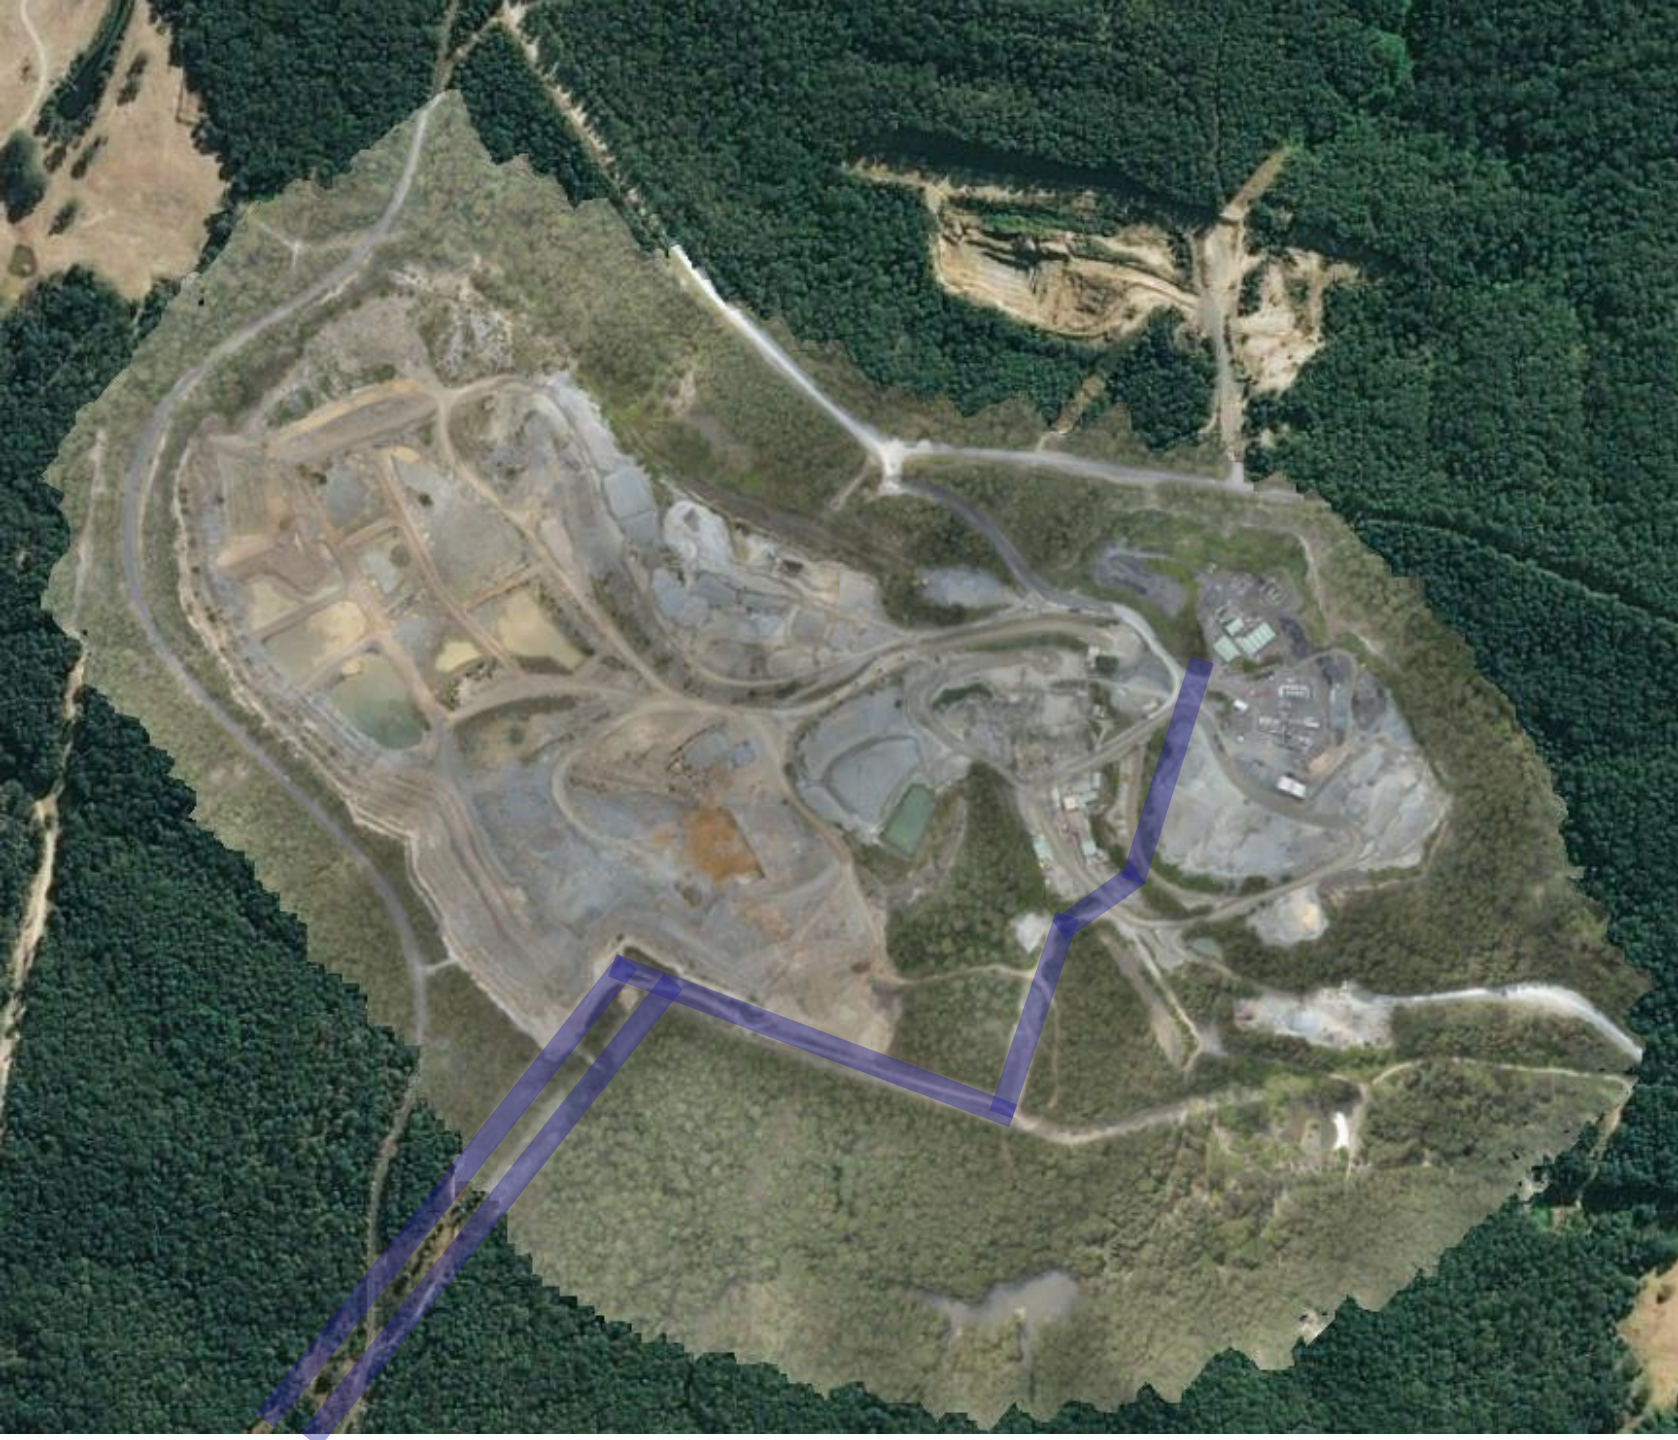
Two sets of power lines owned by Ausgrid traversed the Teralba Quarry Southern Extension Area, being:

(a) the 33kV transmission line traversed the site but was not used by Metromix; and

(b) the 11kV transmission line which connected to a small onsite substation and supplied Downer EDI and the Metromix offices, water supply pump and processing plants.

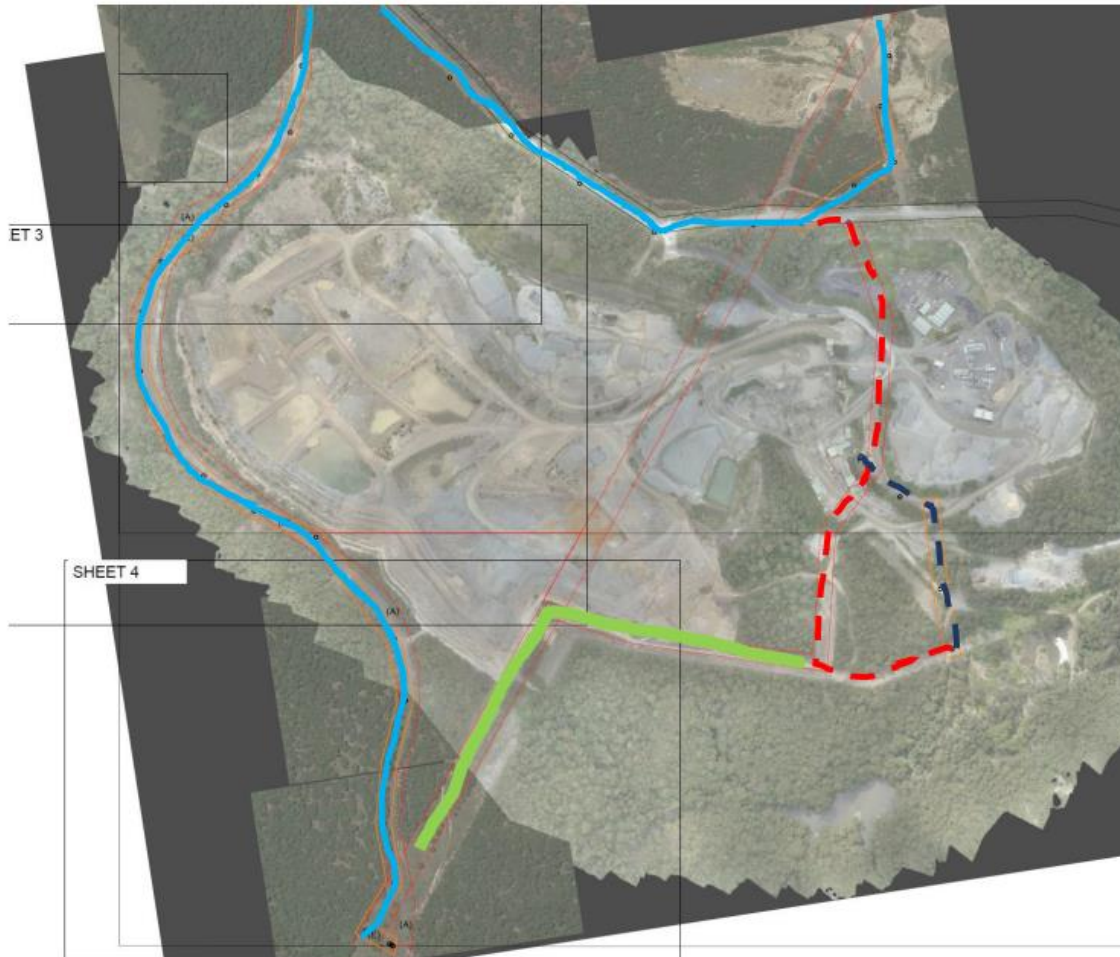
New 33 and 11 kV line (complete)
-

Redundant 33 and 11 kV line  
To be dismantled in "Dismantle Stage 1"
-

New 11 kV line (to be completed).
-

Redundant 33 kV line  
To be dismantled in "Dismantle Stage 2"

The scope of the project required clearance of vegetation to create 20 m easements for the new power lines.

The construction works required the removal of 26 poles, replacement of 17 existing power poles and the installation of 49 new power poles.

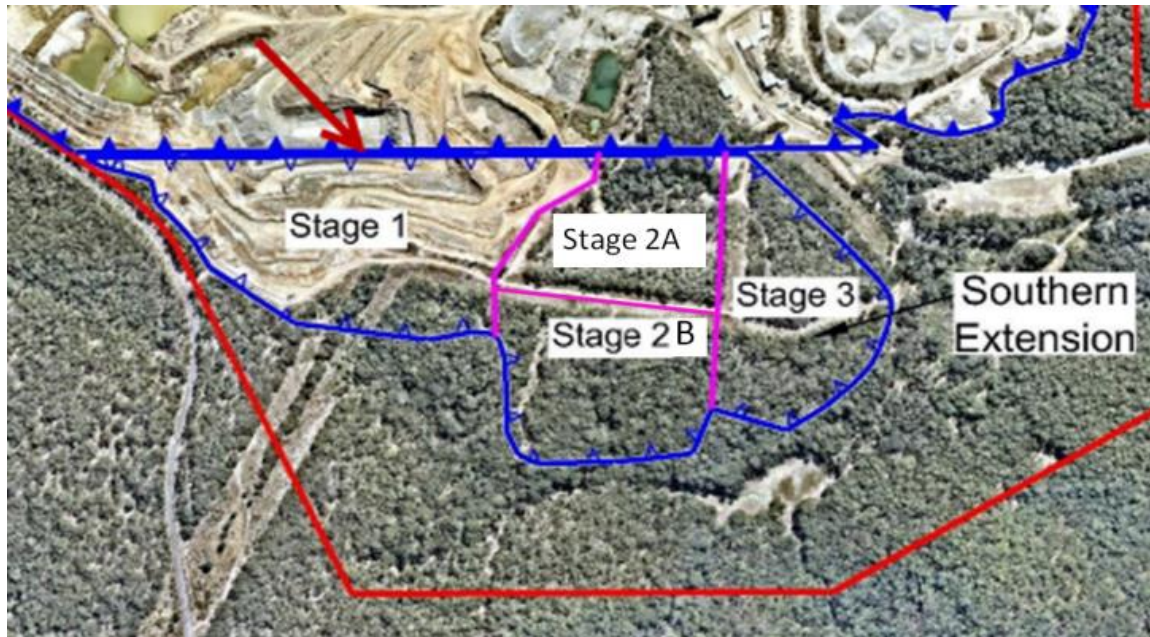
\* To access the reserves in the Southern Extension Area:

Southern Extension	
2019 Recorded Reserves [t]	
Saleable Overburden	1,355,833
Saleable Rock	8,684,641
Total	10,040,474

\* Southern Extension Area provides approx. 14.8 years of useful life.  
(Based on an annual extraction of 678.4kt)

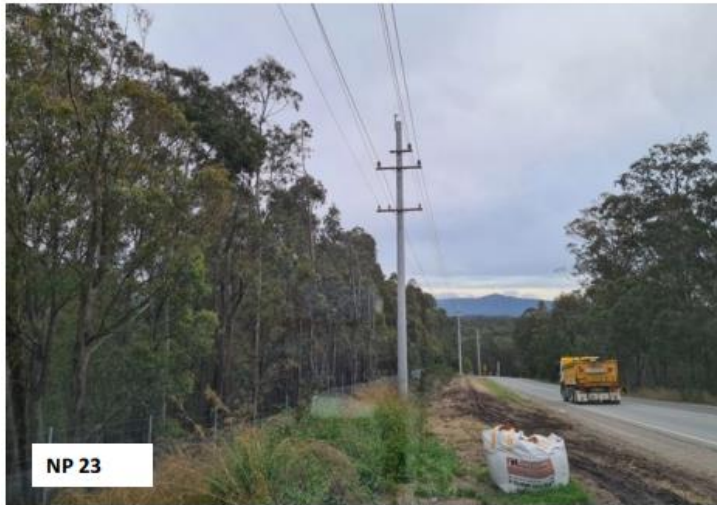
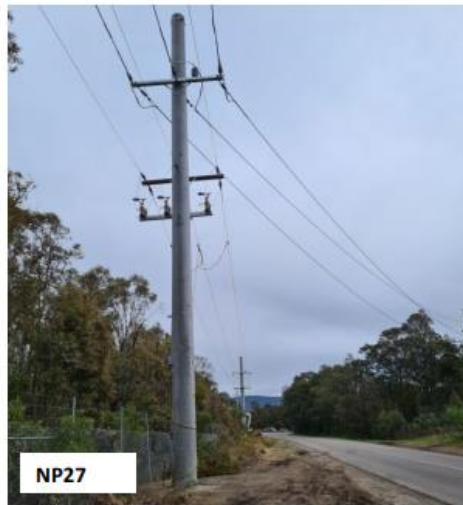
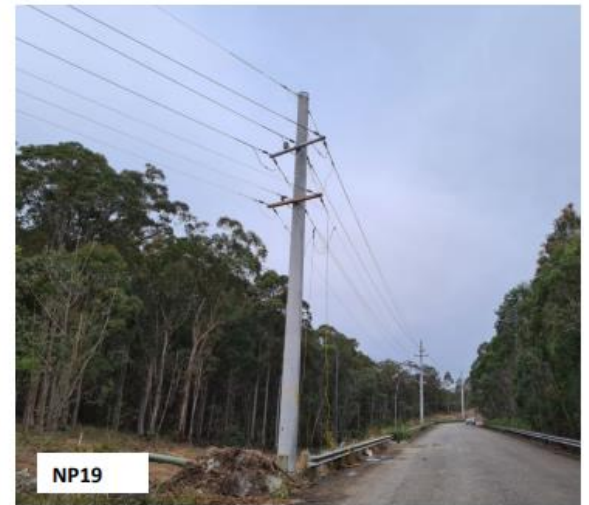
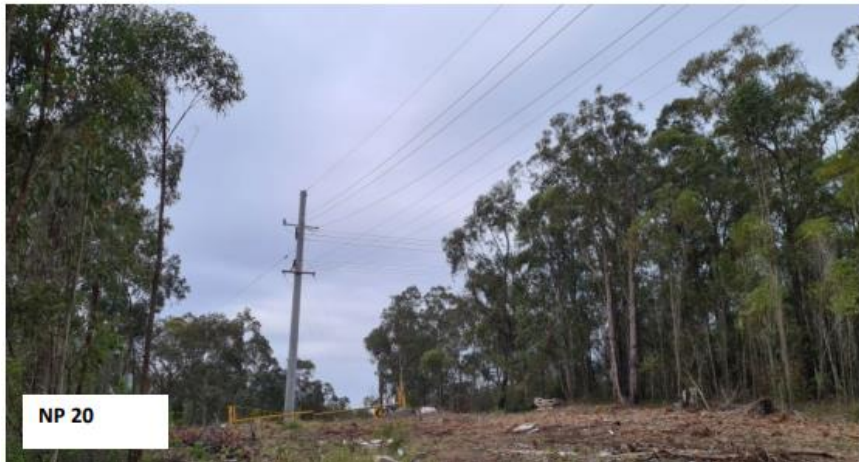
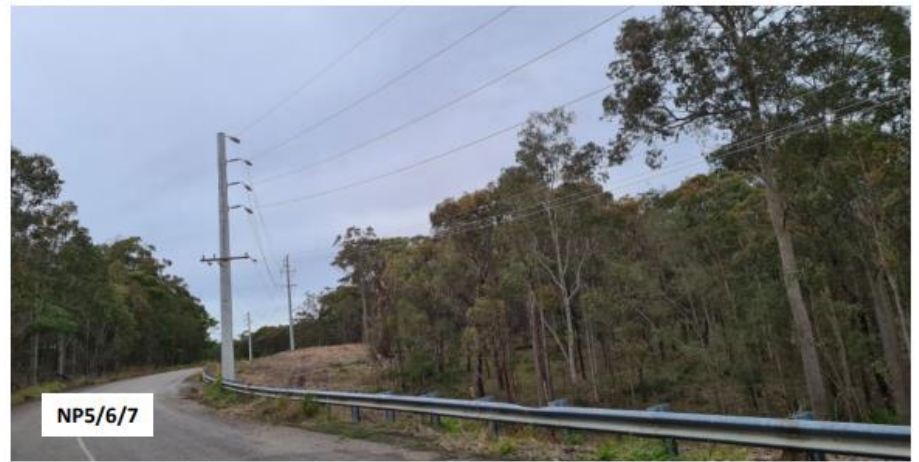
- Deviated from Mine Plan in 2019 to mine Stage 2A ahead of schedule to compensate for the power lines
- Redundant power lines were removed in late September 2020
- New haul road was required to access Stages 1C and 2B. The new road was designed to the Resources Regulator guidelines and risk assessed before construction commenced

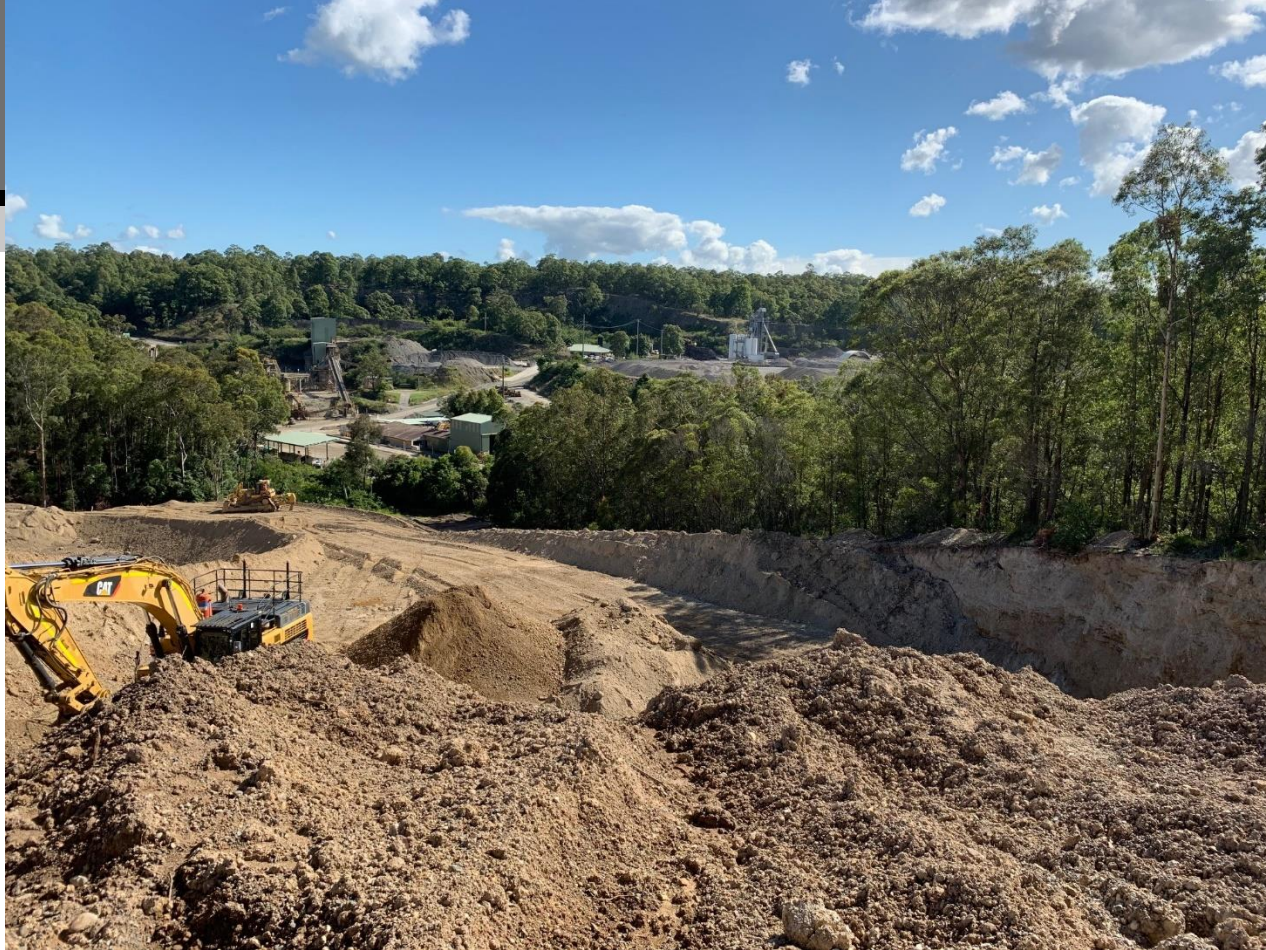
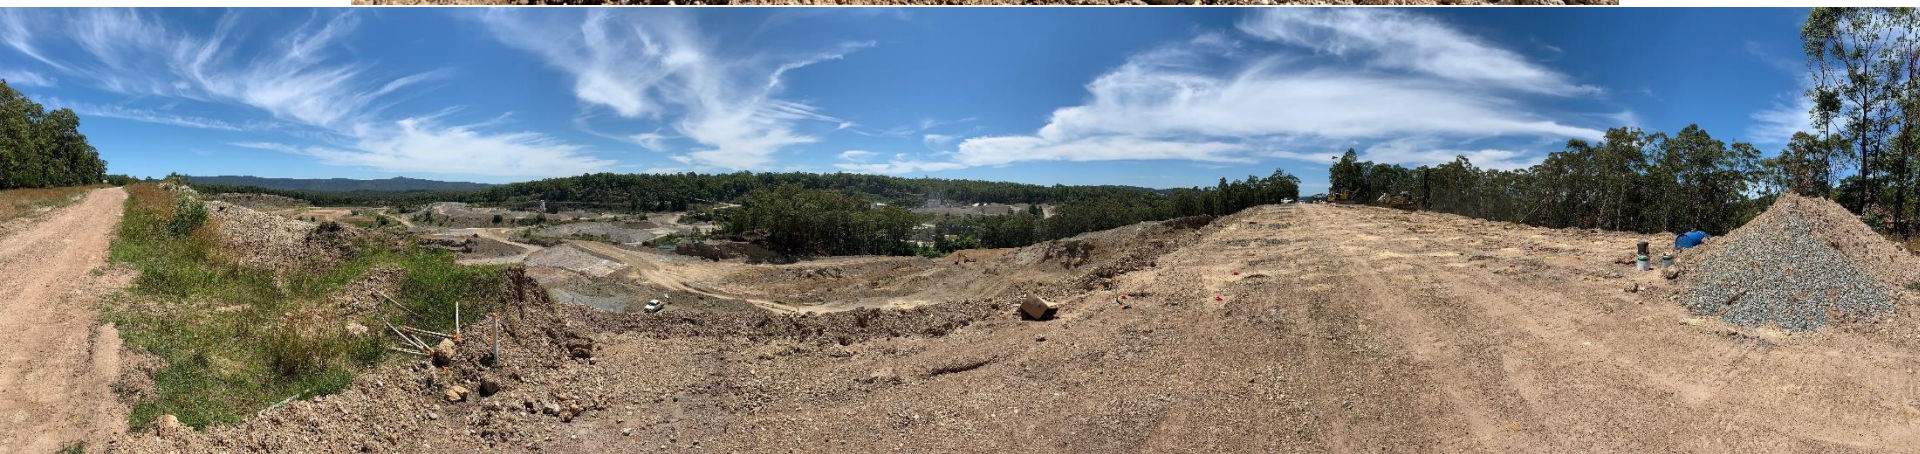
### **Blast – 2018 Ramp**

- Stripping campaign was put out to tender
- Awarded the contract in early October and stripping commenced in late November
- Stripping campaign concluded in early February with approximately 78,174t (48,859m<sup>3</sup>) of overburden removed
- First blast in Stage 1C was done in April 2021
