Teralba Quarry

2021 Annual Review

Project Approval PA10_0183

Period: 1 January 2021 to 31 December 2021

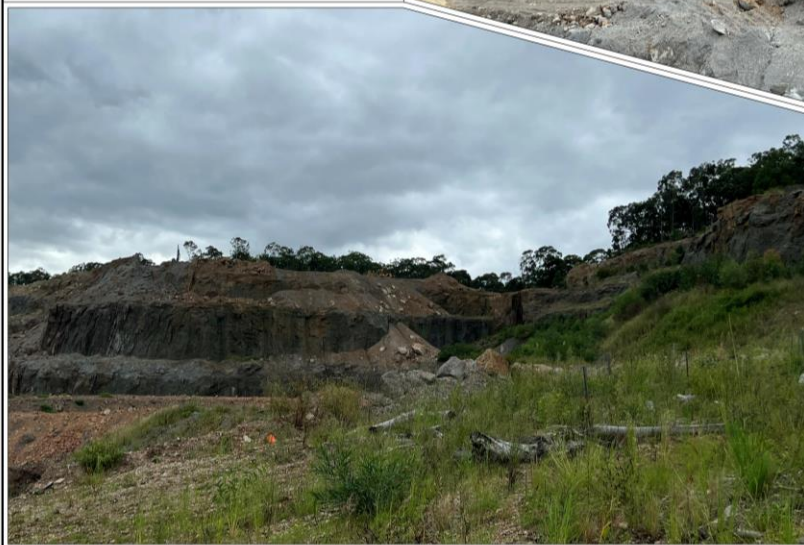
Plate 3: A view along the upper extraction bench in Stage 1B

In order to mitigate visual impacts from these locations, Metromix has continued to prioritise revegetation activities on the two upper benches within Stage 1B with tubestock and placed logs (**Plate 3**) on the visible faces.

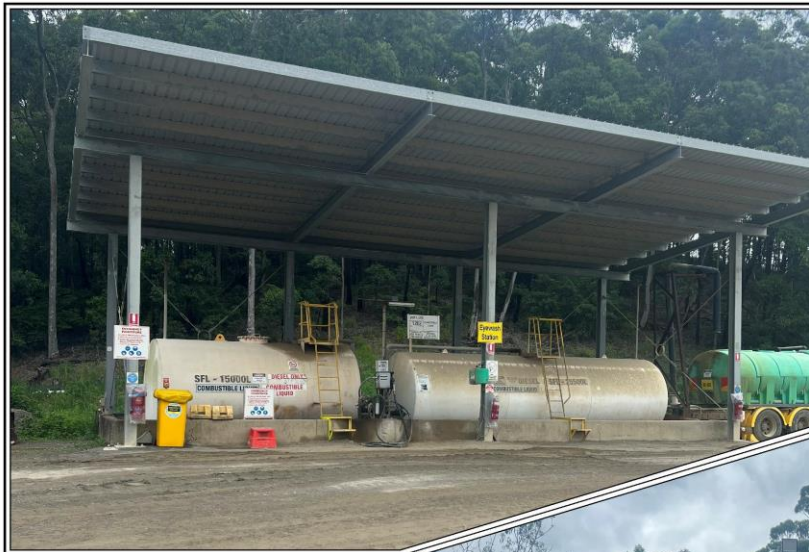
Plate 4: A view of the vehicle refuelling area

Hazardous materials within the Quarry Site are appropriately managed with diesel fuel stored in above ground tanks with roofing and appropriate bunding (110% of the total diesel tank capacity) (see **Plate 4**).

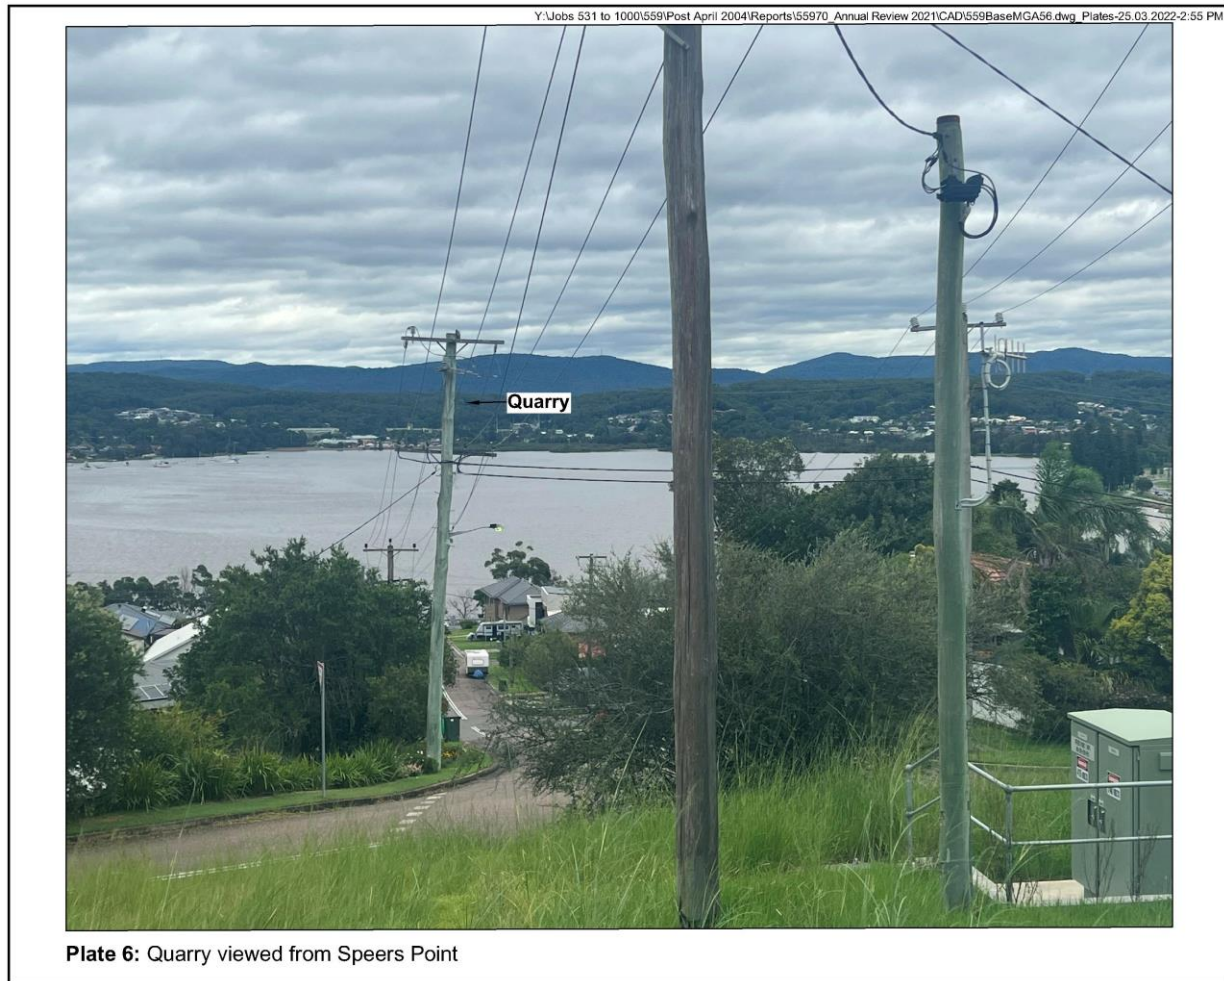
It has been acknowledged in previous reporting that the upper benches of the Southern Extension Extraction Area (Stage 1B) are visible from some parts of the residential areas in the vicinity of Speers Point. The upper benches that are visible represent only minor impacts, as Speers Point is more than 4.3km from the Quarry.

Plate 6 displays the area visible from Speers Point.

During the reporting period, rehabilitation activities on these benches was enhanced through watering and maintenance. Vegetation condition would continue to be monitored in this area.

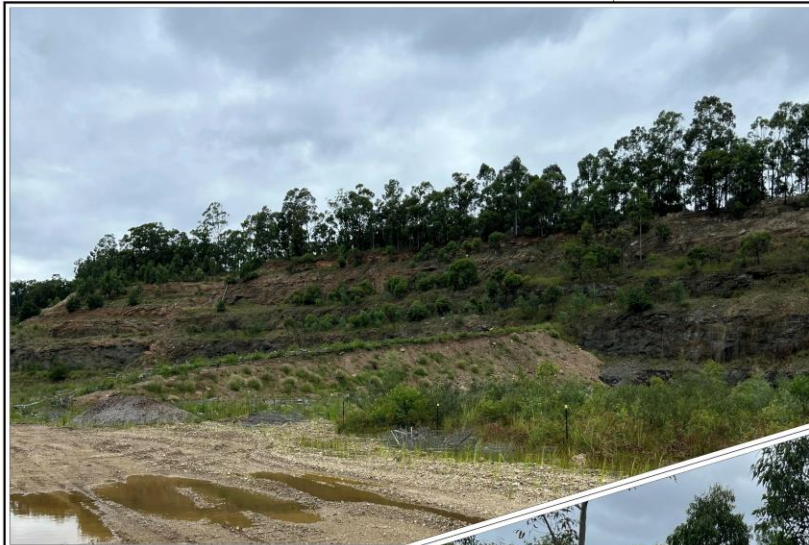
Plate 7: Rehabilitation progress on former Silt Cell 4

The status of land under rehabilitation within former Silt Cell 4 is displayed in **Plate 7** and the older and more developed rehabilitation of former Silt Cell 1 and Silt Cell 2 is displayed in **Plate 8**. The condition of vegetation in former Silt Cell 5 is displayed in **Plate 9**. T.E.N.T.A.C.L.E. Inc. prepared a progress report of the regeneration works undertaken during 2021 on behalf of Metromix, summarising the aims, methods and results of the rehabilitation works. A copy of the progress report by T.E.N.T.A.C.L.E Inc. is reproduced in **Appendix 7**.
