2021 Nest Box Monitoring Report

**2021 NEST BOX MONITORING
REPORT**

Teralba Quarry, Teralba, NSW

Job Reference 074 - November 2021

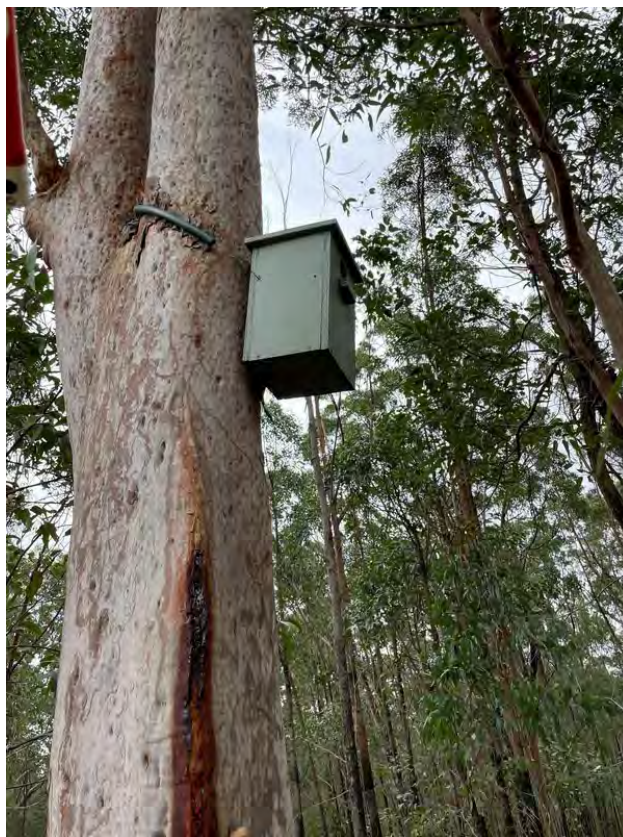
6, Smooth-barked Apple

Check Method	Nestbox camera
Pests?	Yes
Pest Species	Ants
Repairs required?	No
Occupation Evidence?	No

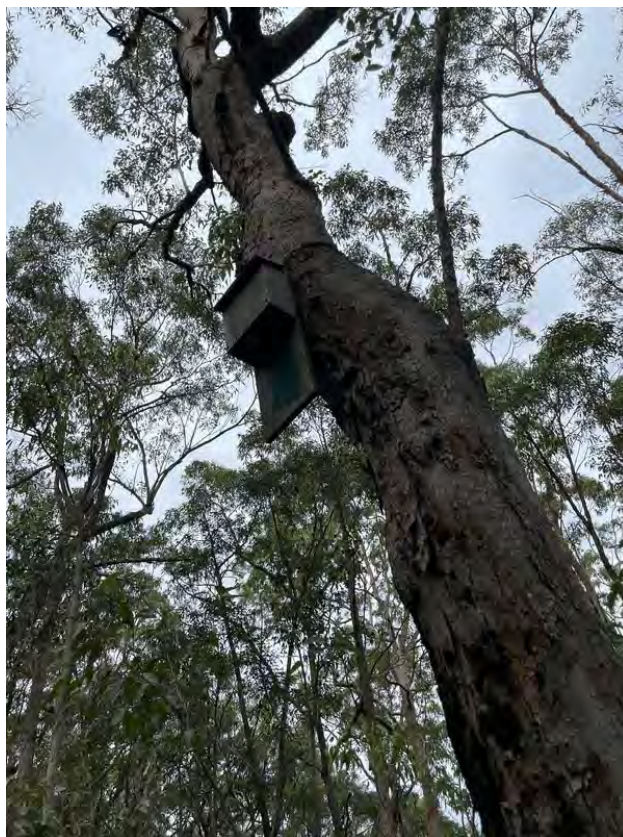
12, Bloodwood

Check Method	Nestbox camera
Pests?	No
Repairs required?	No
Occupation Evidence?	No

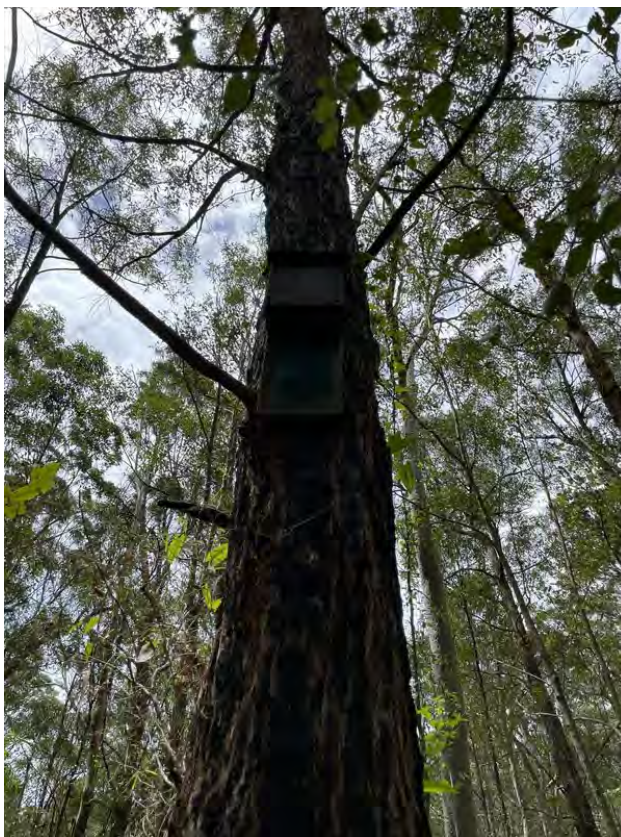
no, 49, Tallowwood

Check Method	Nestbox camera
Pests?	No
Repairs required?	Yes
What sort of repairs?	Vine growing through box
Repairs complete?	Yes
Occupation Evidence?	No
OccupationComments	Pulled the vine out

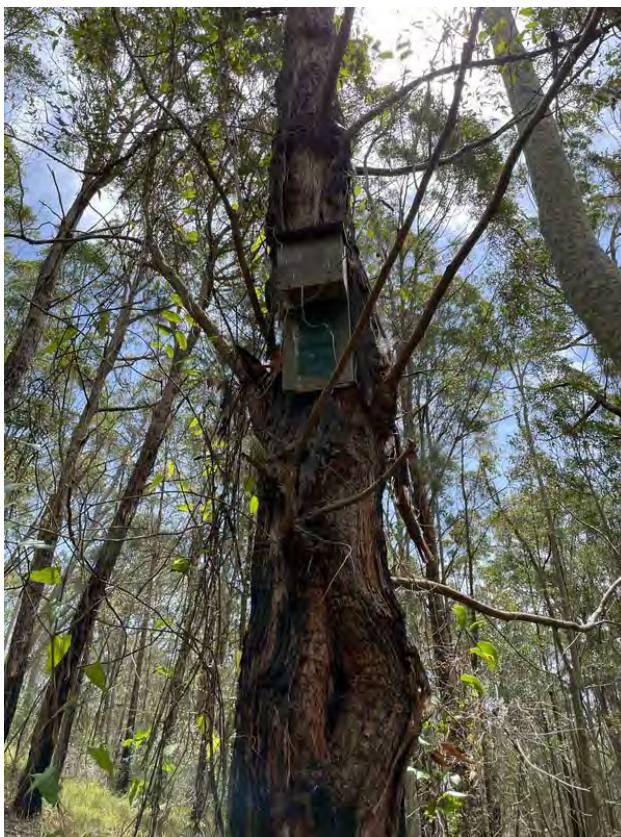
50, Tallowwood

Check Method	Nestbox camera
Pests?	No
Repairs required?	Yes
What sort of repairs?	Lid ajar
Repairs complete?	No
Occupation Evidence?	No

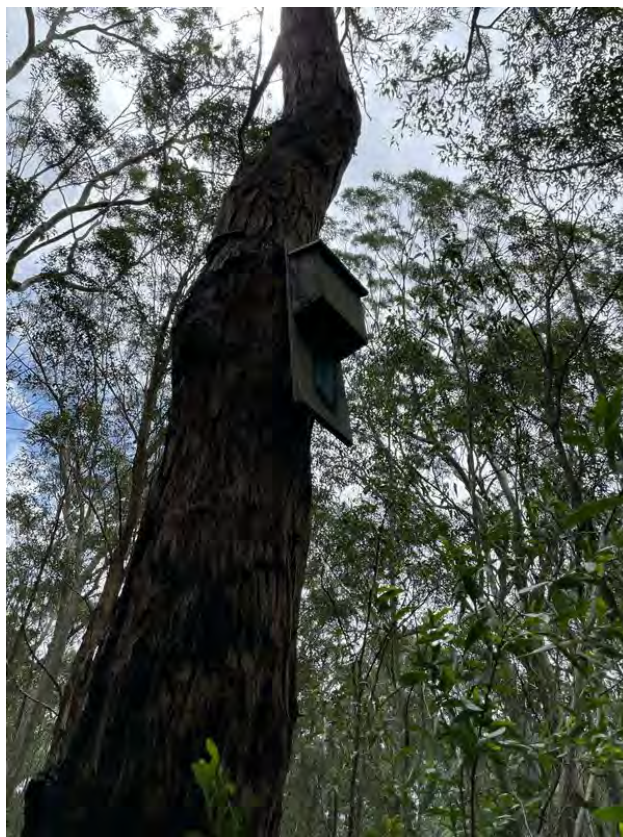
57, Ironbark

Check Method	Nestbox camera
Pests?	No
Repairs required?	No
Occupation Evidence?	No
OccupationComments	Some sort of fungus growing on the box I think, but still looks usable

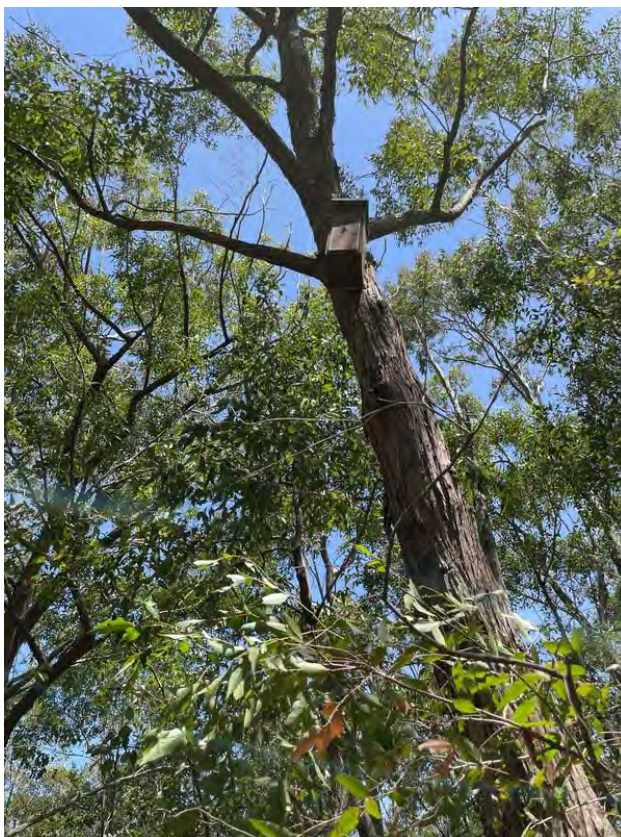
67, Spotted Gum

Check Method	Nestbox camera
Pests?	No
Repairs required?	No
Occupation Evidence?	No
OccupationComments	Chewed entrance

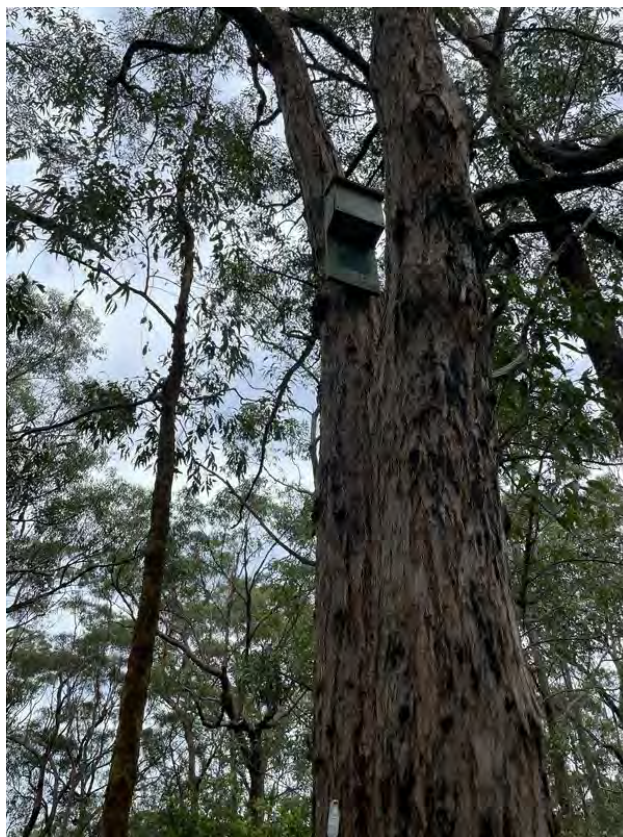
71, Stringybark/Mahogany

Check Method	Nestbox camera
Pests?	Yes
Pest Species	Termites
Repairs required?	No
Occupation Evidence?	No
OccupationComments	Replacement will be needed in next couple of years

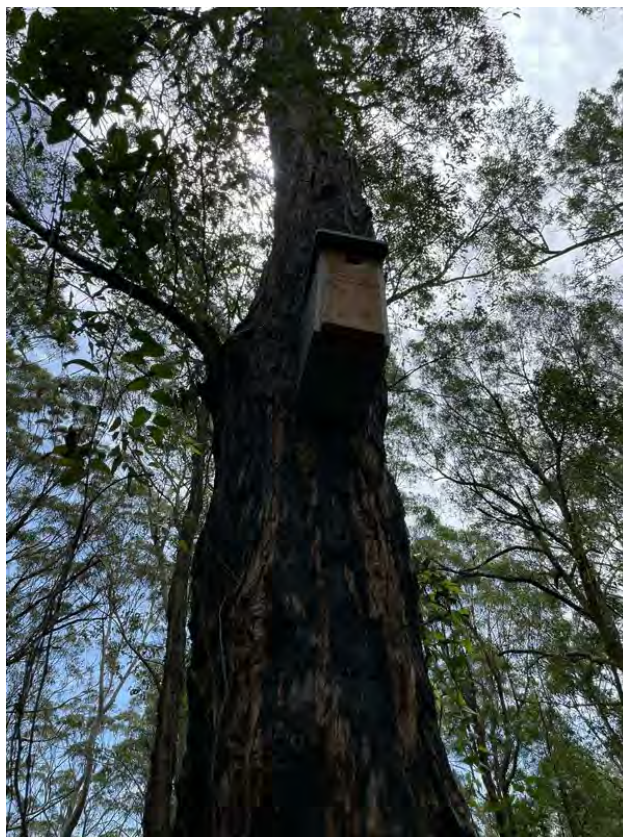
81, Flooded gum

Check Method	Nestbox camera
Pests?	Yes
Pest Species	Mud Wasps
Repairs required?	No
Occupation Evidence?	No

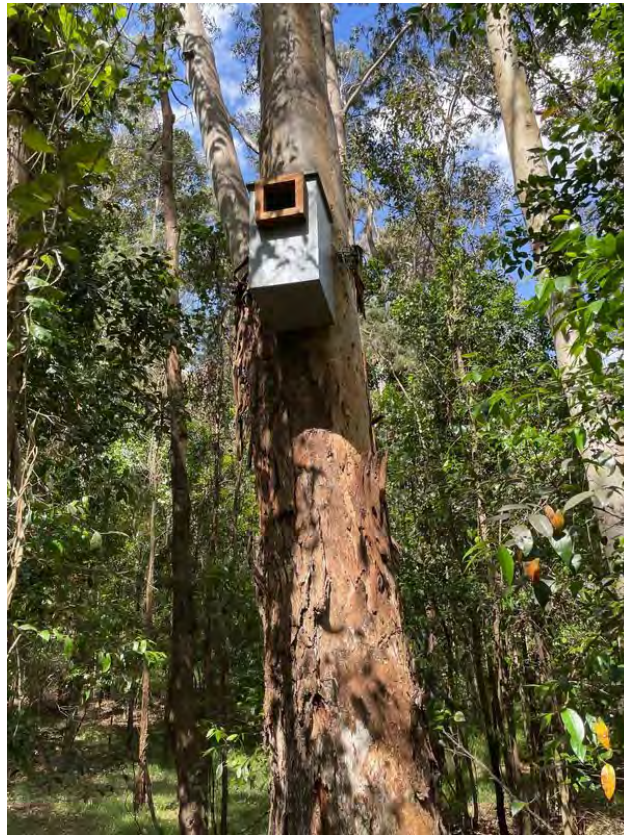
Box Photo

Check Method	Nestbox camera
Pests?	No
Repairs required?	No
Occupation Evidence?	Yes
OccupationEvidenceType	Observed
Fauna Species Observed	Ringtail Possum
Number of fauna Species	1
Count Accuracy	Accurate
OccupationComments	No nesting material other than what came with the box
